ASBESTOS INSPECTION REPORT

**City of Dubuque
Aluminum Furnace
501 East 15th St.
Dubuque, IA 52001
Project #: Z21714W**

BUILDING NAME: Aluminum furnace

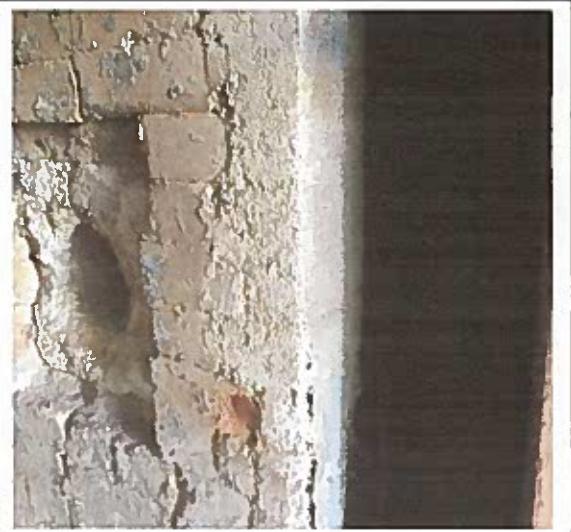
Sample R-1: Taken from front Right Corner, replacement refractory cement.

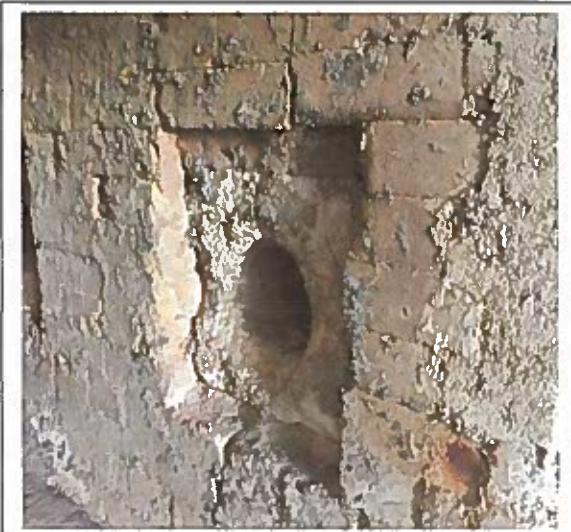
Sample R-2: Refractory brick and mortar, taken from front right side of furnace.

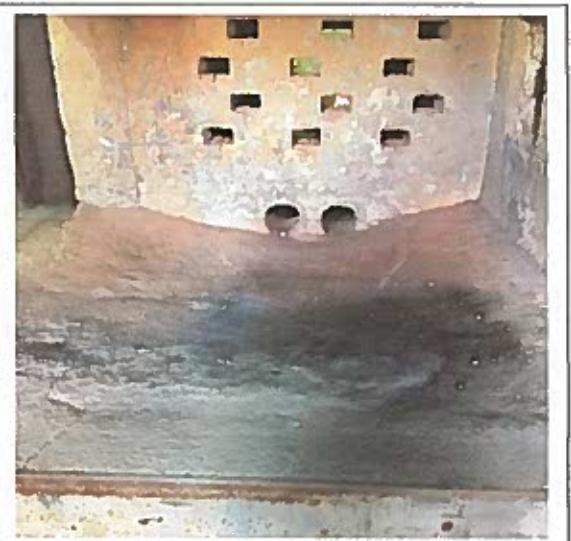
R-3: Refractory cement taken from front floor.

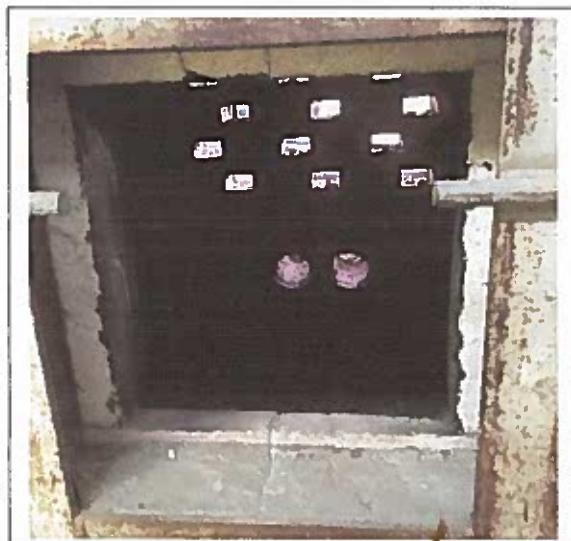
R-4: Refractory cement taken from rear door.

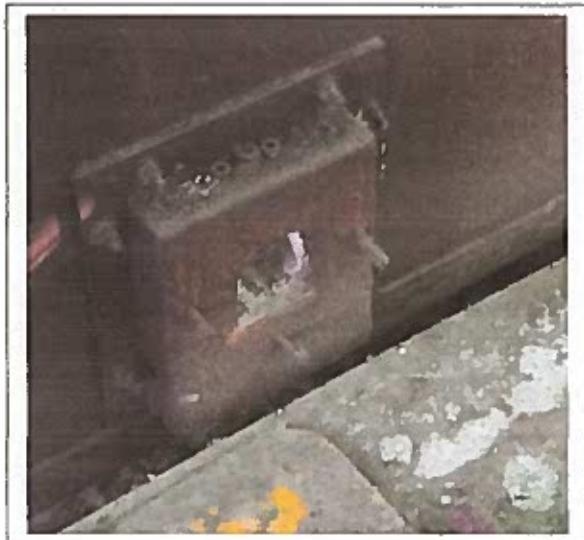
Lab ID Client ID	Sample Location	Layer Name / Sample Description	Asbestos Detected	Asbestos Type (%)	Non-Asbestos Constituents	
0174396-005 R-5	INSULATION POUR SPOUT RIGHT REAR SIDE	LAYER 1 Insulation, Lt. Gray/Yellow	No	None Detected	Fibrous Glass Cellulose Fiber	80% 2%
		LAYER 2 Pour Spout, Dk. Gray	No	None Detected	Gypsum Carbonates Binder/Filler Cellulose Fiber Gypsum Quartz Binder/Filler	18% <1% 99%

R-5: Insulation taken from pour spout right rear side of furnace.
