Caldwell-Designed Structures at Eagle Point Park

Historic Structures Report

2601 Shiras Avenue
Dubuque, Iowa 52001

April 16, 2025
WJE No. 2024.0714.0

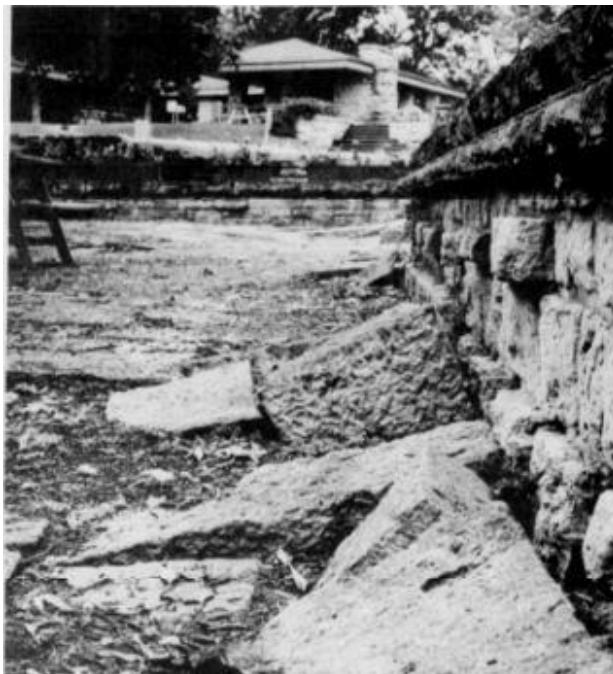
Figure 30. Photograph from the *Dubuque Telegraph Herald*, dated September 15, 1974, depicting distress conditions at the Veranda Rooms terrace.

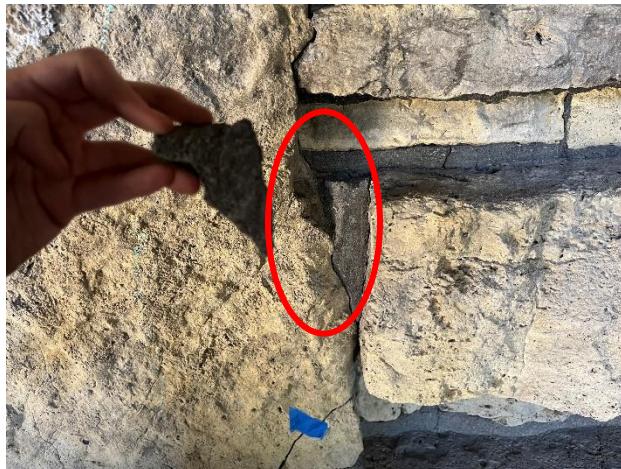
Figure 186. Shallow spalls at edge of stone units.

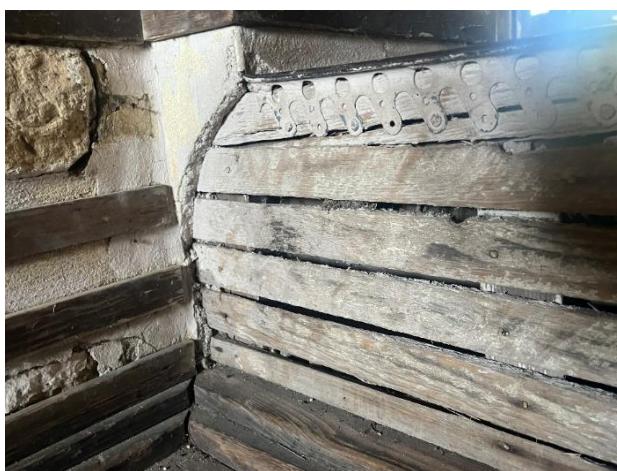
Figure 205. Debonded plaster finish that has fallen loose.

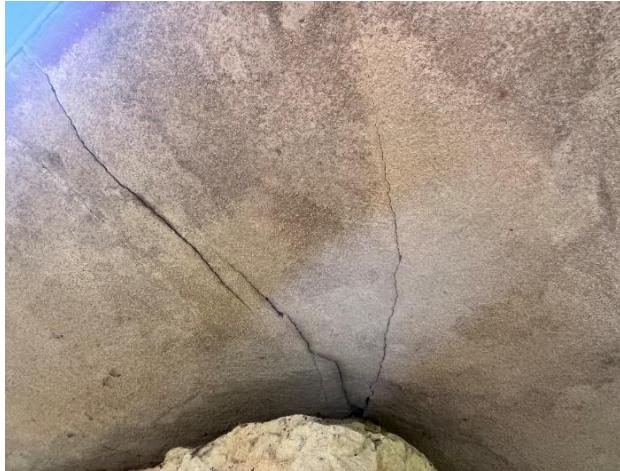
Figure 207. Cracking at the underside of the stucco soffit.

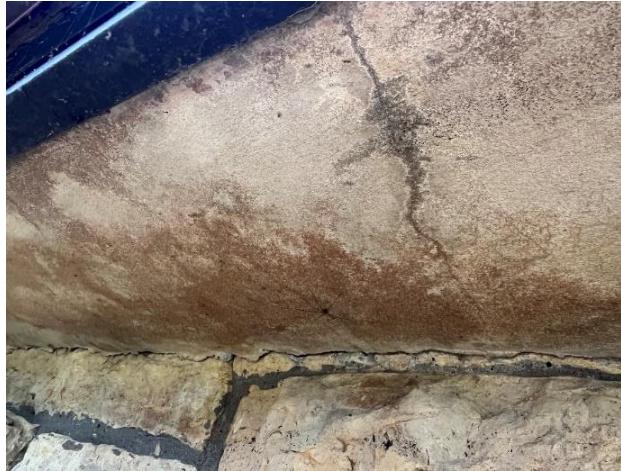
Figure 208. Cracking at the underside of the stucco soffit.

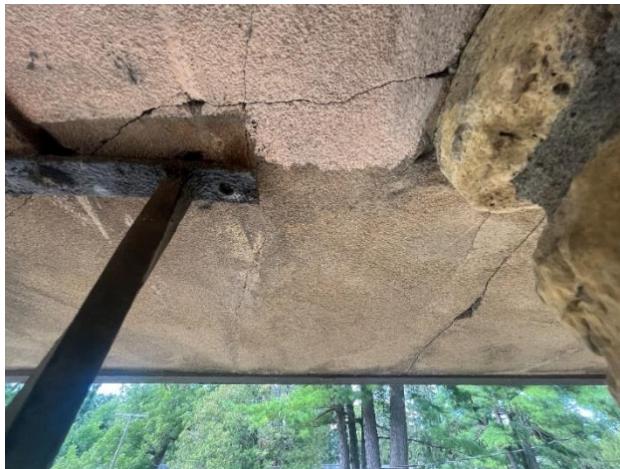
Figure 209. Discoloration of stucco adjacent to crack, indicating that moisture or water infiltration may have been associated with the crack at one time.

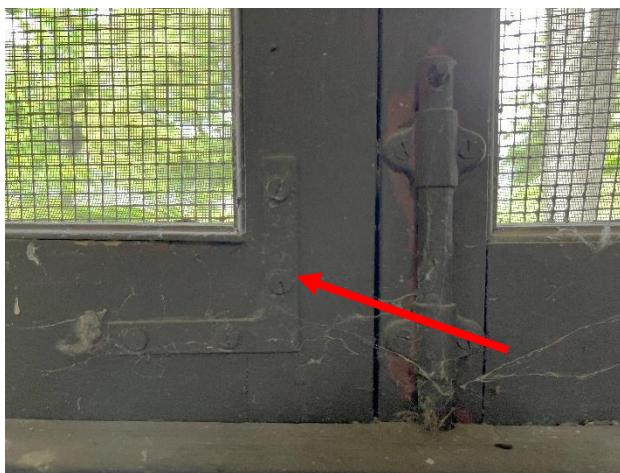
Figure 218. Displaced metal screening at wood-framed window.

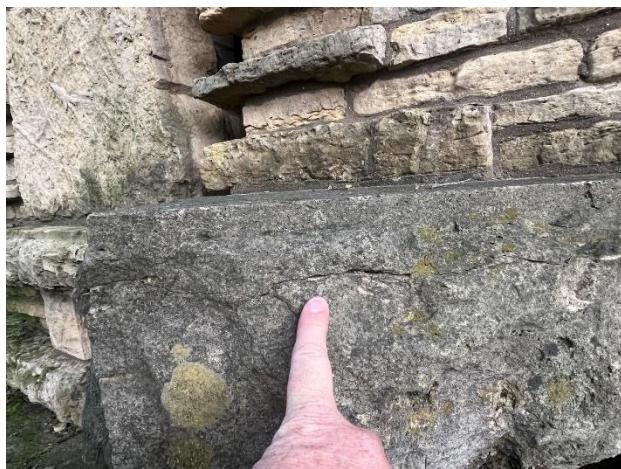
Figure 295. Crack running vertically through the stone.

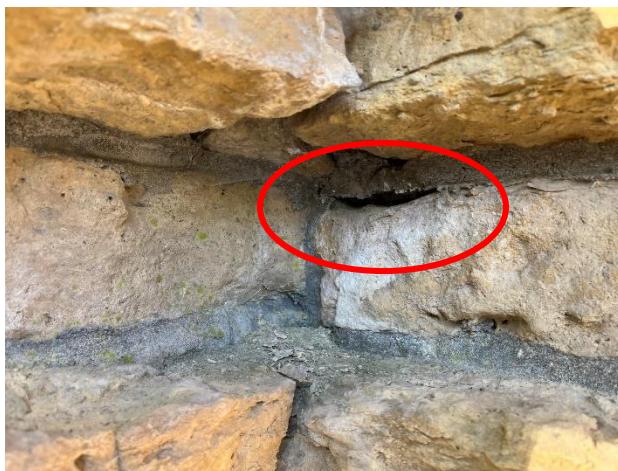
Figure 304. Open horizontal mortar joint.

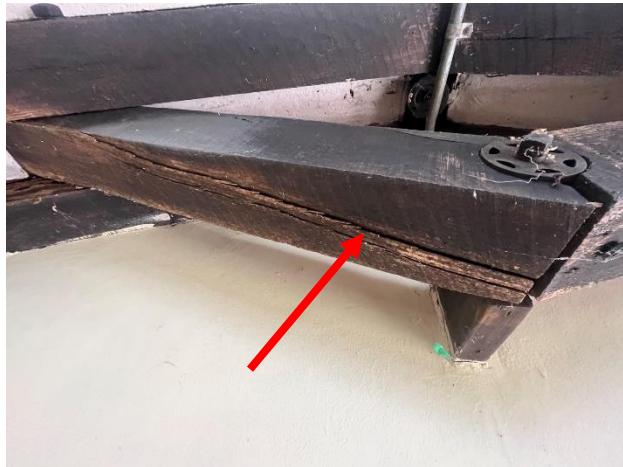
Figure 314. Vertical split at the interior side of the wood post.

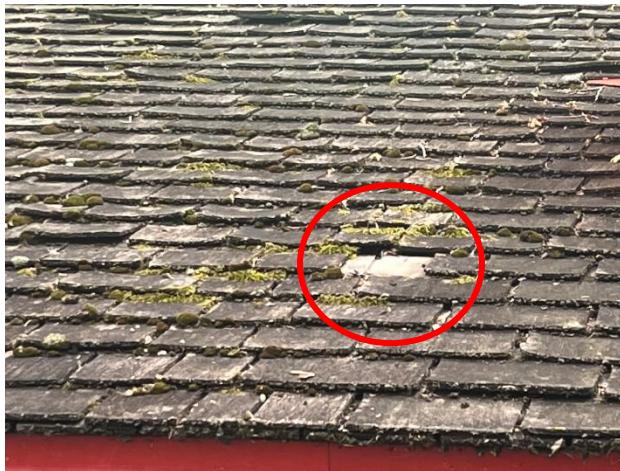
- *Localized Areas of Missing Shingles*. Individual roof shingles are missing at isolated locations (Figure 321). Some of the remaining shingles exhibit minor cupping.
- *Biological Growth*. Biological growth and moss were observed on the wood shingles (Figure 322). The growth is widespread across the roof.

Figure 321. Missing roof shingle.

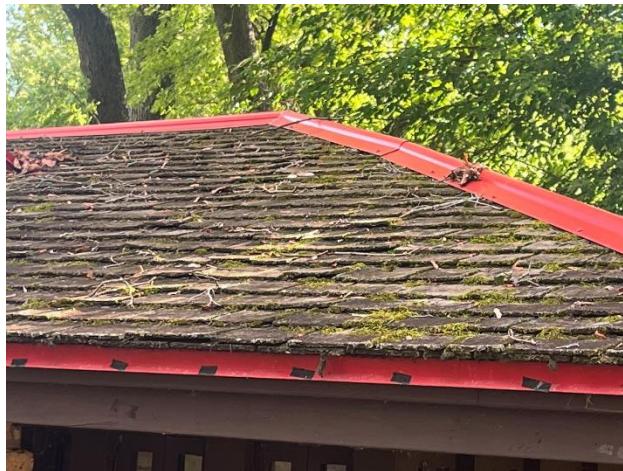
Figure 322. Biological growth and moss on the wood shingles.

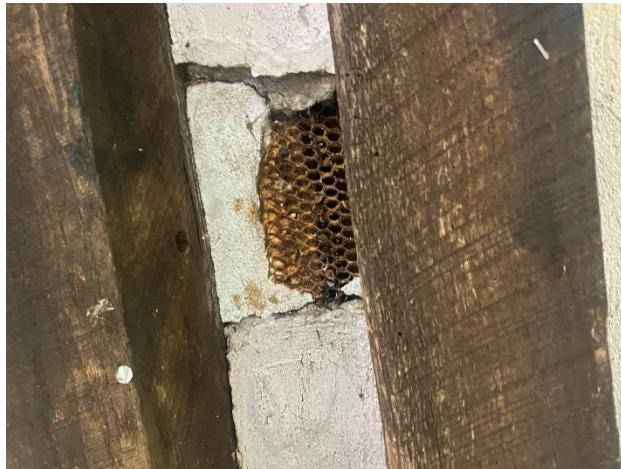
Figure 323. Localized area of damaged plaster at the wall separating the north and south rooms.

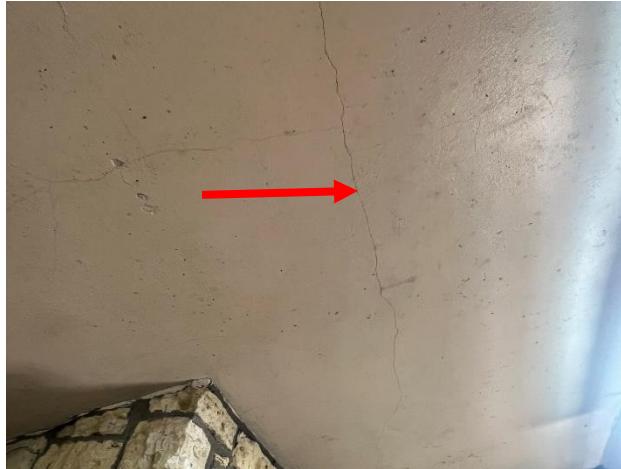
Figure 325. Hairline crack extending perpendicular between roof rafters.

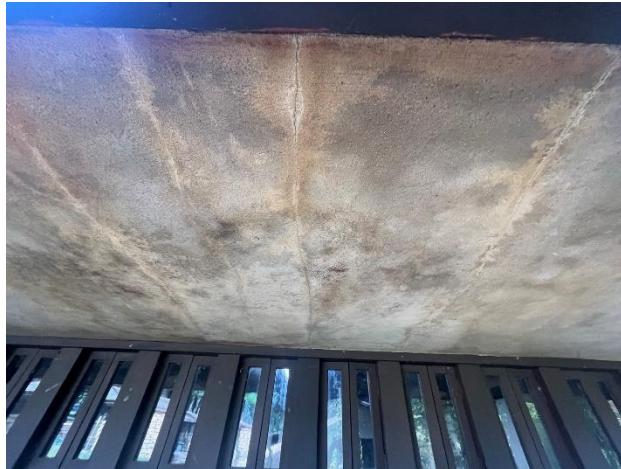
Figure 328. Crack near corner of a stone pier where the depth of the soffit changes.

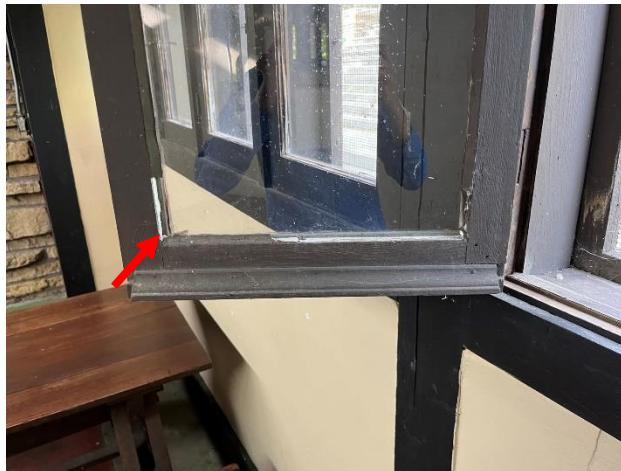
Figure 339. Distress at the top surface of a window sill.

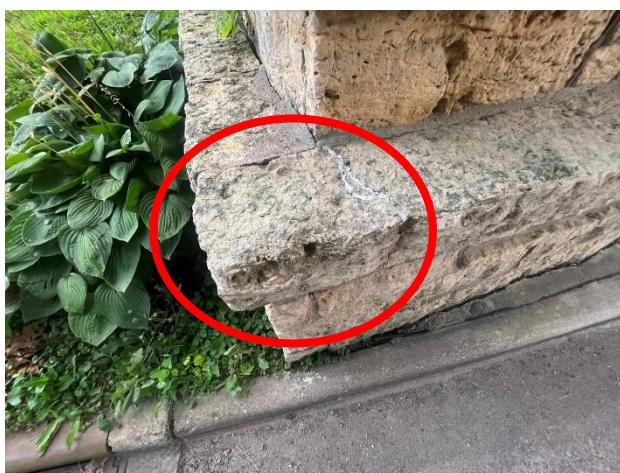
Figure 471. Cracking at the upward-facing surface of a ledge unit.

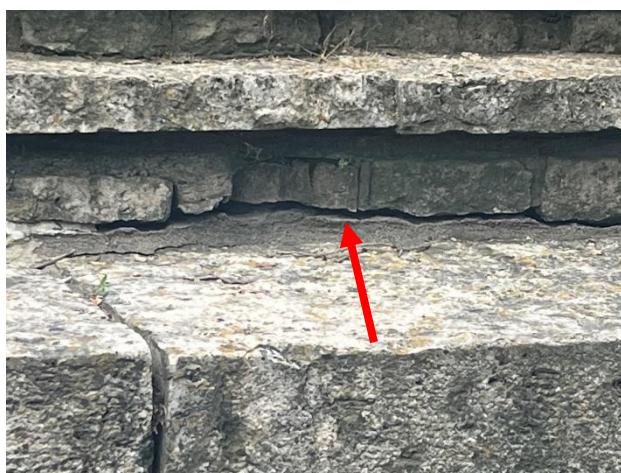
Figure 472. Previously repaired crack. The stone unit was unsound when tapped with a mallet.

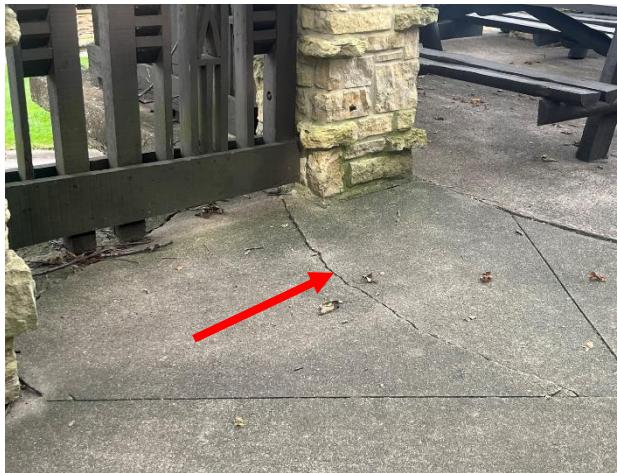
Figure 479. Cracking at the concrete paving of the south terrace.

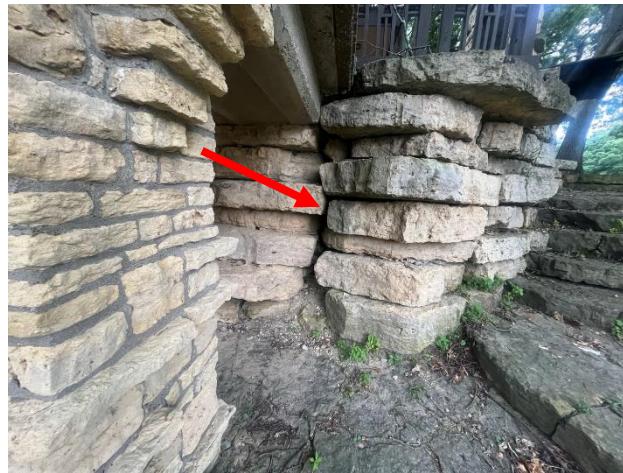
Figure 480. Crack aligned with the edge of the covered stone terrace deck slab.

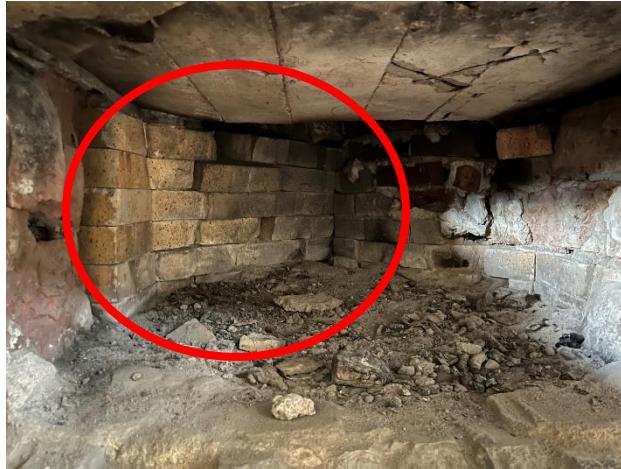
Figure 482. Displaced and loose brick cladding at the firebox.

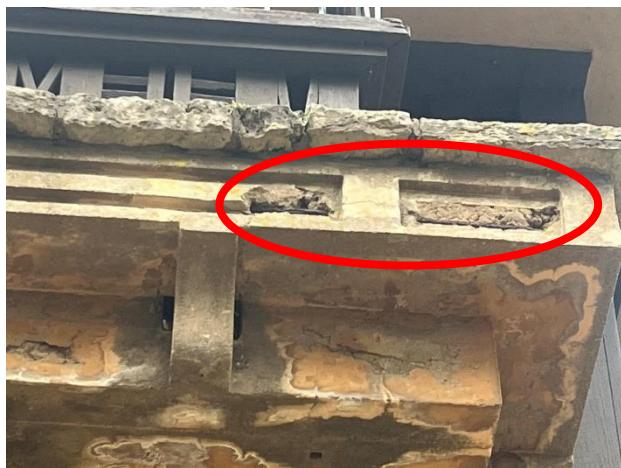
Figure 484. Spall of concrete at balcony edge.

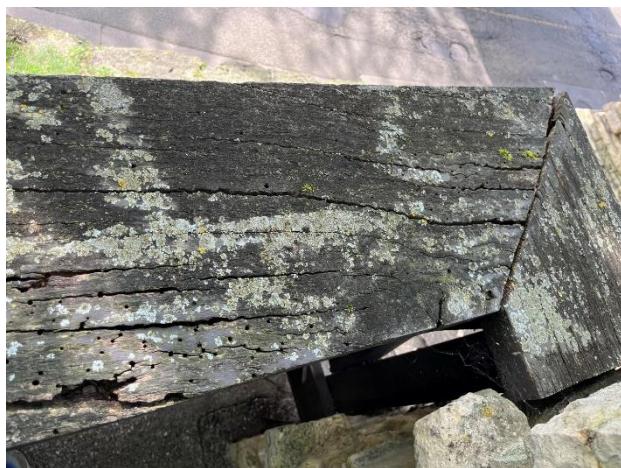
Figure 502. Severe deterioration and biological growth at wood of top rail of railing.

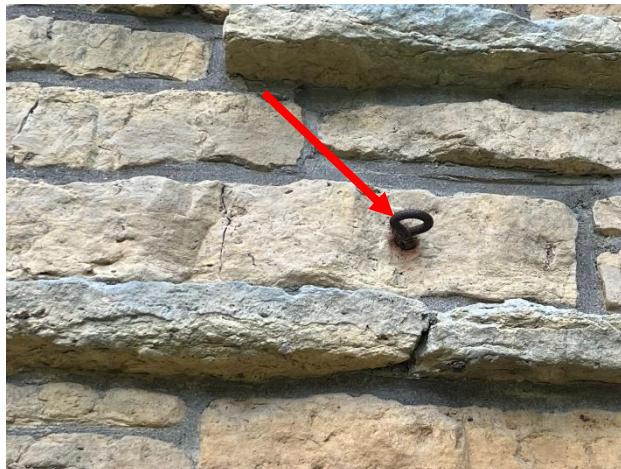
Figure 506. Corroded embedded steel anchor in the stone.

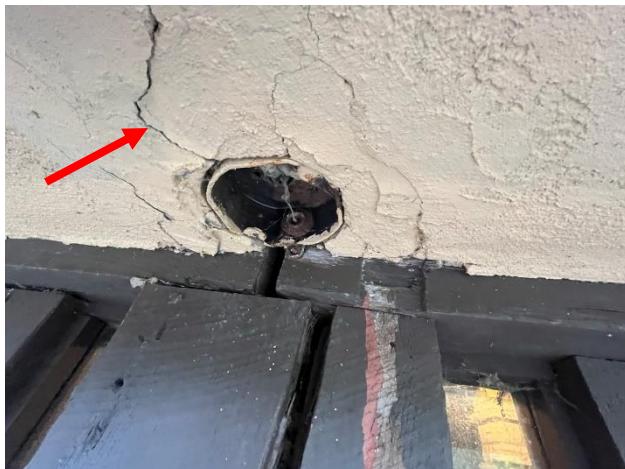
Figure 507. Abandoned junction box in the soffit has resulted in cracking of the adjacent stucco.

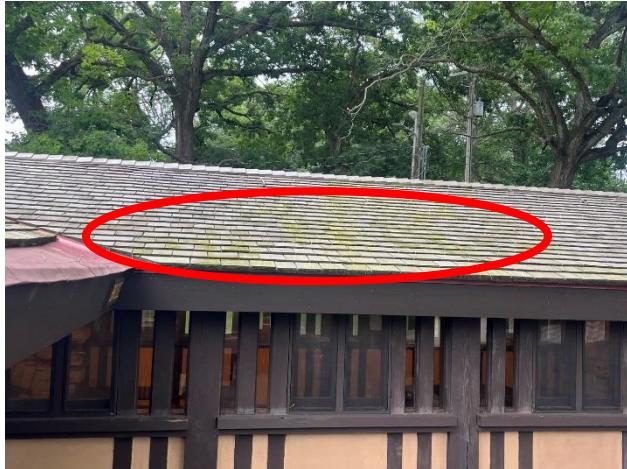
Figure 508. Mild biological growth at the west-facing slope of the roof.

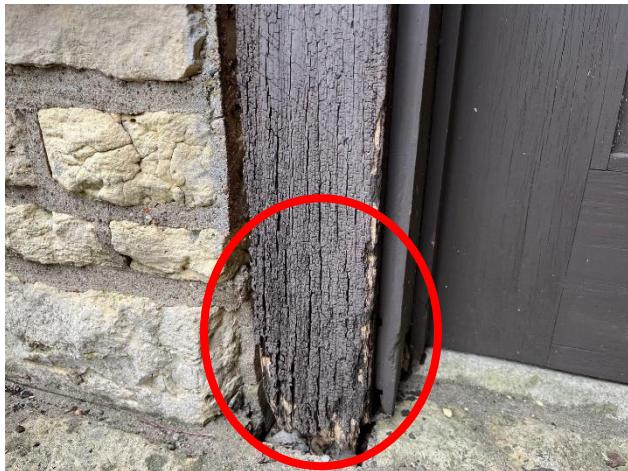
Figure 515. Distress at bottom of vertically oriented wood member.

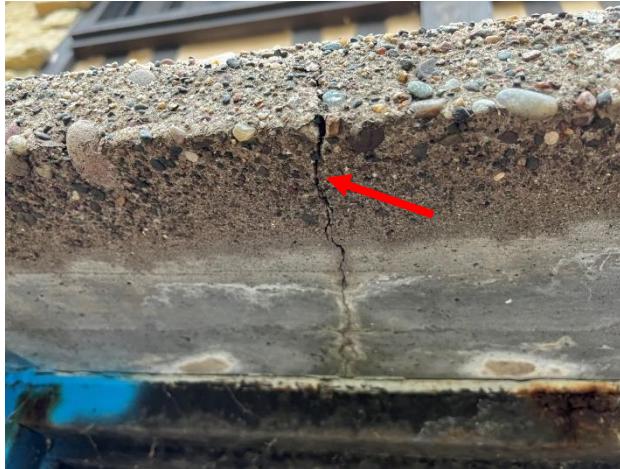
Figure 516. Cracking at concrete lintel with evidence of moisture staining and infiltration along the crack.

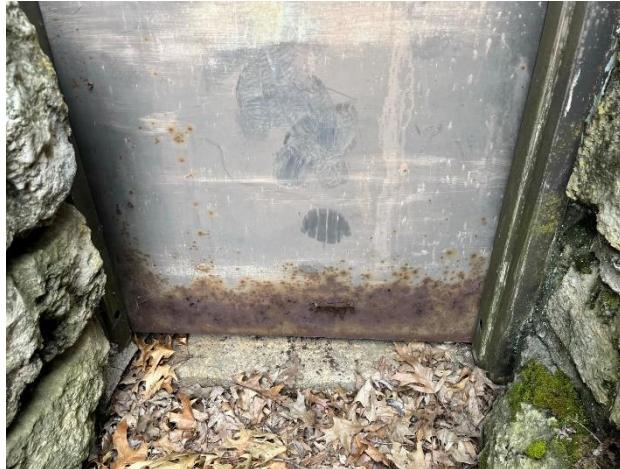
Figure 517. Corrosion along the bottom of the door leaf.

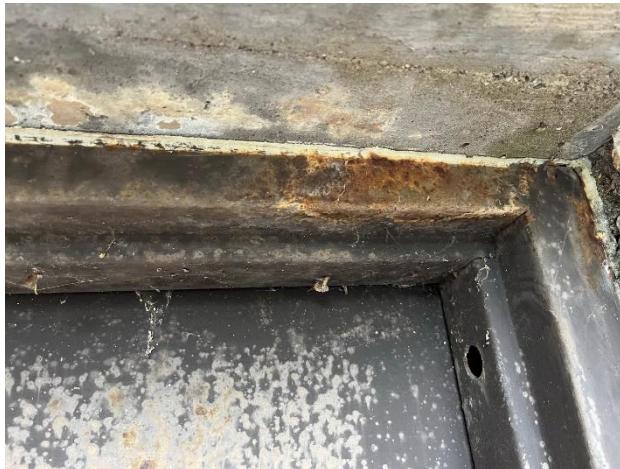
Figure 518. Corrosion at the head of the door frame.

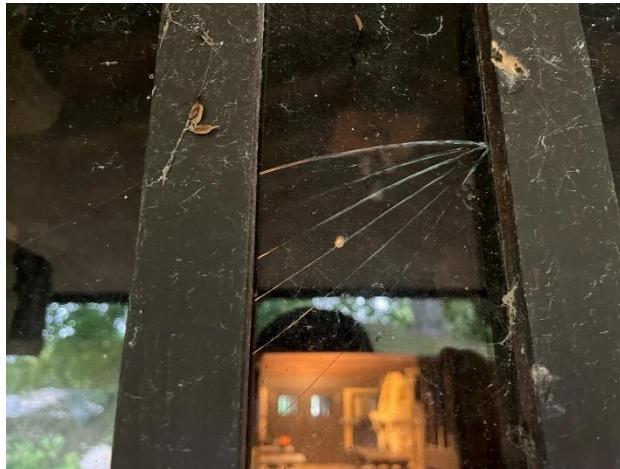
Figure 519. Cracked glass light at door.

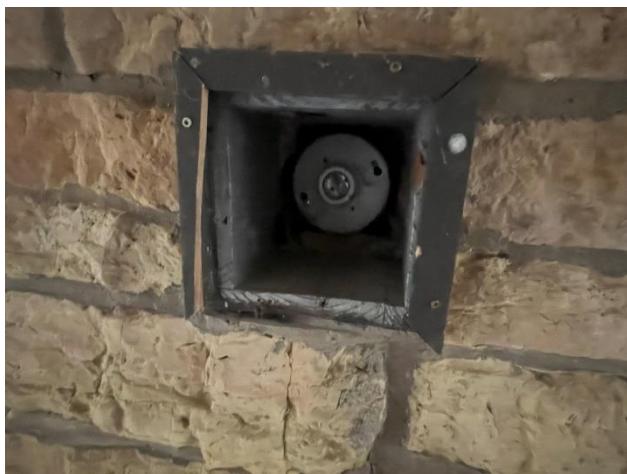
Figure 520. Removed light that has not been replaced.

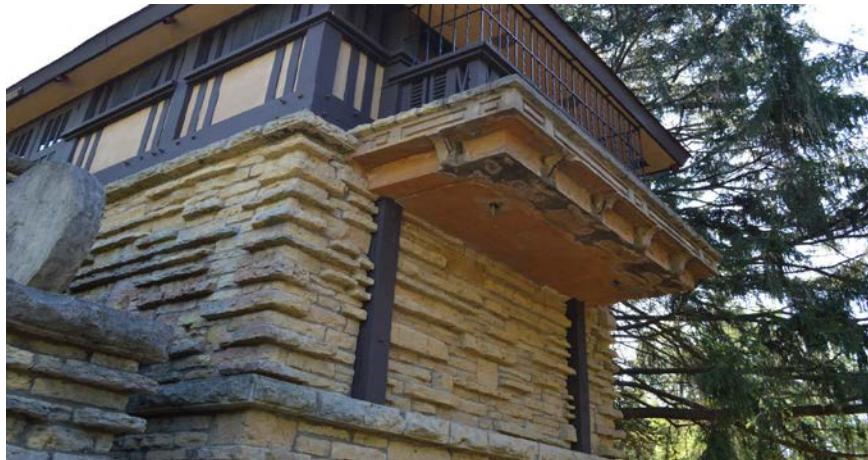
FIGURE 8 Detail of the western end of the Bridge Complex, showing the deterioration of the balcony and its missing lighting fixtures. Source: Photograph by Dr. Julie Schlarman September 14, 2015.
