Caldwell-Designed Structures at Eagle Point Park

Historic Structures Report

2601 Shiras Avenue
Dubuque, Iowa 52001

April 16, 2025
WJE No. 2024.0714.0

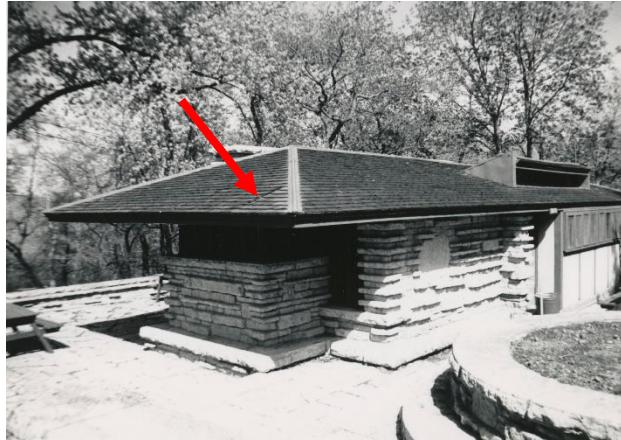
Figure 29. South elevation of the Veranda Rooms, circa 1973 (Source: Center for Dubuque History) The electrical posts that receive the main utility line have been removed. Repairs are visible in the shingle roofing where the posts were located (arrow).

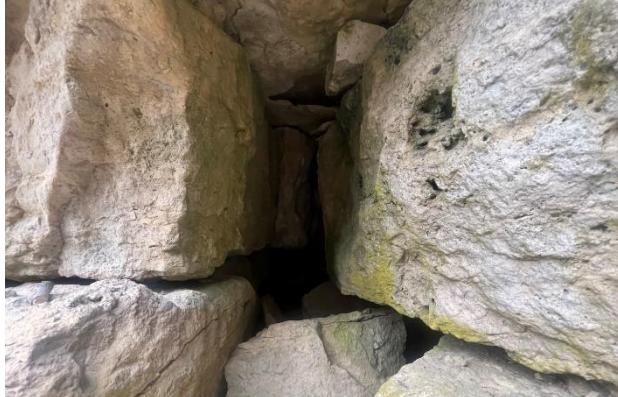
- *Large Gaps and Voids in Dry-Laid Construction.* Large voids were observed at the joints between stone units at the retaining wall that extends under the north terrace and south end of the east pavilion (Figure 60). The voids measured as much as 6 inches wide and to a depth of a few feet. Plants were growing within some of the voids (Figure 61 and Figure 62).

Figure 60. Large voids were observed at the joints between stone units at the retaining wall that extends under the north terrace and south end of the east pavilion.

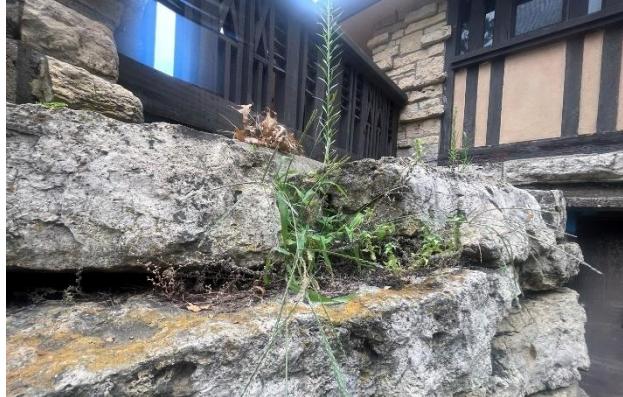
Figure 61. The voids measured as much as 6 inches wide and to a depth of a few feet. Plants were growing within some of the voids.

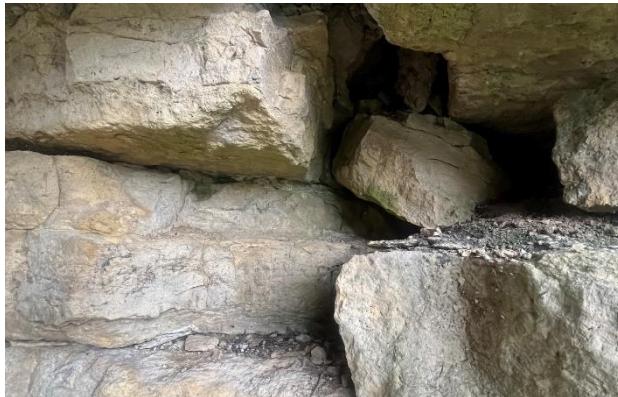
Figure 62. The voids measured as much as 6 inches wide and to a depth of a few feet.

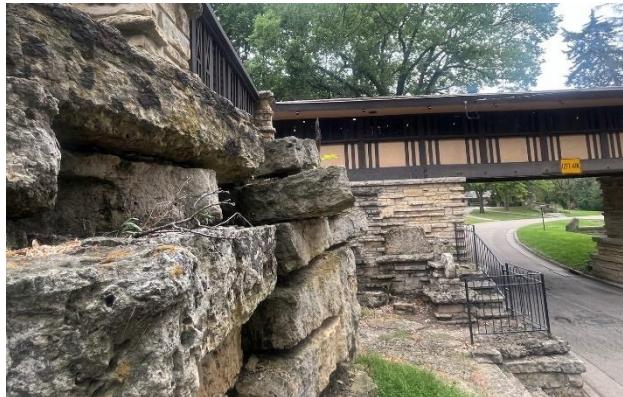
- *Displaced Units and Bulging at the Retaining Wall.* The portion of the retaining wall under the north terrace was observed to have displaced stone units and to be bulging. The bulging was most prevalent approximately 6 feet above grade (Figure 63). The stone units above the bulge appeared to be rotating and tipping backward.

Figure 63. Displacement of stone units and bulging of the wall was most prevalent approximately 6 feet above grade.

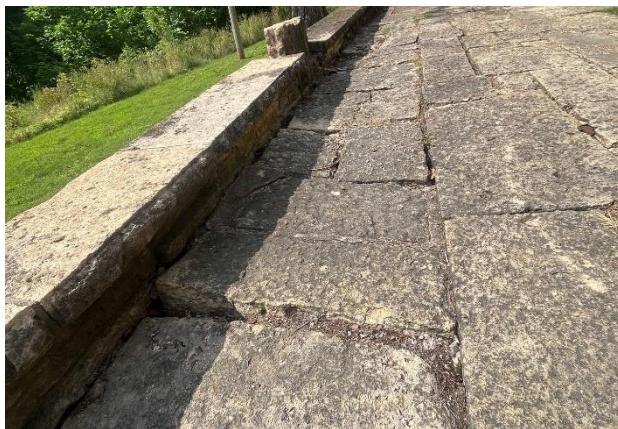
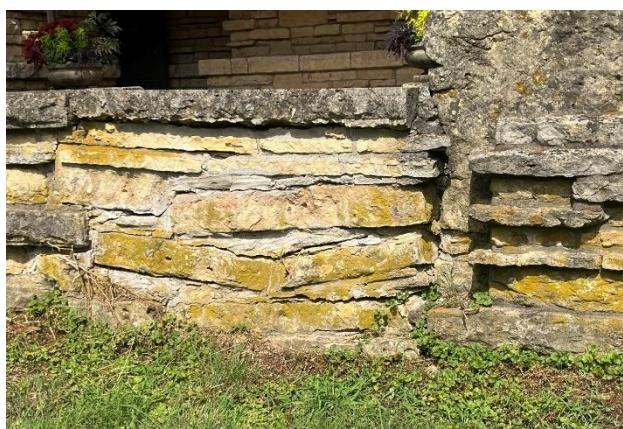
- *Partially Collapsed Stone Parapet Wall.* One location along the west parapet has a stone coping unit that is intentionally oriented vertically rather than horizontal. The stone paving and parapet wall adjacent to this coping unit are displaced and partially collapsed (Figure 64 and Figure 65).

Figure 64. The stone paving and parapet wall adjacent to the coping unit are displaced and partially collapsed.

Figure 65. The stone paving and parapet wall adjacent to the coping unit are displaced and partially collapsed.

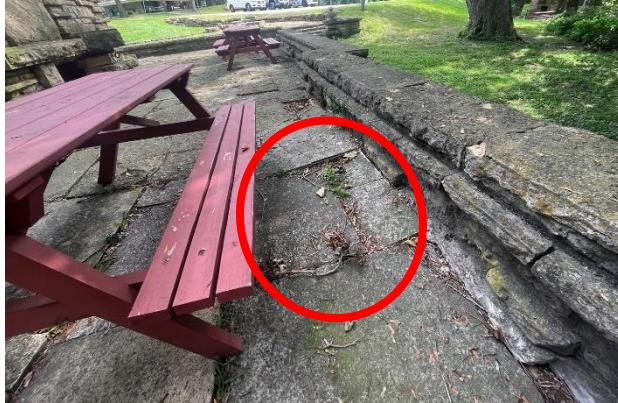
- *Displaced Stone Paving at Veranda Room Terrace.* The stone paving along the west side of the Veranda Room terrace is sunken and displaced. Piles of sand washout were observed at ports in the terrace wall adjacent to the displaced paving (Figure 66 and Figure 67).

Figure 66. Displaced stone paving at Veranda Rooms terrace.

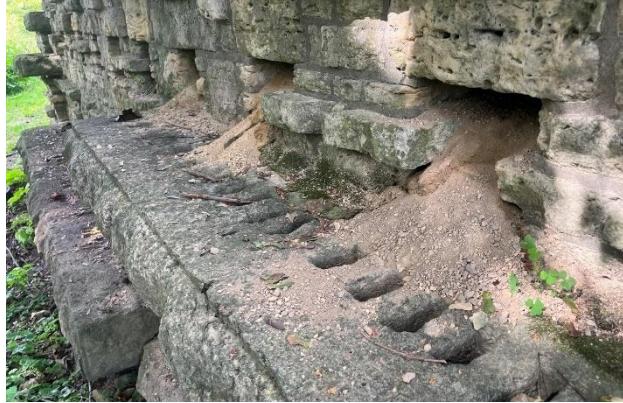
Figure 67. Piles of sand washout were observed at ports in the terrace wall adjacent to the displaced paving.

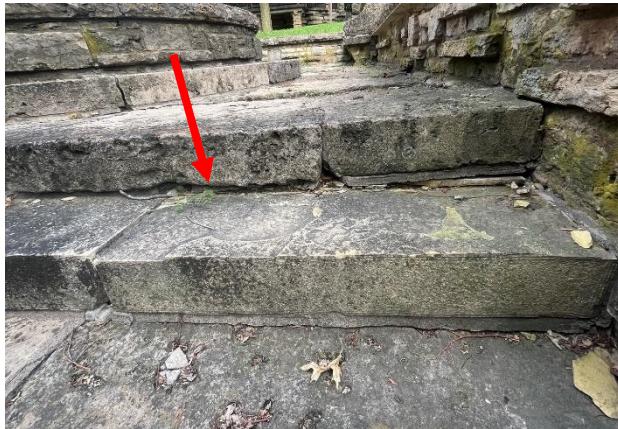
- *Open Mortar Joints.* Many of the mortar joints between stone coping units and along stone terrace stair units are cracked, open, or missing (Figure 68). Where open joints are present, cracking was often observed at the adjacent stone units (Figure 69).

Figure 68. Open mortar joints at stone stair treads.

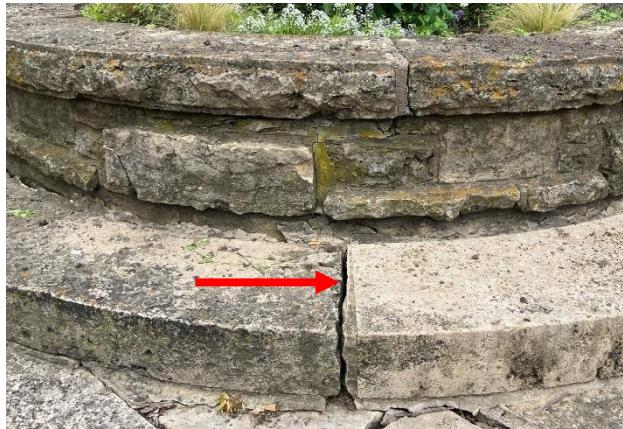
Figure 69. Open mortar joints at circular planter at Veranda Rooms terrace.

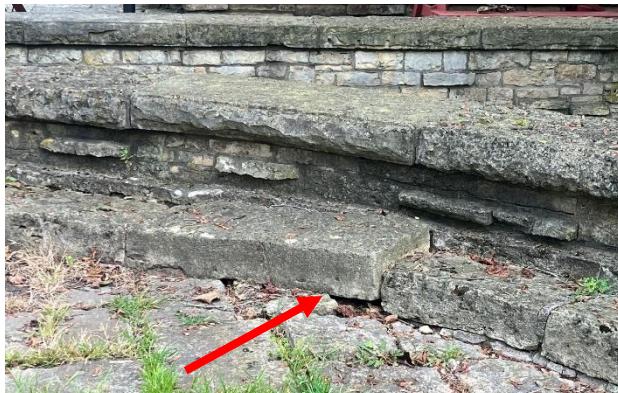
- *Localized Displacement.* A few stone units at the semicircular terrace seating areas are displaced or heaved (Figure 70). Typically, the distress is localized to one or two adjacent units per location. However, displacement was also present at pavers adjacent to partially collapsed parapet walls.

Figure 70. A few stone units at the semicircular terrace seating areas are displaced or heaved.

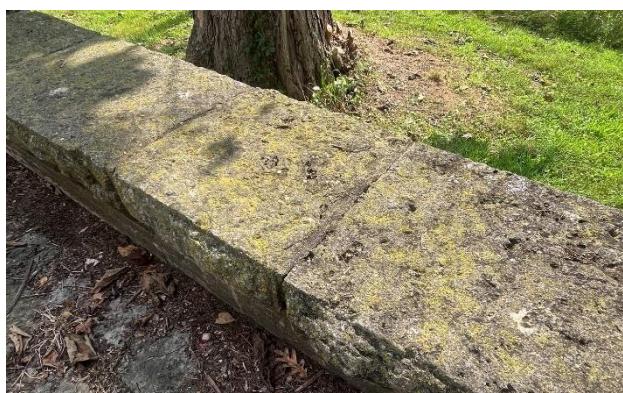
- *Biological Growth.* Moss and lichen were observed at most of the stone parapet walls (Figure 71). At a few locations, plants and weeds were observed at the joints between stone paving units (Figure 72). The joints were originally intended to support grasses; however, the grasses have been replaced by weeds, which have a deeper root system that may impact the performance of the paving system.

Figure 71. Moss and lichen were observed at most of the stone parapet walls.

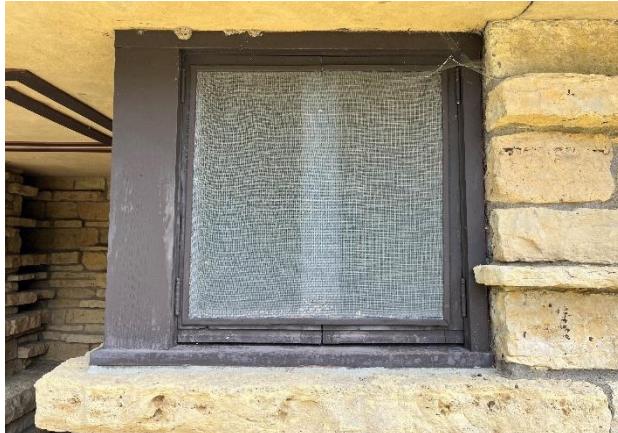
Figure 93. Wood-framed screen mounted over the exterior of the sash, making the windows inoperable.

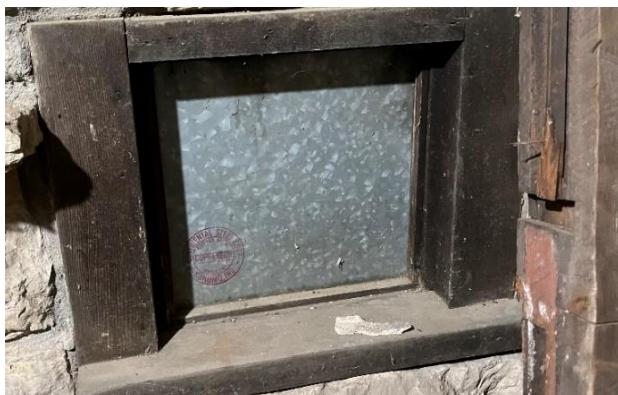
Figure 97. A removed sash infilled with non-original galvanized metal panel.

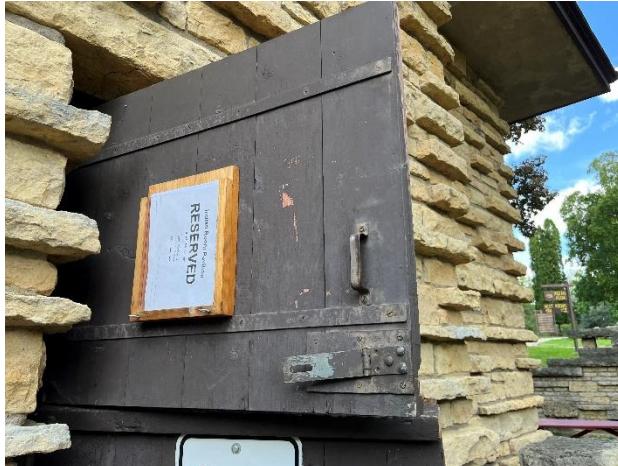
Figure 100. The upper leaf of the south door is reinforced with non-original metal straps that span horizontally across the leaf.

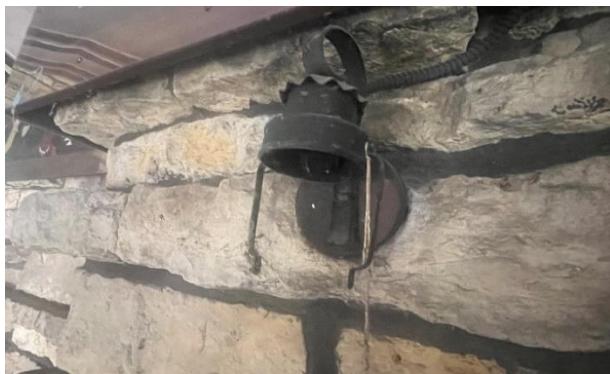
Figure 169. Surface-mounted lantern, with the lamp of the light fixture missing.

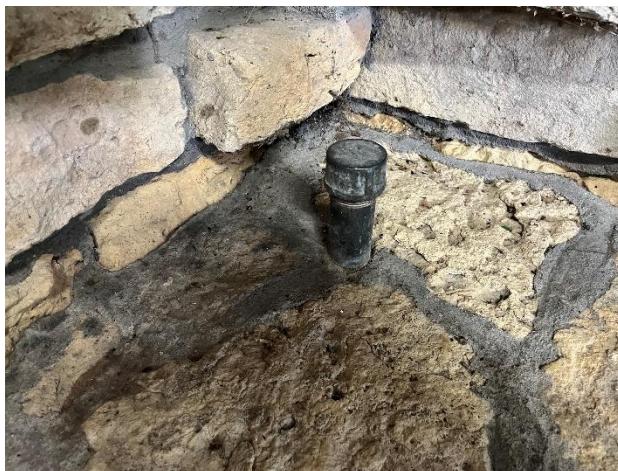
Figure 176. Capped pipe set in floor of community room likely supported a radiant heating system that has since been removed.

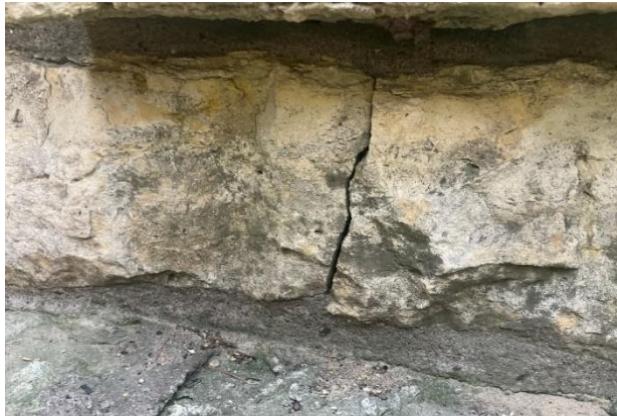
- *Vertical Cracking at Stone.* Localized areas of vertical cracking were observed at the center of several stone units in the field of the wall (Figure 182). The most significant vertical cracking was observed at the stone mantels for both the upper and lower fireplace (Figure 183 and Figure 184). The cracking extended the full depth of the stone mantel and was unsound when evaluated with a sounding mallet. In addition to the cracking, the steel angle that supports the mantels was observed to have surface corrosion (Figure 185).

Figure 182. Localized vertical cracking at the center of several field of wall stone units.

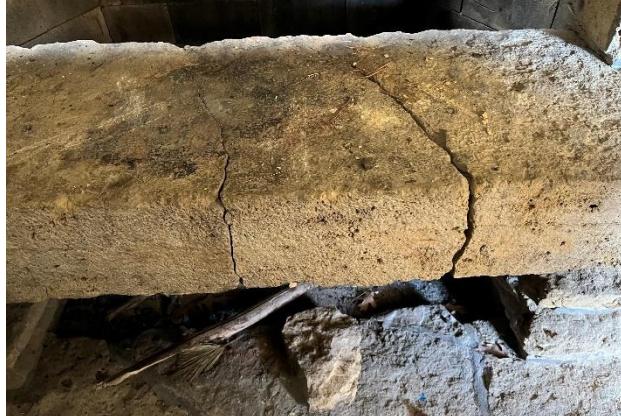
Figure 183. Significant vertical cracking at upper fireplace mantel.

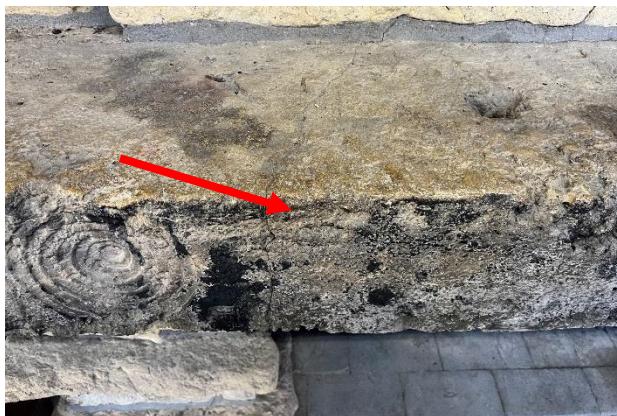
Figure 184. Vertical cracking at lower fireplace stone mantel.

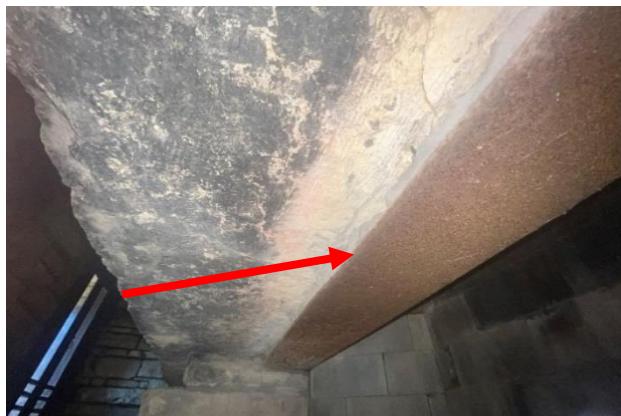
Figure 185. Surface corrosion at the steel angle that supports the mantel.

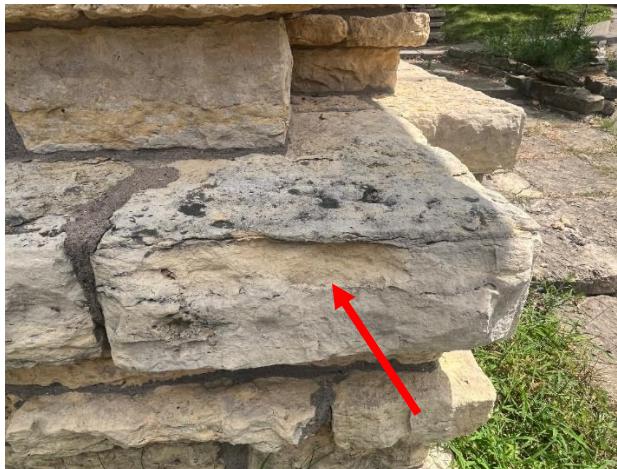
- *Shallow Spalls at Mortar Joints.* Shallow spalls were observed along the edge of some stone units. The spalling resulted in the loss of some of the rock-faced stone but the mortar remained intact (Figure 186).

Figure 186. Shallow spalls at edge of stone units.

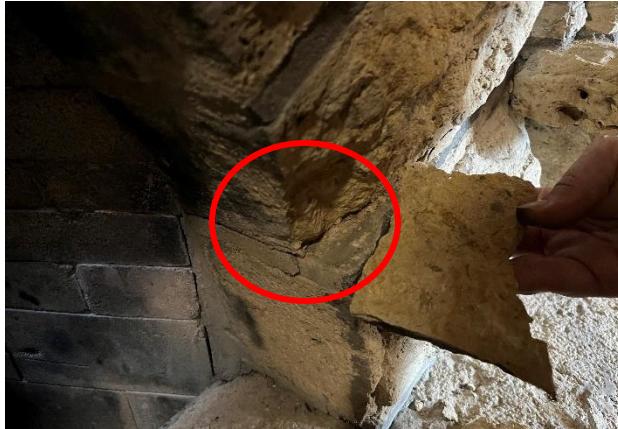
- *Shallow Spalls near Fireplaces.* A few shallow spalls were observed at the stone units around the fireplace openings (Figure 188). The spalls were as large as 4 inches square and 3/8 inch deep.

Figure 188. Shallow spalls at the stone unit around upper fireplace opening.

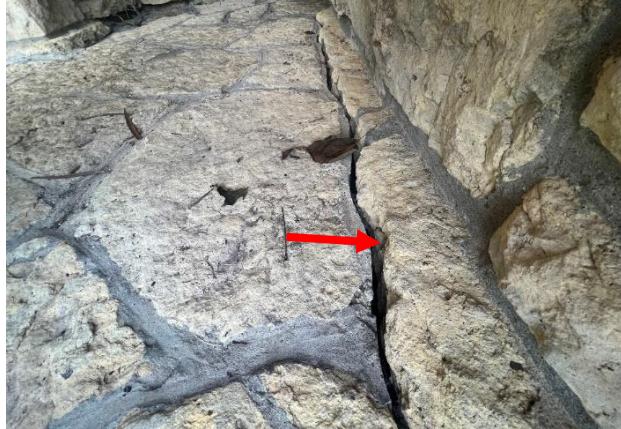
- *Open Joints at Paving.* An open joint was observed between the stone paving at the recessed restroom vestibule and at the adjacent restroom enclosure (Figure 189). The mortar remains intact but has fully debonded from the stone at the restroom enclosure.

Figure 189. Open joint between the stone paving at the recessed restroom vestibule and at the adjacent restroom enclosure.

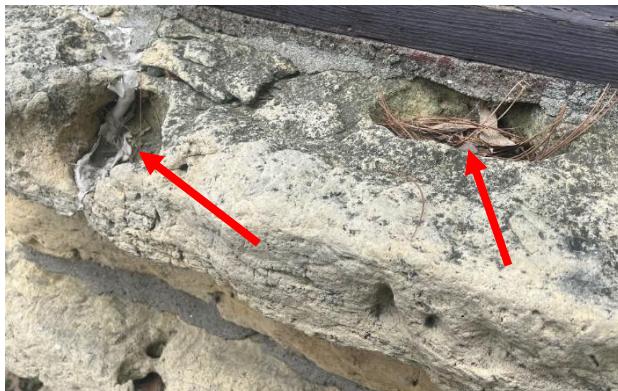
- *Localized Pitting.* Deep pockets and pits were observed in the stone at a few locations (Figure 190). The pitting was observed at isolated stone units and was typically aligned with areas of water runoff or dripping.

Figure 190. Deep pockets and pits in the stone.

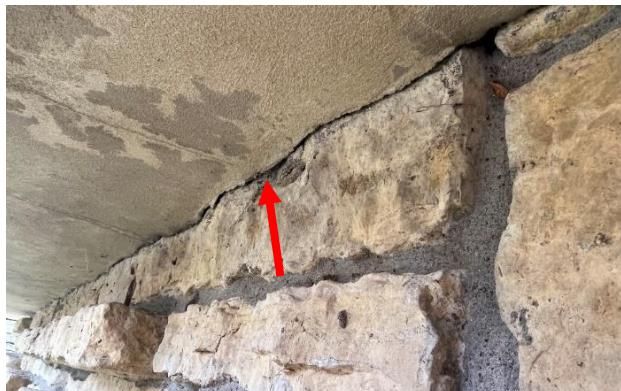
Figure 191. Continuous gap, measuring 1/8 inch wide, between the materials.

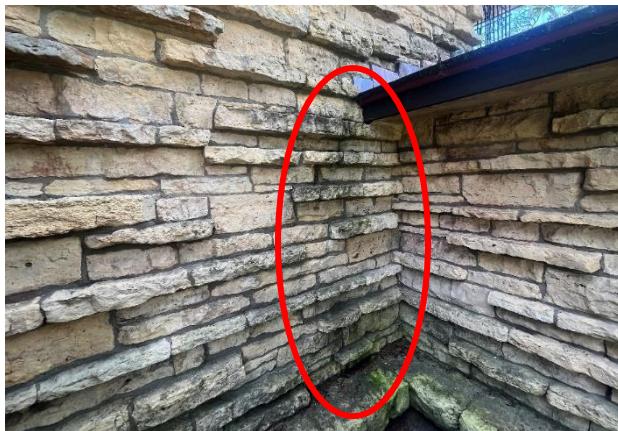
- *Biological Growth.* Biological growth and soiling were observed at the stone walls, specifically at upward-facing surfaces and at wall areas perpendicular and adjacent to locations subject to water runoff from roofs (Figure 192).

Figure 192. Biological growth and soiling at stone walls perpendicular and adjacent to roof runoff.

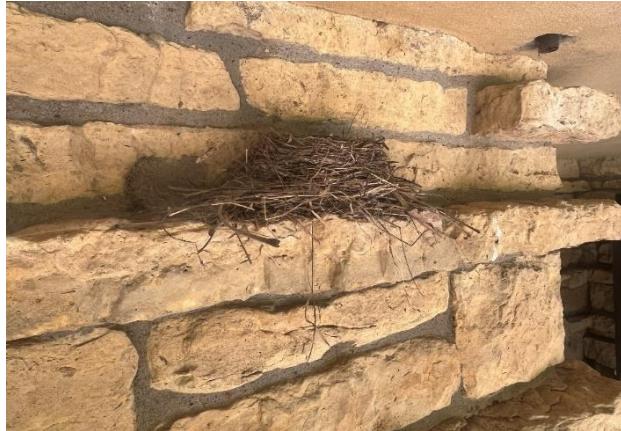
- *Pest Infestations.* At several locations, bird and insect nests were observed adjacent to projecting stone units (Figure 193).

Figure 193. A bird nest adjacent to projecting stone units.

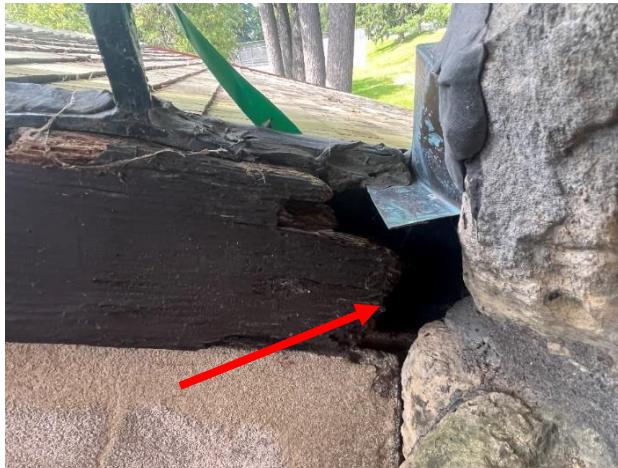
- *Deteriorated Wood Trim.* The wood top rail and trim at the exterior balconies had severely deteriorated, resulting in complete section loss and areas that were soft when probed (Figure 194). The distress was observed at the ends of the rail and trim, where these features abut the wall.

Figure 194. Complete section loss at the wood top rail and trim at the exterior balconies.

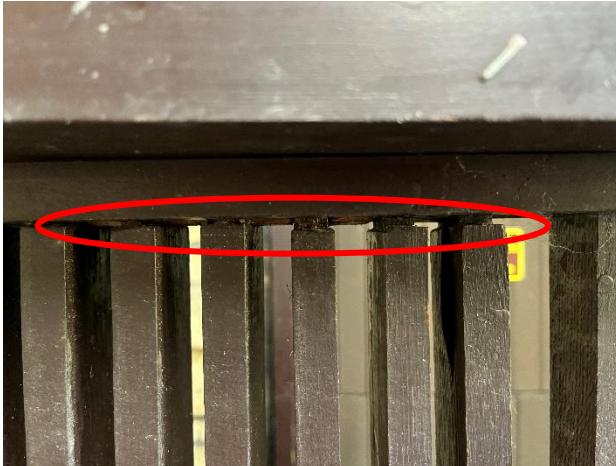
- *Gaps at Wood Joints.* Gaps measuring as wide as 3/8 inch were observed between wood elements at the wood screen of spindles that is located at the north bench. The vertical spindles are separated from the top rail of the screen (Figure 196).

Figure 196. Vertical rails separated from the top rail of the screen.

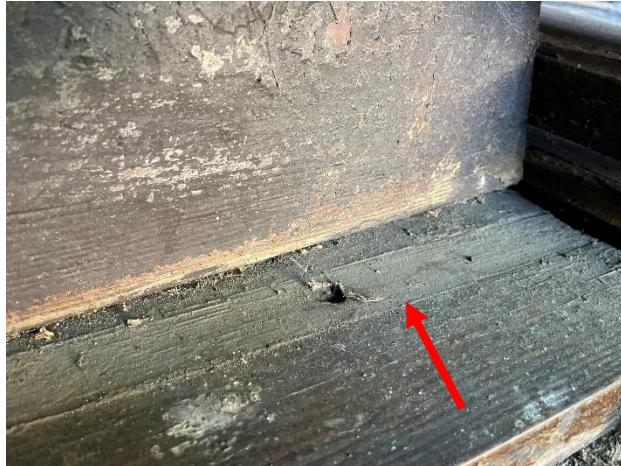
- *Splits, Displacement, and Missing Wood Elements.* Wood benches at the fireplace exhibited splits and missing portions of the wood framing at the foot of the bench. The vertical board that supports the center of the bench seat was observed to be displaced and not aligned with the center of the bench seat (Figure 197). Some of the decorative 2x8 wood members that surround the support posts at the base of the bench have split and portions are missing (Figure 198 and Figure 199).

Figure 197. Displaced vertical board that supports the center of the bench seat.

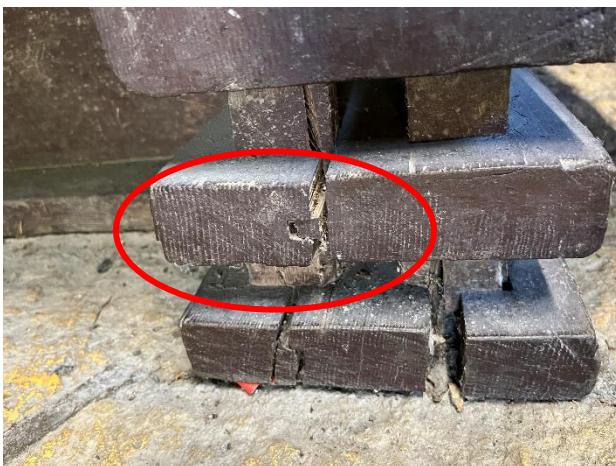
Figure 198. Split decorative 2x8 wood members that surround the support posts at the base of the bench.

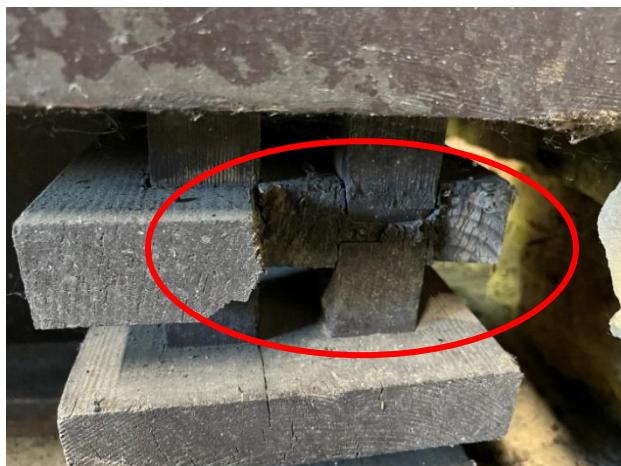
Figure 199. Missing portions of the decorative 2x8 wood members are missing.

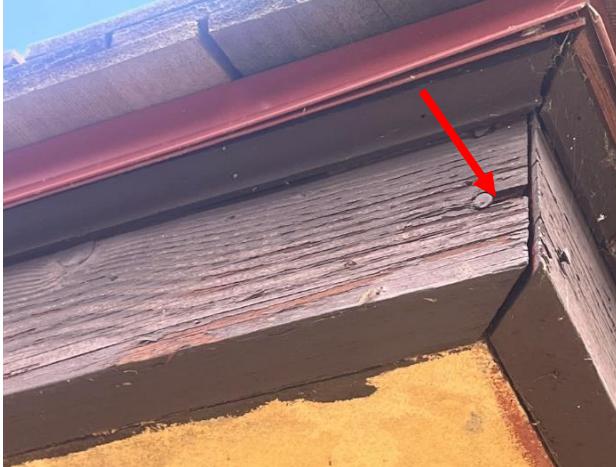
- *Minor Checks and Splits.* Minor checks and splits are present at the ends of some wood fascia boards, aligning with fastener locations (Figure 200). Localized areas of peeling paint were observed, typically near the ends of wood fascia members.
- *Biological Growth.* Biological growth was observed at the wood shingles and at the stone on the upward-facing surface and the lower portion of the walls (Figure 201). The growth at the roof shingles is light green. Biological growth at the stone includes reddish brown, black, and green discoloration.

Figure 200. Minor checks and splits at the ends of some wood fascia boards.

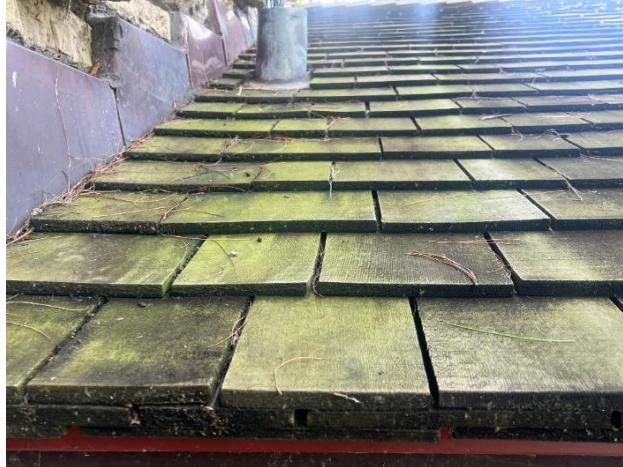
Figure 201. Biological growth at wood shingles.

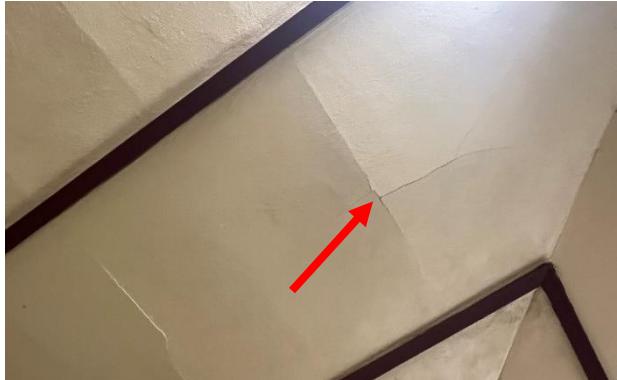
- *Cracking and Debonding of Interior Plaster.* Cracks extend perpendicular to the wood trim pieces at the non-original plaster ceiling of the restrooms. The cracks are as wide as 1/16 inch. At some locations, the plaster is sagging and appears to have debonded from the substrate. The pattern of cracking is more irregular where sagging was observed (Figure 202).

Figure 202. Irregular cracking pattern where sagging was observed.

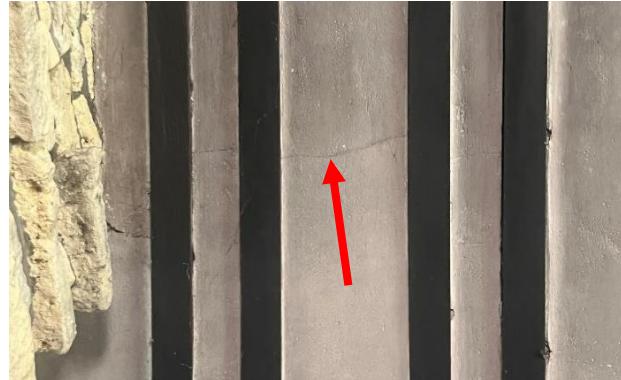
Figure 203. Straight line cracking in plaster.

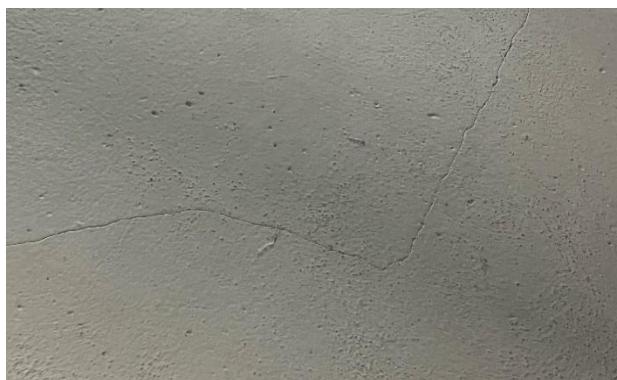
Figure 204. Incrementally stepped cracking across the plaster surface.

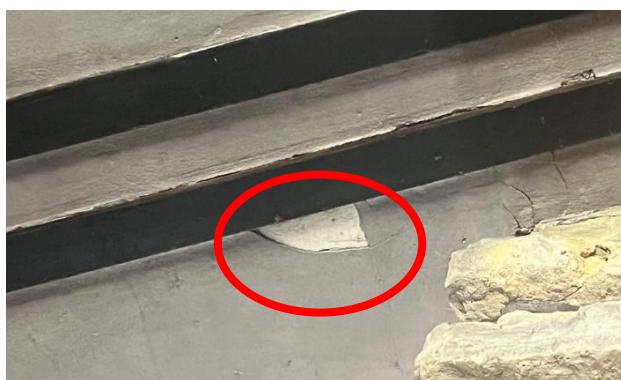
- *Hairline Cracking at Interior Plaster.* Hairline cracking at the historic plaster ceilings extend perpendicular between wood trim pieces as well as across the plane of the ceiling. The cracking is generally in a straight line or steps incrementally across the plaster surface, likely aligning with the location of joints in the wood lath (Figure 203 and Figure 204). At isolated locations, typically along the wood trim, small areas of the plaster finish have debonded from the scratch coat and fallen loose (Figure 205).

Figure 205. Debonded plaster finish that has fallen loose.

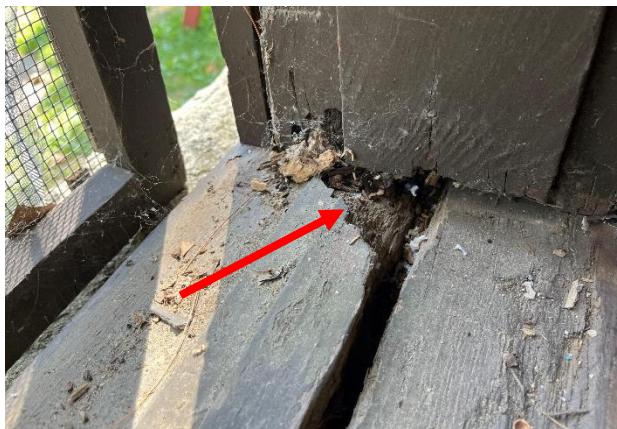
- *Deteriorated Wood at Sill and Framing.* At a few locations, the wood sill has split and was soft when probed. The distress typically aligns with the exterior face of the sash (Figure 211). The wood window jamb adjacent to the sill also exhibits deterioration along the bottom edge.
- *Split wood at Mullion.* At least one window mullion had a split at the wood cladding that extends the full depth of the wood to a length of approximately 6 inches (Figure 212).
- *Split at Wood Door Cladding.* At one location, the wood cladding at the upper leaf of a Dutch door had split. The split extends approximately 12 inches and has resulted in the loss of wood along the edge of the cladding board (Figure 213).

Figure 211. Split wood sill that was soft when probed.

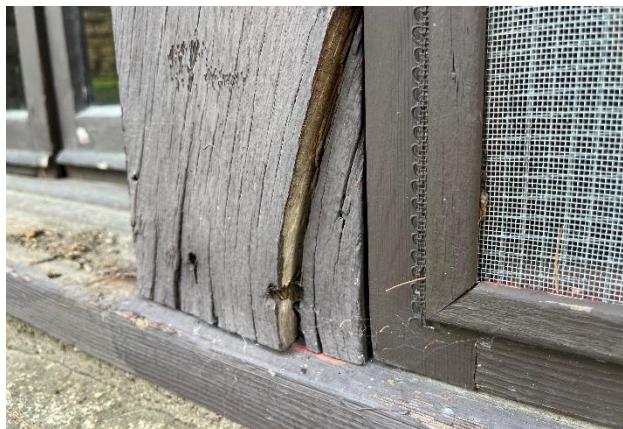
Figure 212. Split at the wood cladding of window mullion that extends the full depth of the wood for a length of approximately 6 inches.

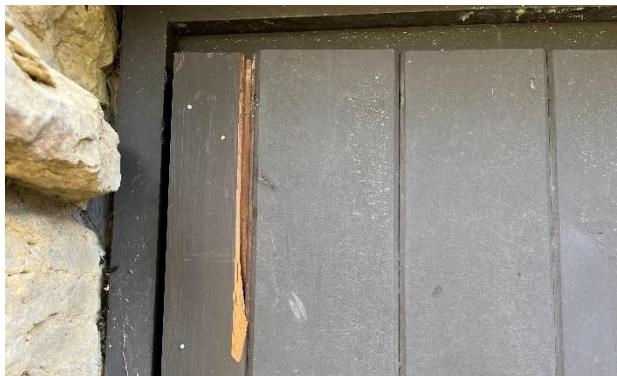
Figure 213. Split at upper leaf of Dutch door.

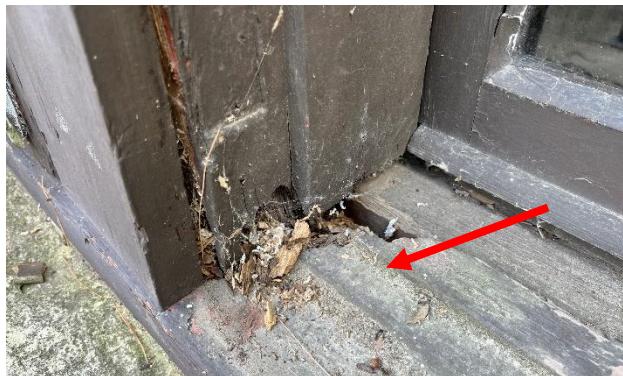
- *Deteriorated Wood at Windows.* Minor wood deterioration was observed at windows. Where observed, the distress included localized areas of wood that was found to be soft when probed, with small splits and checks at the end of framing members, and isolated areas of peeling paint (Figure 214 and Figure 215).

Figure 214. Localized area of wood that was found to be soft when probed, with small splits and checks at the end of framing members.

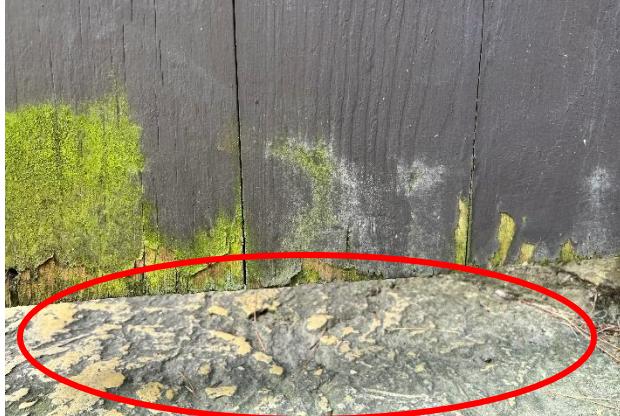
Figure 215. Isolated areas of peeling paint.

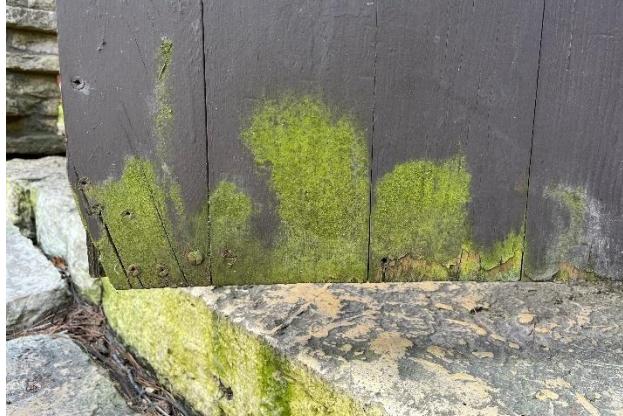
- *Deteriorated Wood at Doors.* Minor wood deterioration at doors includes chips and splits along the base of door leaves, biological growth, and areas of missing or abraded coating (Figure 216 and Figure 217).

Figure 216. Minor wood deterioration at doors including biological growth.

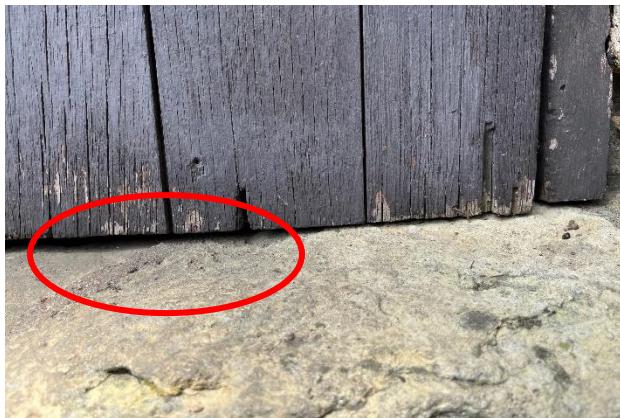
Figure 217. Minor wood deterioration at doors including chips and splits along the base of door leaves.

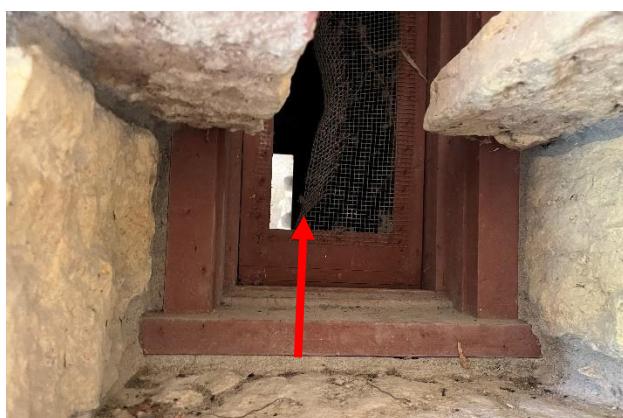
- *Damaged Window Screens.* Approximately half of the wood-framed window screens exhibit distress conditions, including missing or loose wood stops, damaged and displaced metal screening, and checking and splitting at the ends of the wood framing members (Figure 218).

Figure 218. Displaced metal screening at wood-framed window.

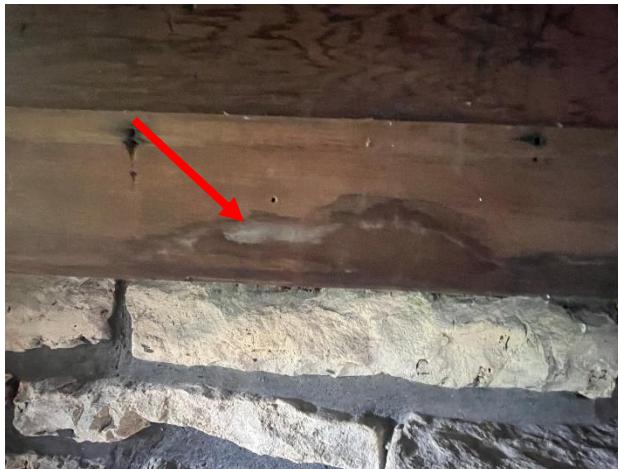
- *Moisture Staining at Wood.* Moisture staining and white soiling were observed along the bottom framing member surrounding the interior mural. The irregular pattern of soiling extends the full length of the frame and is as wide as 2 inches at some locations (Figure 221).
- *Scratches on Mural.* Scratches were observed on the wood backing of the mural (Figure 222). The scratches are typically 1/16 inch wide and appear to be associated with previous vandalism. At a few locations, scratches extend through the painted surface and have abraded the paint coating (Figure 223).

Figure 221. Moisture staining and white-colored soiling along the bottom framing member.

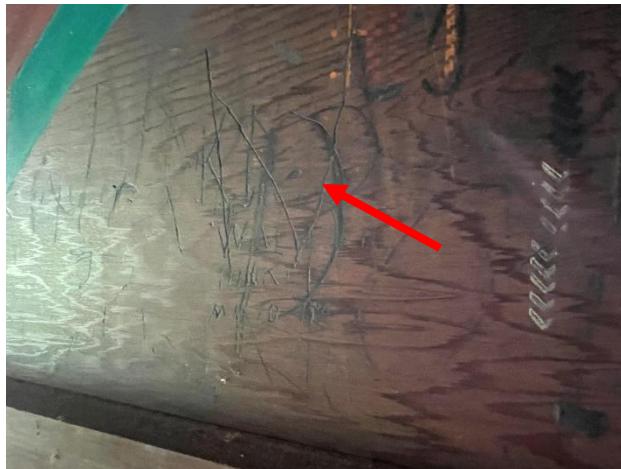
Figure 222. Scratches on wood backing of mural.

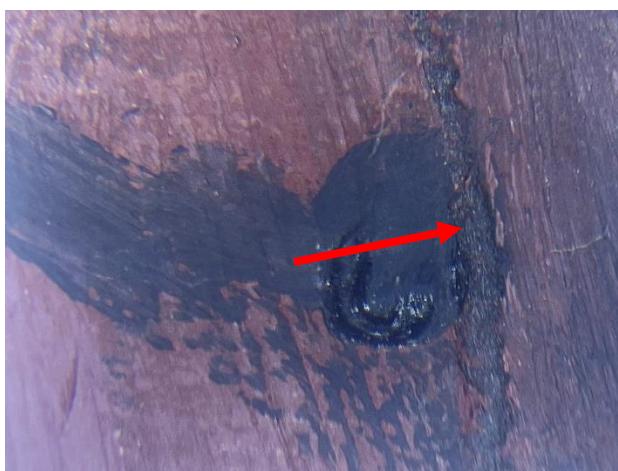
Figure 223. Scratch extended through the painted surface and abrading the paint coating.

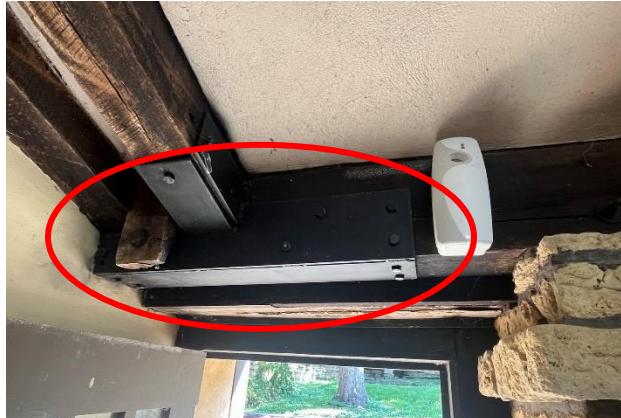
Structural repairs have been made to the beam and rafters at the north and south ends of the east dormer (Figure 236). The repairs include installation of a saddle consisting of steel angles, each measuring 8-1/2 inches by 6 inches and 1/4 inch thick, that have been welded together. The saddle measures approximately 30 inches long and supports the underside of the 10-inch-square beam that spans east–west along the east side of the building and the base of the 5-inch-square rafters that support the framing for the ends of the dormer roofs.

Figure 236. Structural repairs made to the beam and rafters at the north end of the east dormer.

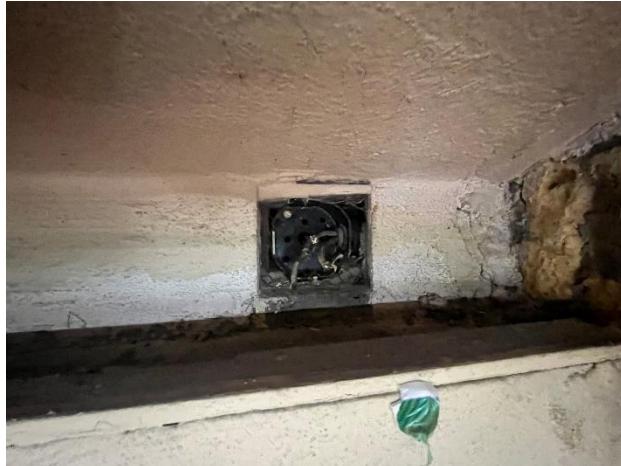
Figure 278. Cloth-jacketed electrical wire within the junction box.

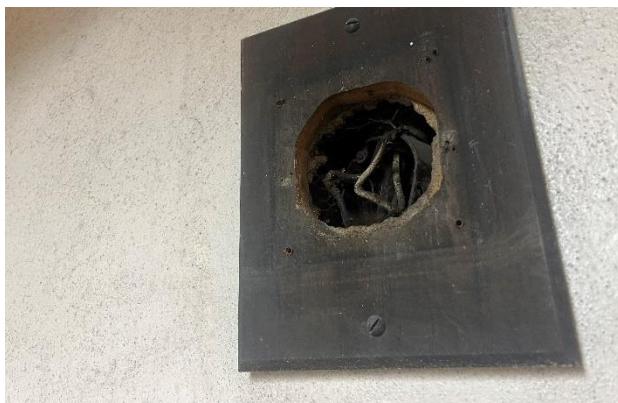
Figure 279. Evidence of historic light fixture and wood back plate.

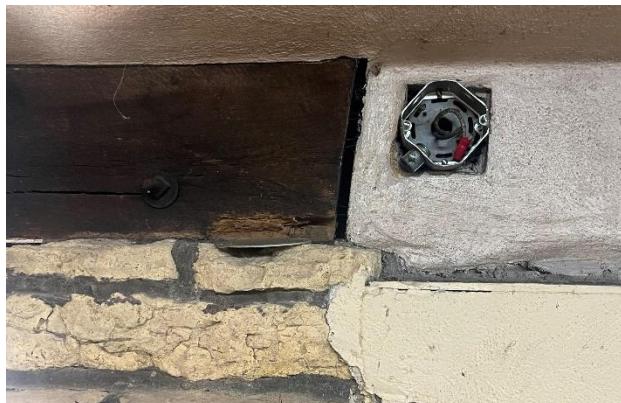
Figure 280. Historic junction box that supported a light fixture adjacent to the door at the south room.

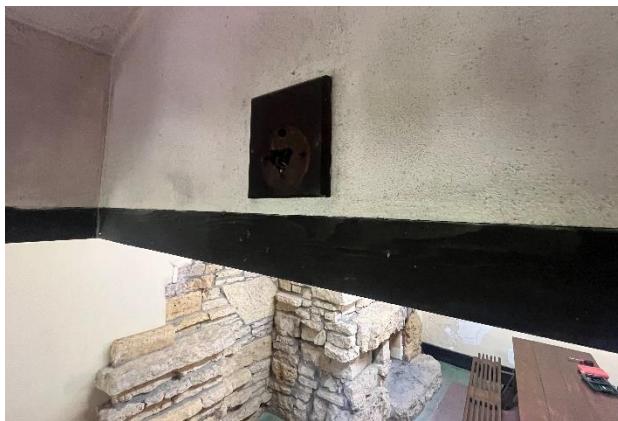
Figure 281. Junction box that historically supported a light fixture at the south window cove.

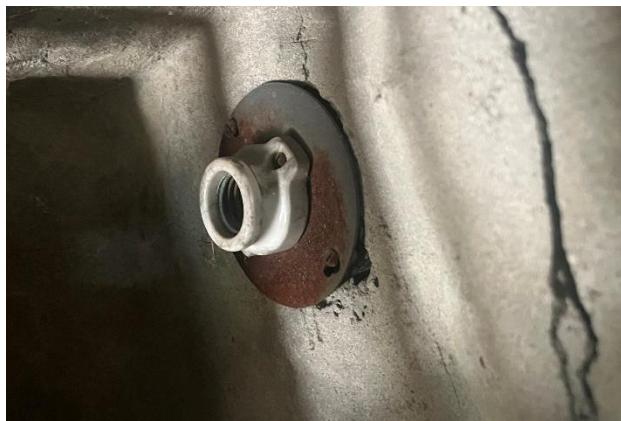
Figure 282. Historic light fixture with a circular metal plate and porcelain light socket.

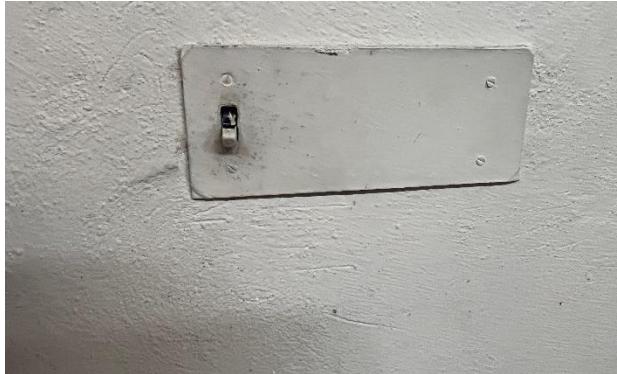
Figure 283. Original light switch in south room with non-original blank-off panel reducing the panel to a single switch.

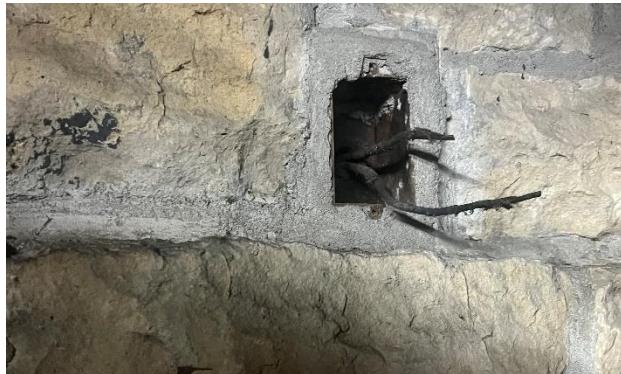
Figure 284. Abandoned switch in storage closet with cloth-jacketed wiring.

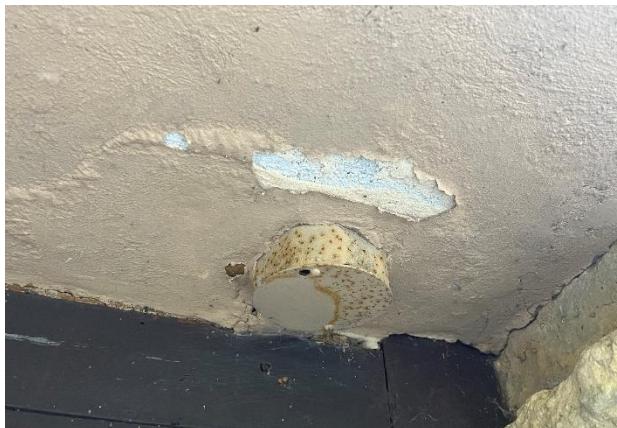
At present, there is no exterior lighting for the Veranda Rooms; however, evidence of historic exterior lighting includes a metal junction box, surface-mounted to the stucco soffit near the south entrance door, and previous patch repairs to the stucco soffit above the north entrance door, where a lighting fixture may have been mounted (Figure 285).

Figure 285. Exterior surface-mounted junction box near the south entrance door.

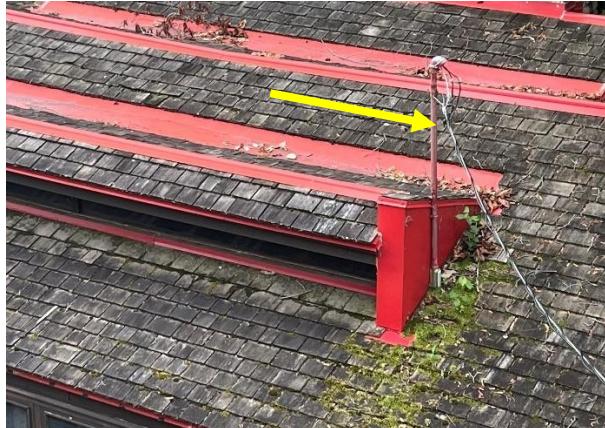
Figure 286. Conduit for main service line located at the north end of the east dormer.

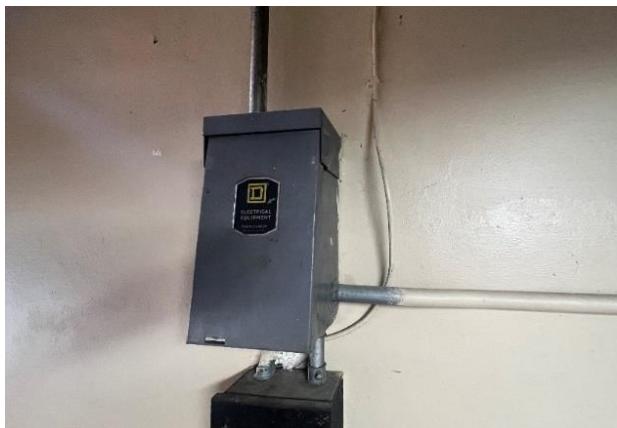
The building is currently served by a two-switch electrical panel located at the south interior wall of the north room. The electrical panel, manufactured by Square D, is mounted to the wall and connected to the main utility service (Figure 287). The electrical panel feeds electrical conduit through two sub-panels; one surface-mounted box immediately below the electrical panel and one mounted to the north elevation of the south room, opposite the north sub-panel (Figure 288). Throughout the structure, the active metal conduit, outlets, and light switches are surface-mounted. Each room has a surface-mounted light switch and a surface-mounted GFCI receptacle. Each room has two double ballast fluorescent light fixtures suspended from metal chains attached to metal hooks in the plaster ceiling (Figure 289).

Figure 287. Surface-mounted electrical panel in the north veranda room. Note the black sub-panel below.

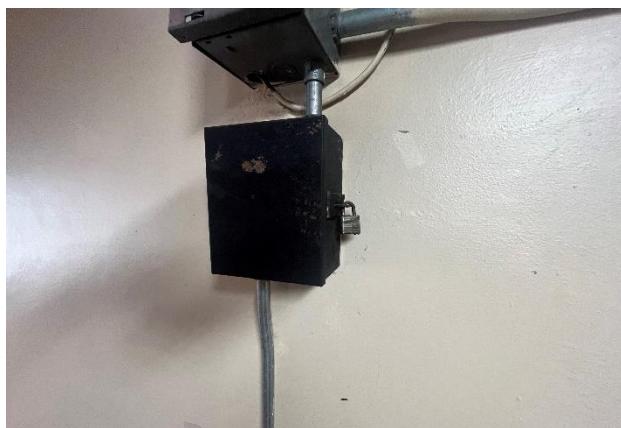
Figure 288. Sub-panel surface-mounted to wall at north room.

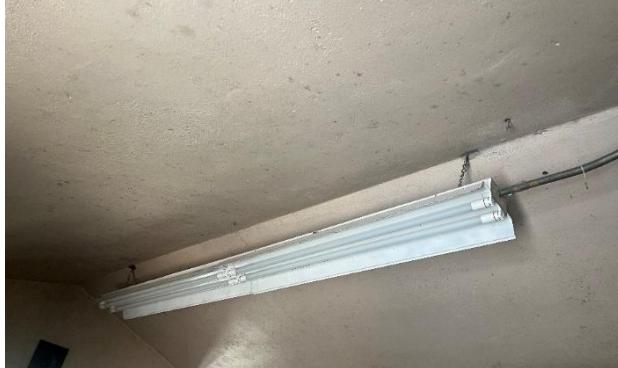
Figure 289. Non-original double ballast fluorescent light fixture suspended along the interior ridge of the roof.

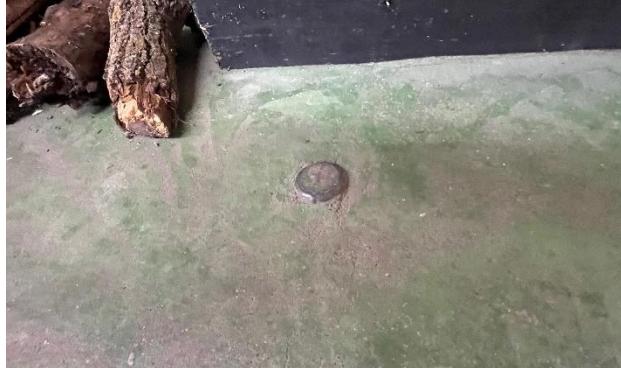
Historically, the rooms had radiant heating. However, only capped pipes embedded in the concrete flooring remain (Figure 290). Each room also has a floor drain that extends to the main sewer pipe under the building.

Figure 290. Cap of pipe where radiant heating unit was located.

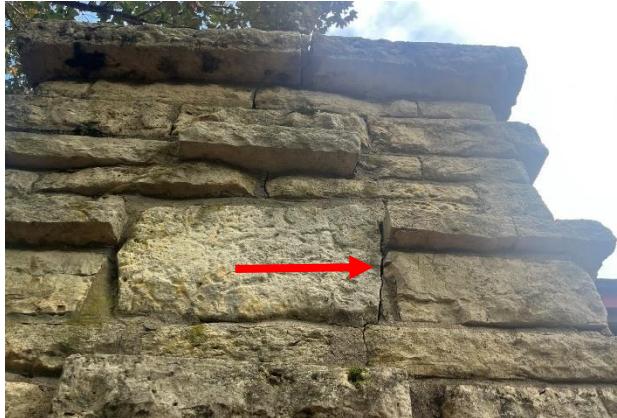
- *Vertical Cracking at Chimney.* Vertical cracking was observed at the exterior west elevation of the north chimney (Figure 291). The cracking extends from an open mortar joint at the chimney coping, down into the field of wall. Cracks extend through mortar joints and stone units (Figure 292).

Figure 291. Vertical cracking at the exterior west elevation of the north chimney.

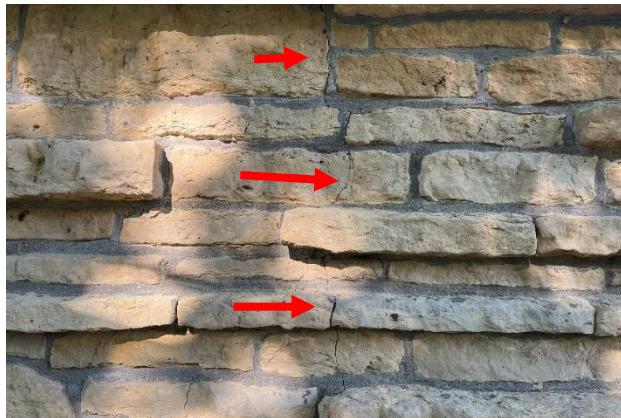
Figure 292. Cracks extended through mortar joints and stone units.

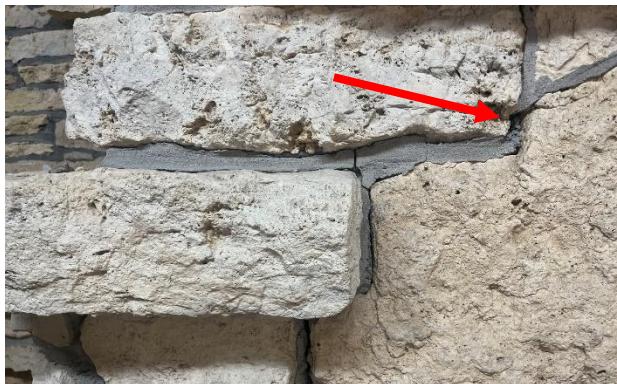
- *Cracking at Fireplace.* Vertical cracking was observed at the interior elevation of both the north and south fireplace. The cracking consists of open mortar joints and cracked stone units extending from the joint between the chimney and the dormer window or roof framing (Figure 293). Some of the cracks have been previously repaired (Figure 294).

Figure 293. Open mortar joint at cracked stone unit.

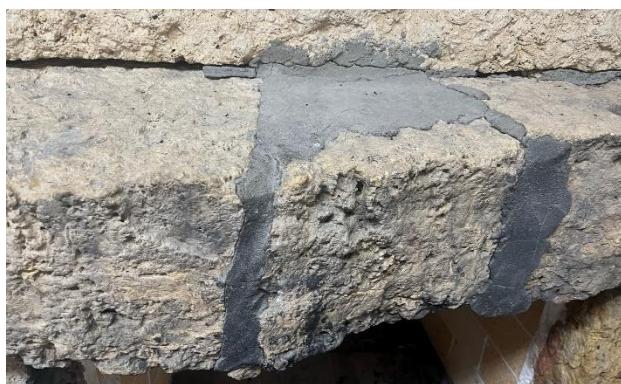
Figure 294. Previously repaired crack.
