Caldwell-Designed Structures at Eagle Point Park

Historic Structures Report

2601 Shiras Avenue
Dubuque, Iowa 52001

April 16, 2025
WJE No. 2024.0714.0

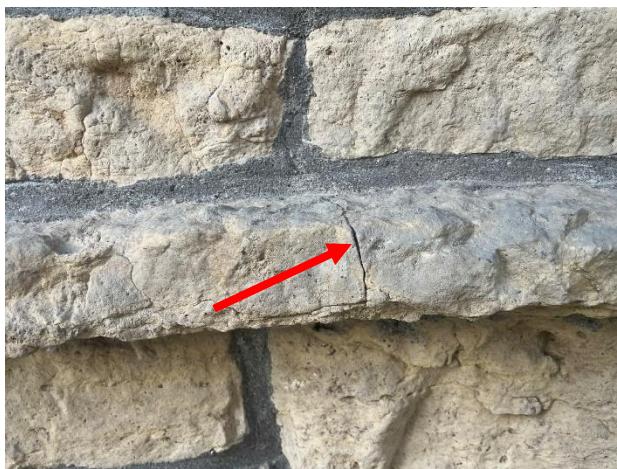
- *Cracking at Stone.* At a few locations, hairline cracking was observed in the stone. The cracking typically extends vertically through the stone and aligns with cracked mortar joints (Figure 295). At a few locations, specifically at projecting stone units near the exterior fireplace, the cracking is oriented horizontally and the stone above the crack was found to be unsound when tapped (Figure 296).

Figure 295. Crack running vertically through the stone.

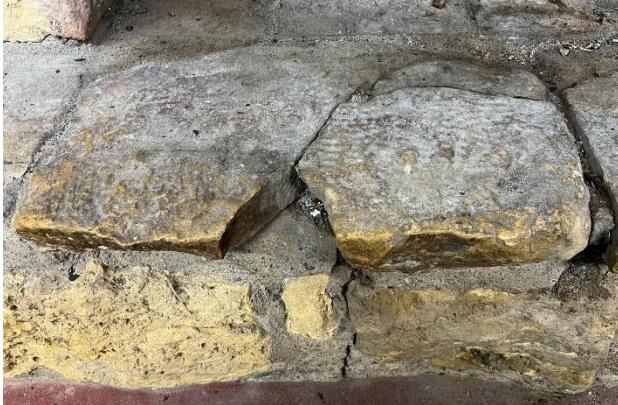
- *Cracking Stone Hearth.* The stone hearth at the north fireplace is cracked and loose (Figure 297).
- *Open Transition Joint.* At the west elevation, the joint at the interface between the stucco eave and stone wall is open (Figure 298). The wood top plate for the roof framing is exposed to view from the exterior.

Figure 297. Cracked and loose stone at the hearth of the north fireplace.

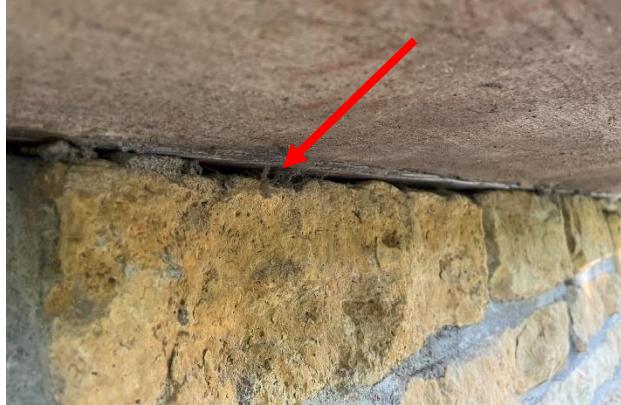
Figure 298. Open joint at the interface between the stucco eave and stone wall.

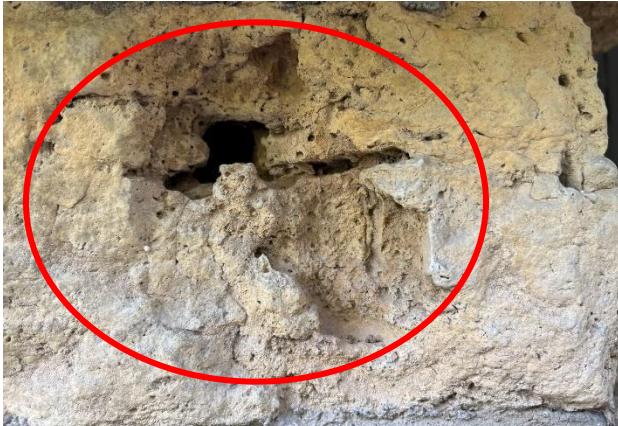
- *Localized Pitting.* Isolated stone units with deep pockets and pits were observed (Figure 299). These conditions were observed at stone units that are mostly concealed from weather, indicating that the condition may be inherent to the stone.

Figure 299. Stone unit with deep pockets and pits.

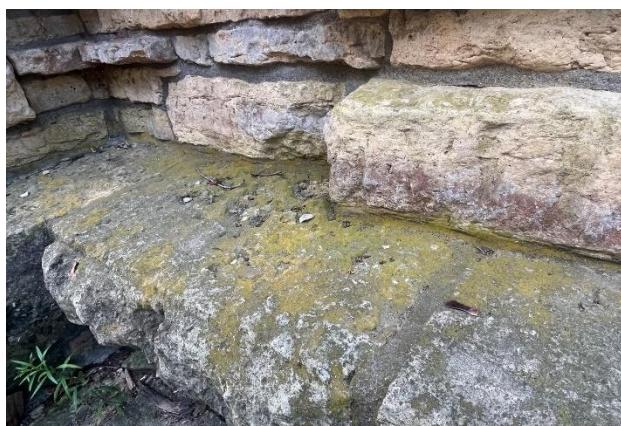
- *Biological Growth.* Biological growth and soiling were observed at the stone walls, specifically at upward-facing surfaces and around the base of the building (Figure 300 and Figure 301).

Figure 300. Biological growth and soiling at upward-facing surface.

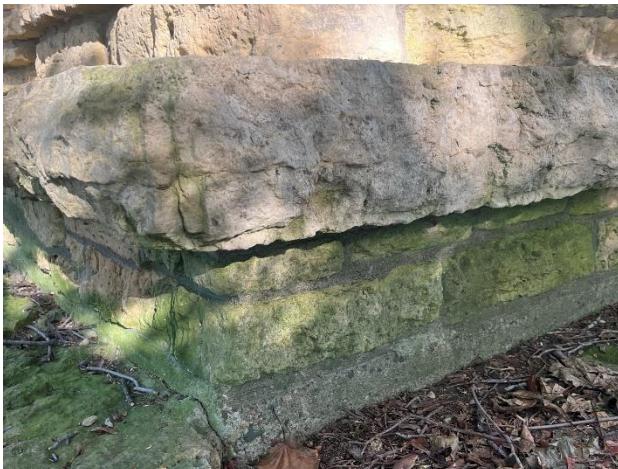
Figure 301. Biological growth and soiling around the base of the building.

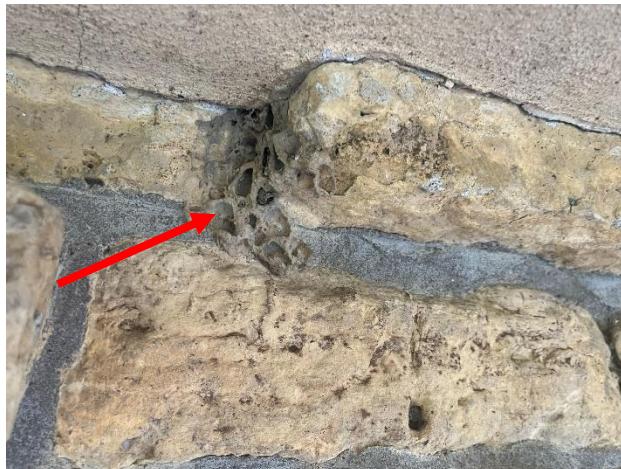
- *Pest Infestations.* Small insect nests were observed at corners of wood-framed windows and at projecting stone units (Figure 302).
- *Soiling Above Fireplace.* Dark soiling, likely soot, was observed above the north fireplace (Figure 303).

Figure 302. Small insect nest at projecting stone unit.

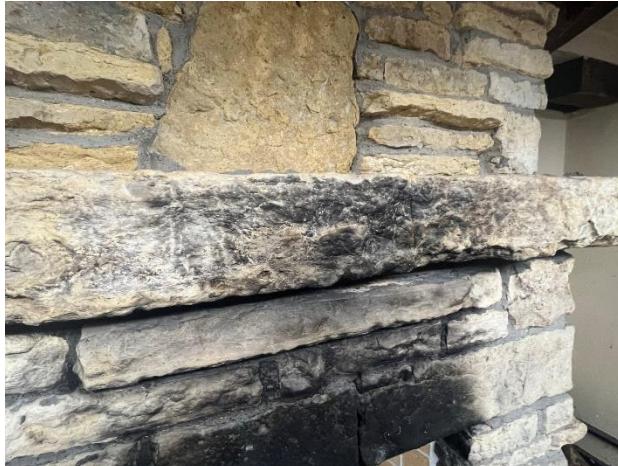
Figure 303. Dark soiling, likely soot, above the north fireplace.

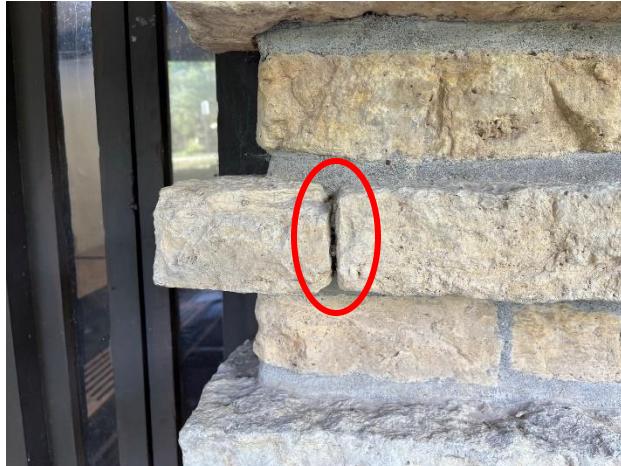
- *Open Mortar Joints.* Horizontal mortar joints are generally in good condition; however, isolated areas of open mortar joints were observed (Figure 304). At some locations, the stone along the edge of the mortar joint has spalled, resulting in a partially open joint (Figure 305).

Figure 304. Open horizontal mortar joint.

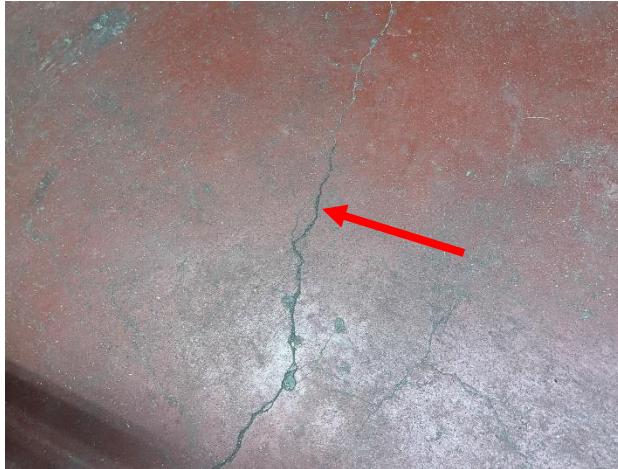
- *Cracking at Interior Flooring.* At the north room, hairline cracking extends across the center portion of the interior floor (Figure 306). The cracks align with the edges of the fireplace.
- *Missing Drain Strainer.* The drain strainer for the interior floor drain at the north room is missing (Figure 307). The drain appears to be clogged with debris.

Figure 306. Cracking at interior floor of north Veranda Room.

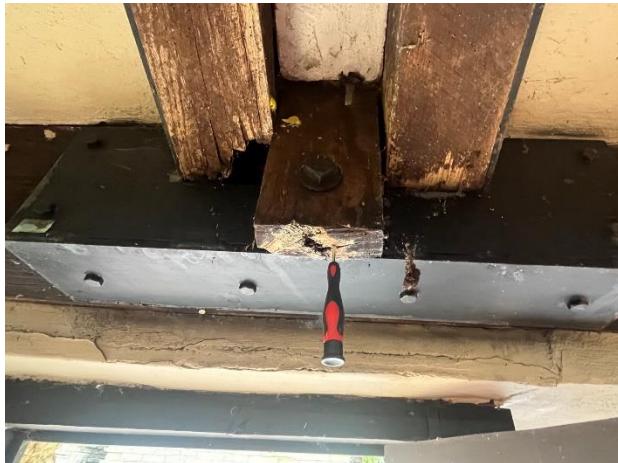
- *Deterioration of wood.* Distress was observed at the wood beam above the north entrance, the wood framing for the dormer window above, and at the lower half of the roof rafter located immediately south of the north entrance. The distress aligns with the north end of the east dormer window. The wood was observed to be damp and was found to be soft and rotted when probed with an awl (Figure 308). Portions of the wood beam and framing exhibited over a 50 percent loss of section (Figure 309). Portions of the wood around the anchors for the supplemental steel plate repairs had deteriorated.

Figure 308. Awl probing soft and rotted wood.

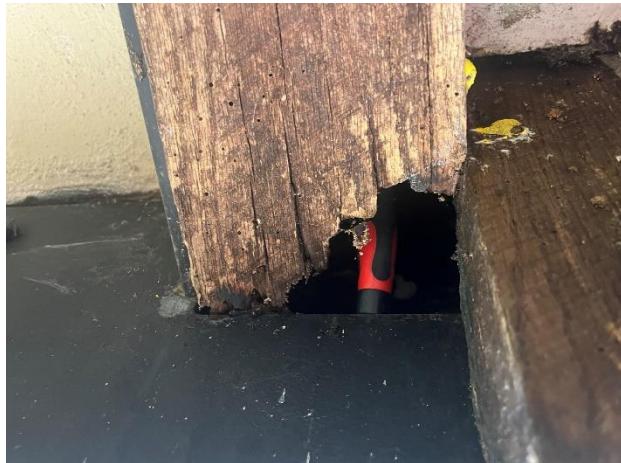
Figure 309. Wood framing exhibiting over a 50 percent section loss.

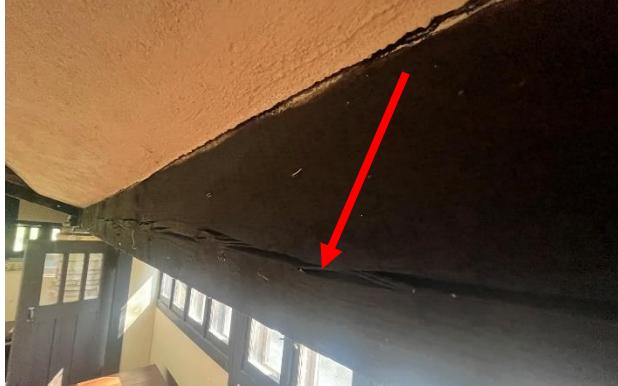
- *Splitting and checking of wood framing members.* A large area of checking was observed to extend the full length and at the mid-height of the wood beam that extends south from the north entrance, over the window bay on the east elevation of the building (Figure 310). In addition to the checking, the lap joint at the end of the beam is split. The split measured 3/16 inches wide. Checks were also observed at the ends of the beam and aligned with anchor locations (Figure 311).

Figure 310. Large area of checking at mid-height of wood beam.

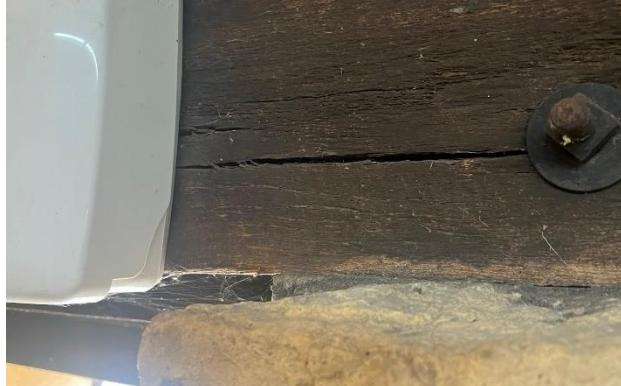
Figure 311. Checking at the ends of a beam aligned with anchor locations.

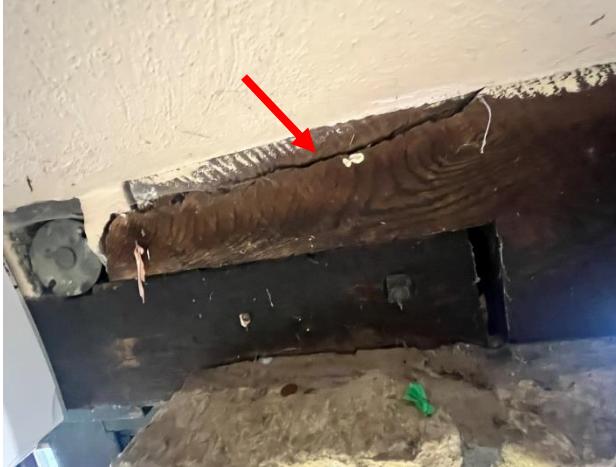
- *Open Joints.* The vertical joints between wood beam sections appear to be separating. The vertical joint at the lap between beams over the north entrance is wider at the top than at the bottom, indicating that the south beam may be sagging (Figure 312). The vertical joint between beams over the south entrance appears to be widening, as evidenced by the 1/2-inch-wide joint and nails visible within the open joint (Figure 313).

Figure 312. Indication that the south beam may be sagging.

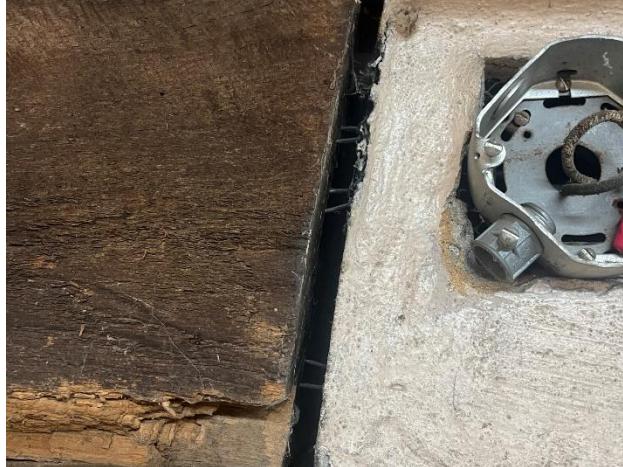
Figure 313. Joint, 1/2 inch wide with visible nails.

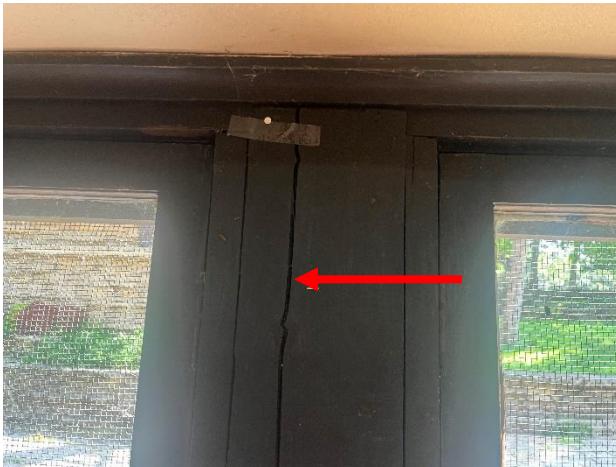
- *Bowing of the wood beam.* The wood beam that supports the roof framing at the north end of the east elevation is bowed. The beam appears to sag approximately 1/8 inch per foot, over a length of approximately 8 feet, with the lowest part of the beam aligning with a wood post. The post exhibits a vertical spilt, present on both sides of the wood post, that measures as wide as 3/16 inch at the top and tapers to a hairline crack over the upper 5 feet of the post (Figure 314).
- *Checked Wood Diagonal Truss Member.* One of the wood diagonal bracing members at the south room exhibited checking at the underside, along the full length of the member (Figure 315).

Figure 314. Vertical split at the interior side of the wood post.

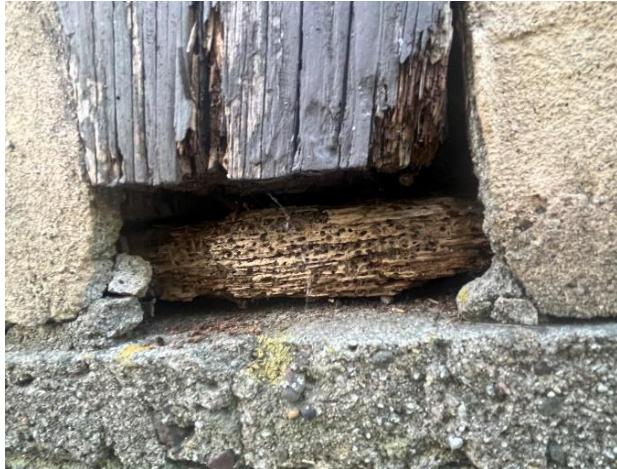
- *Gaps at Base of Wood Trim.* Gaps were observed below two of the wood trim members on the stucco wall at the east elevation (Figure 316). The gaps measured approximately 1-1/2 inches wide. The wood sill plate for the wall framing was exposed to view and exhibited evidence of insect damage.
- *Small Chips at Wood Base.* In general, the wood baseboard and trim within the building are in good condition. Small chips and abrasions were observed, although typically painted over, indicating they have been present for some time.

Figure 316. Gap below wood trim members.

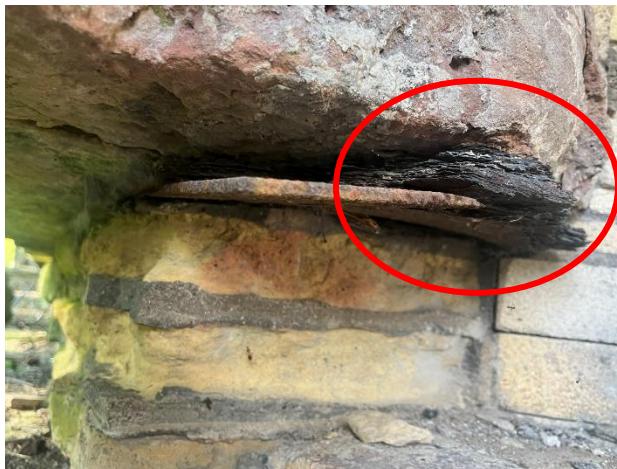
- *Corrosion of Embedded Steel.* The steel lintels and hardware at the west elevation fireplace exhibit extensive corrosion build-up at some locations. In addition to corrosion, stone units adjacent to the steel lintel were spalled or cracked, and the concrete lintel over the hearth is cracked and spalled at locations that align with the steel reinforcing (Figure 317 through Figure 320).

Figure 317. Corrosion and rust jacking at steel plate at fireplace.

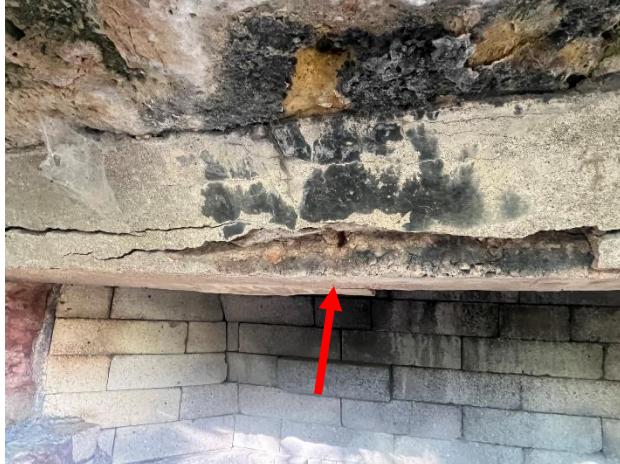
Figure 319. Spalls at concrete lintel aligning with steel reinforcing.

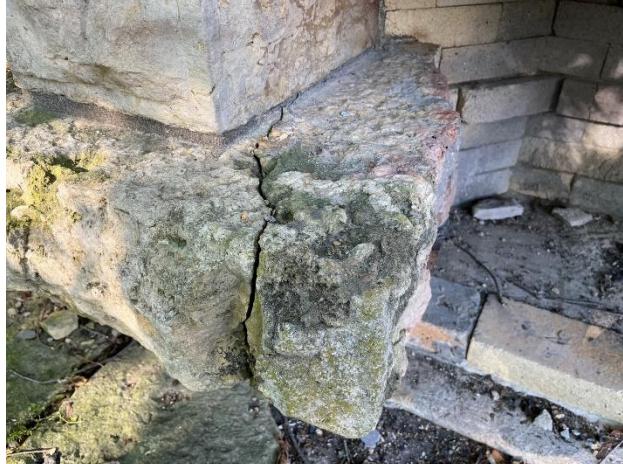
Figure 320. Cracked stone unit adjacent to steel lintel.

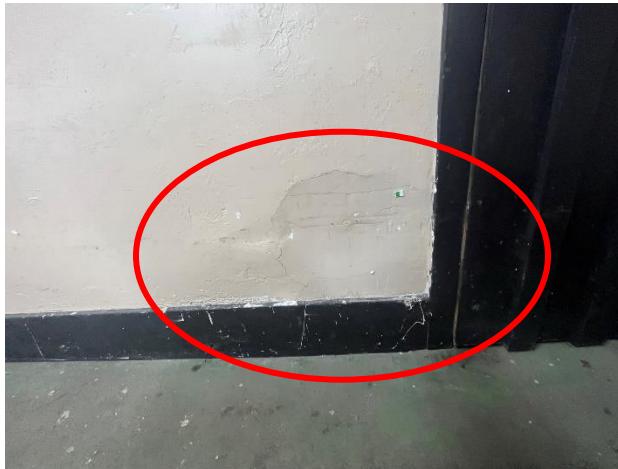
- *Interior Plaster Damage.* Localized areas of damaged plaster were observed at the wall that separates the north and south rooms (Figure 323 and Figure 324). The damage includes shallow dents in the wall; previous repairs, some of which have failed; peeling paint; and hairline cracking that appears to be associated with a physical impact.

Figure 323. Localized area of damaged plaster at the wall separating the north and south rooms.

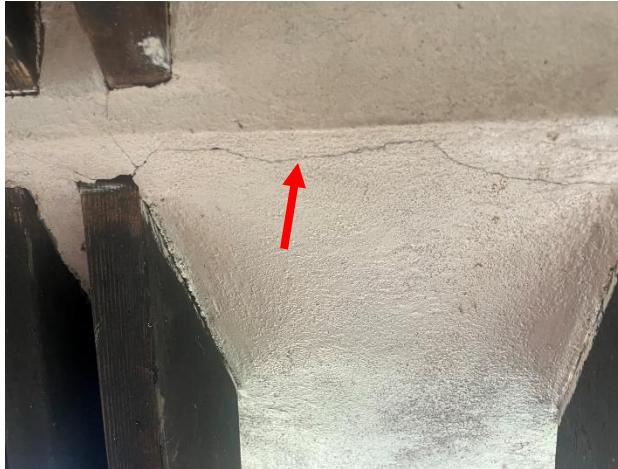
- *Cracking at interior Plaster Ceiling.* Hairline cracking was observed at the north room, extending perpendicular between roof rafters (Figure 325). The cracks are typically less than 12 inches long. Hairline cracking at the south room, where the wood truss framing is not exposed to view, typically consists of cracks extending perpendicular to one another and extending the full length of the room (Figure 326). The cracks are typically aligned with the corners of the fireplace and dropped soffit as well as metal electrical fixtures recessed into the plaster finish.

Figure 325. Hairline crack extending perpendicular between roof rafters.

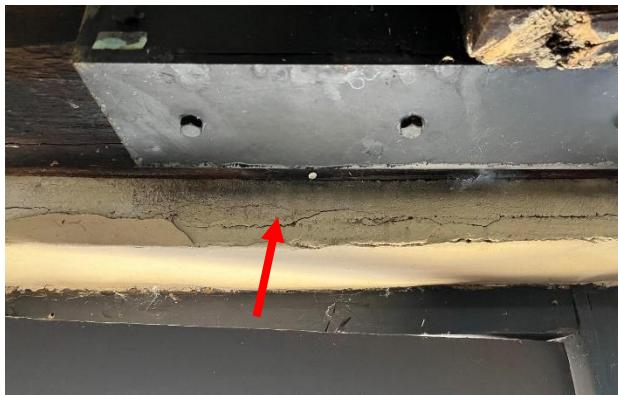
- *Interior Plaster Failure.* The plaster over the exterior door to the north room and between adjacent rafters has failed. Conditions range from cracking around areas of previous repair to complete loss of plaster with the metal lath exposed (Figure 327). The distress appeared to be associated with active leakage and deterioration of the wood framing.

Figure 327. Failed plaster over exterior door of north Veranda Room.

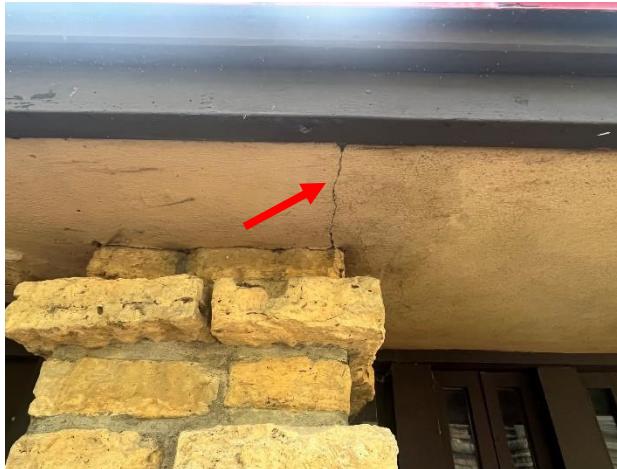
- *Cracking at Stucco Eaves.* Cracks were observed extending perpendicular across the stucco of the roof eaves. Cracks ranged from hairline to as wide as 1/8 inch. Cracks were typically located near corners of piers, where the depth of the soffit changes (Figure 328). Longer cracks were located at the deep roof eaves located on the north and south ends of the building. At these locations, the cracks are spaced approximately 14 inches apart and exhibit discoloration around the crack (Figure 329).

Figure 328. Crack near corner of a stone pier where the depth of the soffit changes.

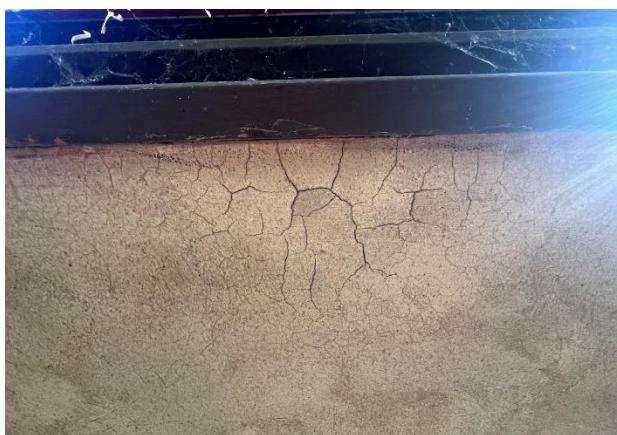
- *Map Cracking of Stucco at Eave.* Map cracking was observed at a few locations in the stucco soffit and is concentrated along the edge of the eave, adjacent to the roof fascia (Figure 330). At one location, the stucco finish has cracked and the scratch coat is exposed to view (Figure 331).

Figure 330. Map cracking along the edge of the eave.

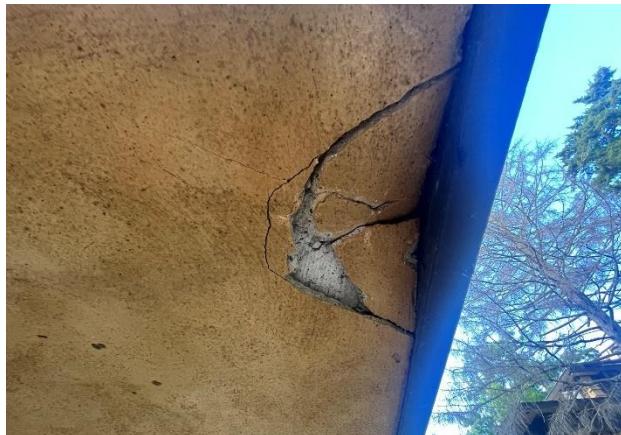
Figure 331. Cracked stucco with scratch coat exposed.

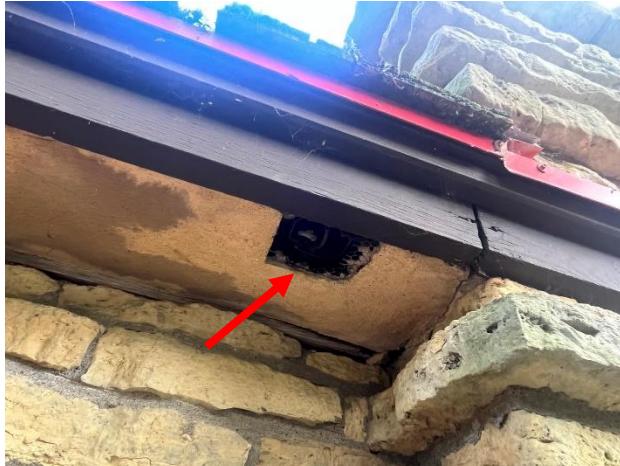
- *Openings in the Roof Eave.* Openings, measuring 7 inches square, were observed in the stucco eave (Figure 332). The openings appear to be associated with a historic light fixture that has since been removed.

Figure 332. 7-inch square opening in stucco eave.

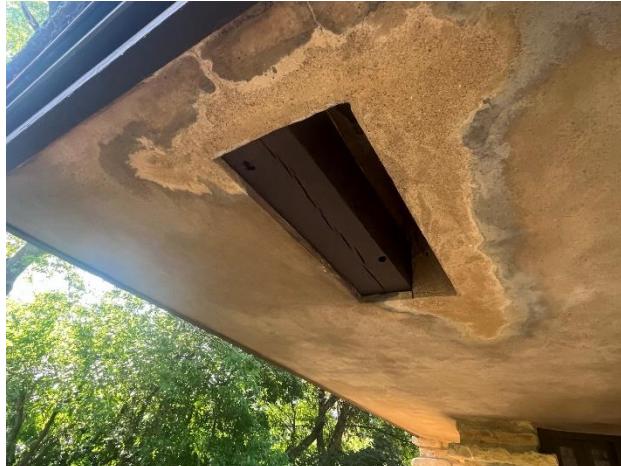
- *Previous Patches.* Previously installed stucco patches were observed at soffit locations where vertical posts connected to the wood roof framing have been removed (Figure 333).
- *Peeling Paint.* Peeling paint was observed at the stucco soffit (Figure 334). The distress appears to be associated with locations of previous stucco repairs near electrical junction boxes that were painted to match the historic stucco.

Figure 333. Previous stucco patch.

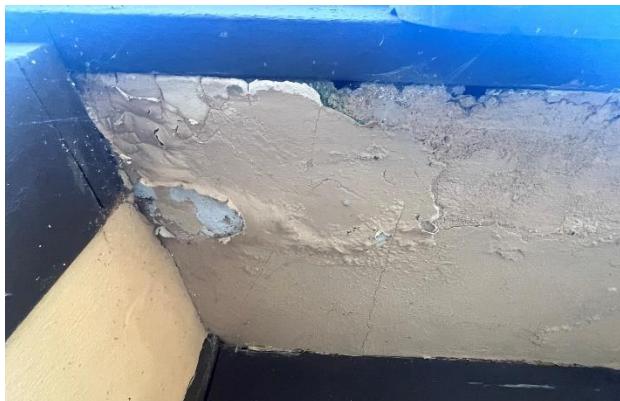
Figure 334. Peeling paint at the stucco soffit.

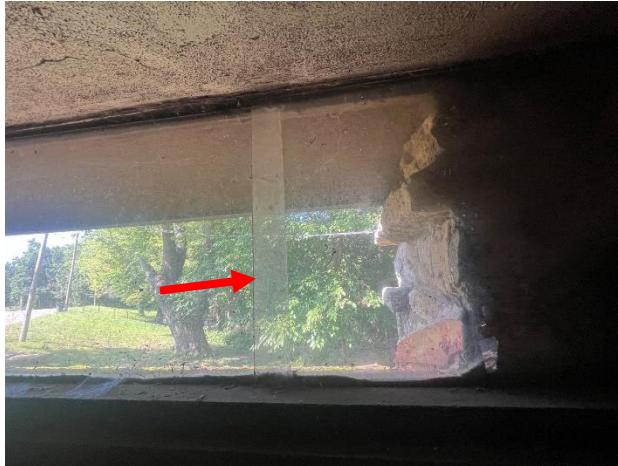
- *Open Joints at Dormer Glazing.* The dormer windows contain acrylic glazing panels, many of which overlap at the ends, and do not have a dividing mullion (Figure 335). Some of the panels exhibit bowing. At the west elevation, the bowing is exacerbated by build-up of debris between the dormer window and chimney (Figure 336). The open joints between the acrylic panels appear to align with interior distress conditions.

Figure 335. Dormer window with overlapping acrylic panel glazing and no dividing mullion.

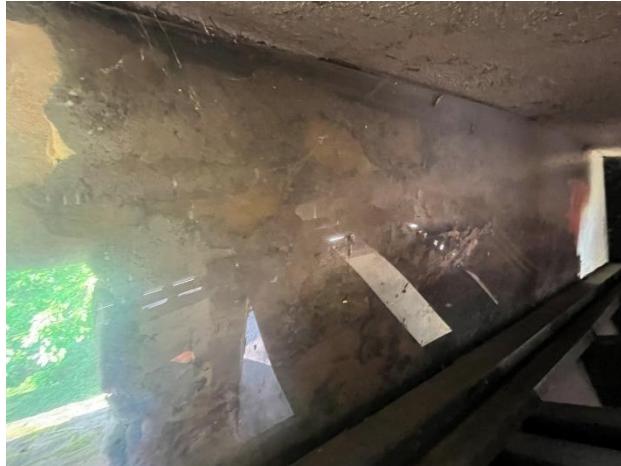
Figure 336. Bowing due to built-up debris between dormer window and chimney.

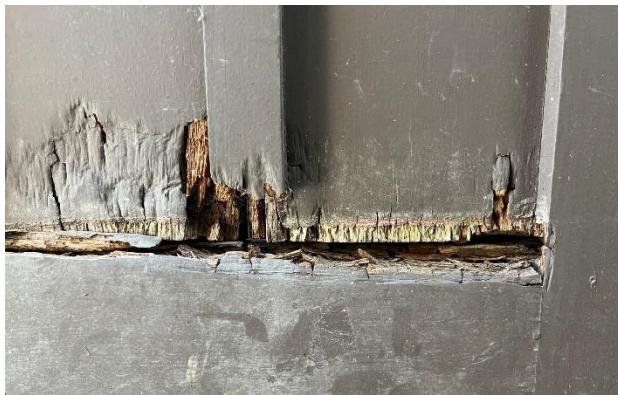
- *Wood Deterioration.* The wood at windows, doors, and exposed framing members exhibits minor checking, rot, and peeling paint. The distress was observed at the bottom end of vertical members and door panels as well as at the top surface of some window sills (Figure 337, Figure 338, and Figure 339). Some isolated wood checking was observed at wood fascia members.

Figure 337. Distress at the bottom end of door panels.

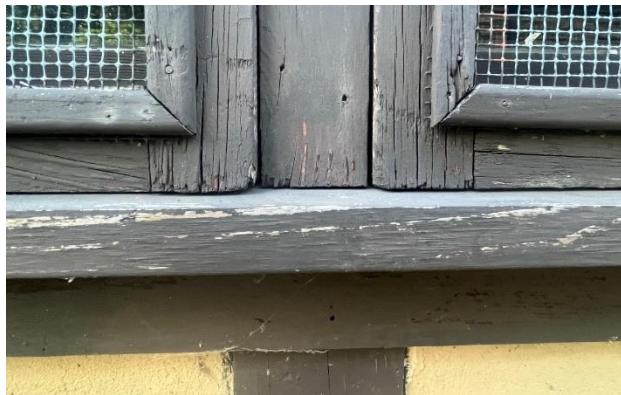
Figure 338. Distress at the top surface of a window sill.

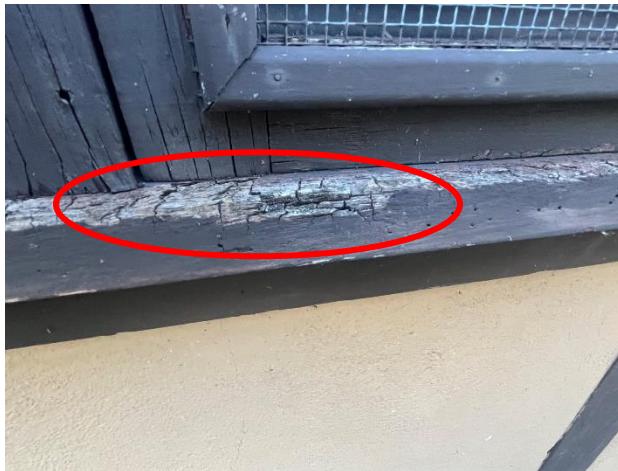
Figure 339. Distress at the top surface of a window sill.

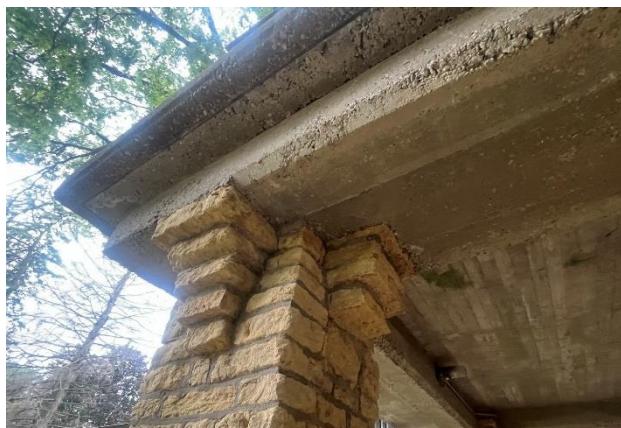
The stone piers, measuring approximately 26 inches square, have corbelled stone haunches, that project 10 inches from the top of the pier, on all four faces of each pier and support the cast-in-place concrete slab (Figure 361 and Figure 364). Historically, there was a light fixture below the haunch at the west elevation of each pier. After 1975, the fixtures were removed and stone dutchman units installed (Figure 363 and Figure 364). The piers have concrete footings measuring approximately 4 feet square on which stone paving units are set. The concrete deck slab measures 5-1/2 inches deep and has a form board finish with the form boards measuring 3 inches wide (Figure 365). Concrete beams are cast into the slab. Perimeter beams are located along the east and west edges of the slab, measure 29 inches wide by 13 inches deep, and bear on the stone piers. Perpendicular beams are oriented east-west, measure 15 inches wide by 13 inches deep, and are spaced 10 feet on center (Figure 366). The west edge of the slab extends 10 inches beyond the perimeter beam and has a thickened slab edge, measuring 9-1/2 inches deep with a drip cast into the underside (Figure 367). The concrete slab supports the structure for the

Figure 367. Edge of the concrete deck slab.

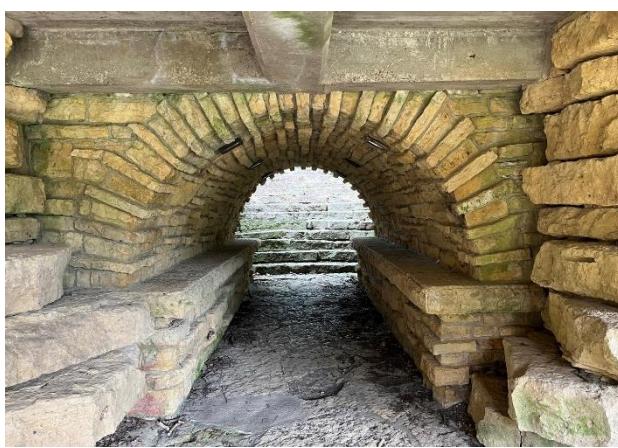
Figure 368. West elevation of the archway.

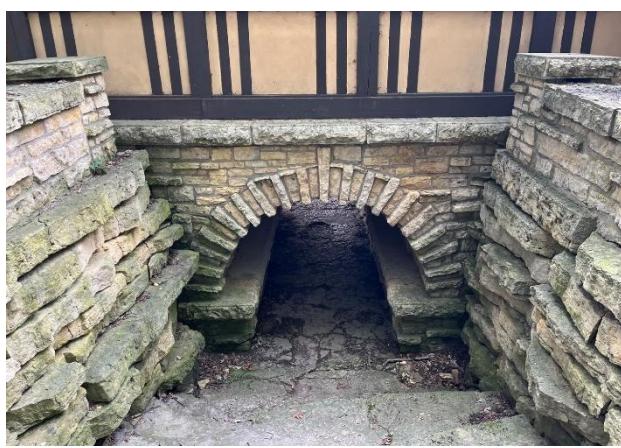
Figure 369. East elevation of the stone archway with the archway stair in the foreground.

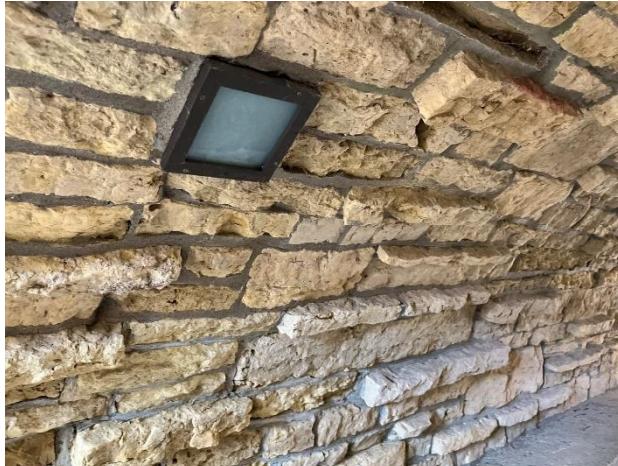
Figure 370. Stone coursing at the arch.

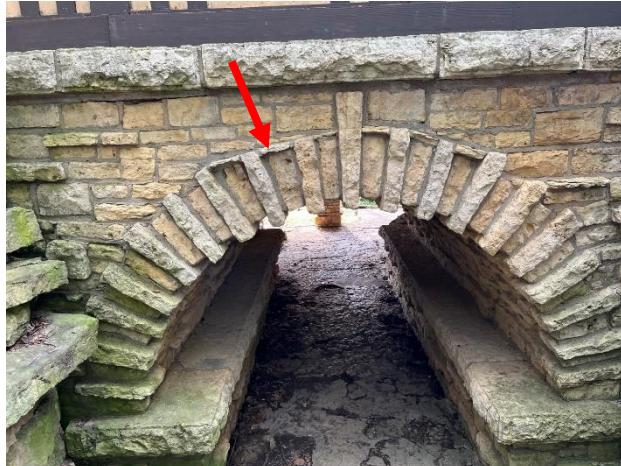
The covered stone terrace provides access to a barrel-vaulted tunnel that extends east from the terrace, under the east pavilion, and to a stone stair (Figure 368 and Figure 369). The tunnel measures 6 feet 6 inches tall by approximately 8 feet wide and includes partial-height walls, measuring 32 inches tall, that support the arch. The partial-height walls project into the arch space, creating ledges on each of the arches measuring 16 inches deep. The load-bearing arch structure consists of stone units that vary from 2 to 3 inches wide and 6 to 26 inches long (Figure 370). The stone voussoirs at the entrance to the barrel vault alternate in length with the longer units also projecting 2 inches beyond the plane of the wall. At the east entrance, which is exposed to the elements, thin projecting stone units are set in the mortar joints above the voussoirs, creating a drip ledge to manage water runoff (Figure 371).

Figure 371. Stone voussoir at the stone archway with the stone drip edge units indicated by arrow..

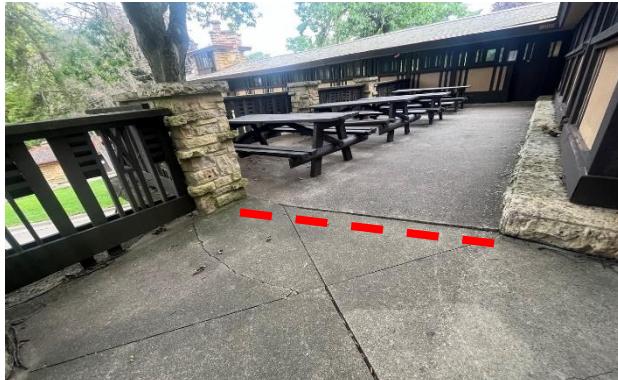
The south terrace is located over the covered stone terrace and has two different concrete paving systems (Figure 372). The concrete paving at the south portion of the terrace integrates with the concrete walk that extends along the east side of the east pavilion. It includes a grid of control joints cast into the slab. The concrete paving at the north half of the terrace appears to pre-date the concrete at the south half and does not have any control joints. There are abandoned anchor holes in the concrete from a previous terrace railing system.

Figure 372. Concrete paving at the south terrace. Note that concrete in the foreground is different than the concrete in the background.

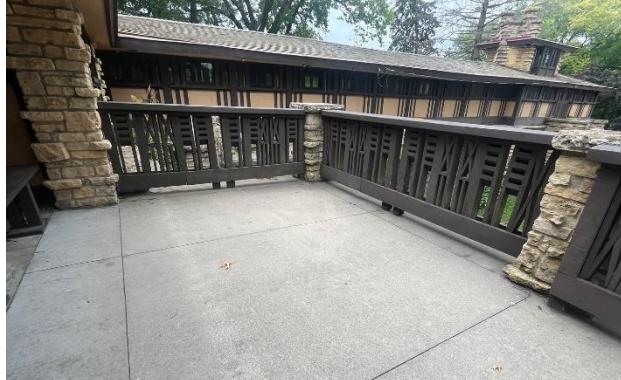
The north terrace is an extension of the open-air covered patio at the north end of the east pavilion and wraps around the north side of the Bridge Complex. Like the south half of the south terrace, the north terrace has concrete paving with control joints and appears to have been installed at the same time as the paved walk at the east side of the building (Figure 373).

Figure 373. Concrete paving at the north terrace.

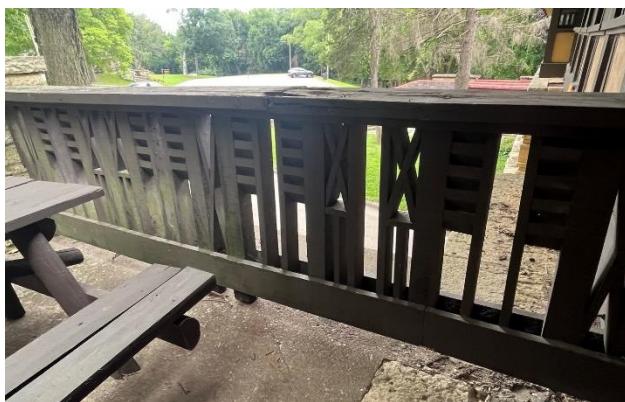
Figure 374. Wood guardrail at the south terrace.

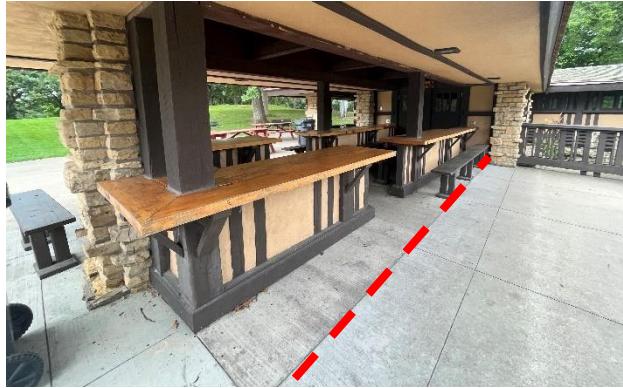
Figure 376. Concrete floors at the covered patio and north terrace. Note that the concrete at the covered patio is different than the concrete at the north terrace.

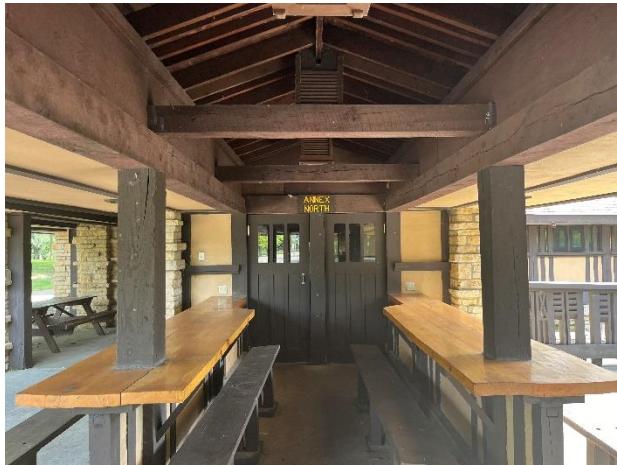
Figure 377. Exposed roof framing at the center of the space and stucco clad soffits at the edge of the space.

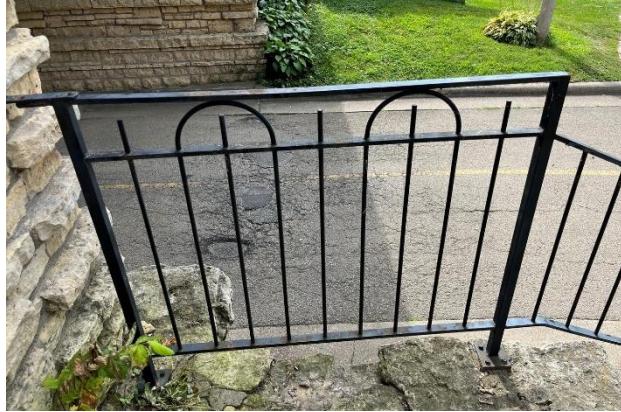
Figure 388. Metal guardrail at west side of east stairs.

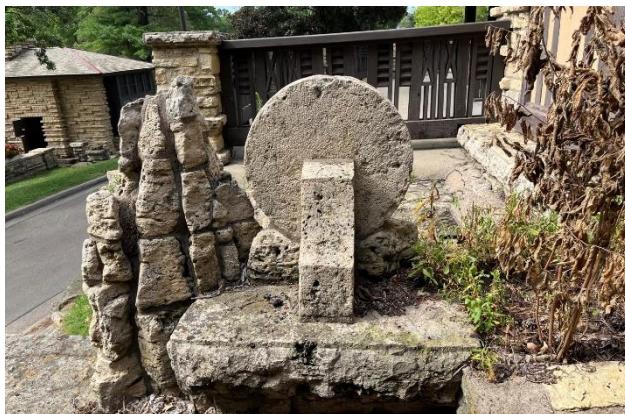
wall that features a circular stone decorative unit mounted onto the coping and the remains of what appears to be a light fixture integrated into the stone base (Figure 389). A recess in the stone and abandoned conduit from the previously removed wood lantern post remain. At the top of the flight is a landing that provides access to a door leading to the east pavilion.

Figure 389. Stone cheek wall that features a circular stone decorative unit mounted onto the coping and the remains of what appears to be a light fixture integrated into the stone base.

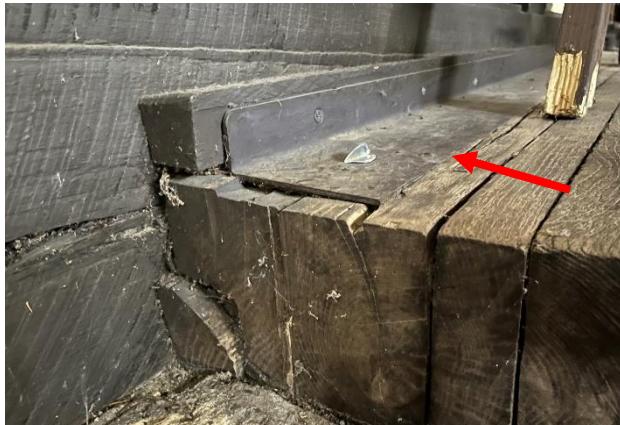
Figure 405. Edge of wood deck bridge framing showing steel angle.

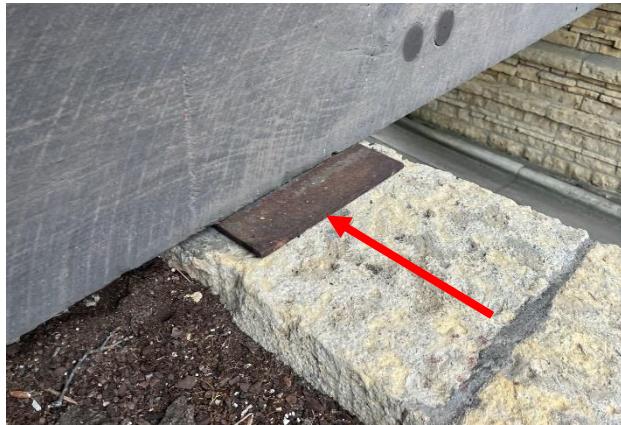
Figure 406. Steel plate upon which the bridge deck framing bares.

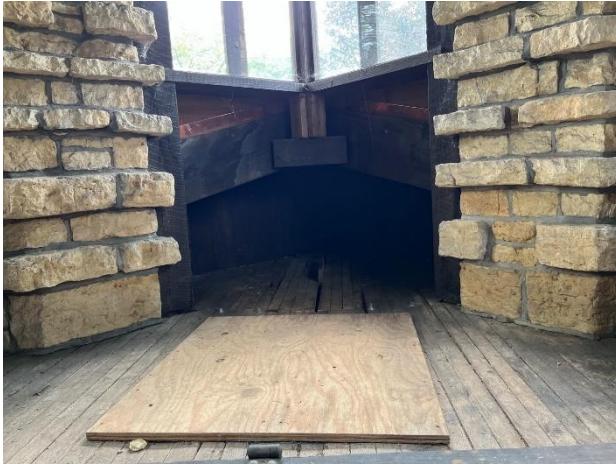
The lookout tower at the west pavilion has an original flooring system consisting of wood-framed tongue-and-groove floorboards that measure approximately 2-7/8 inches wide and extend east-west across the room (Figure 408). The floor is constructed of 2x4 framing and has 1 inch by 2-1/2 inch wood boards, which are visible from the west room, mounted to the underside of the framing (Figure 409).

Figure 409. Wood tongue-and-groove flooring at lookout tower.

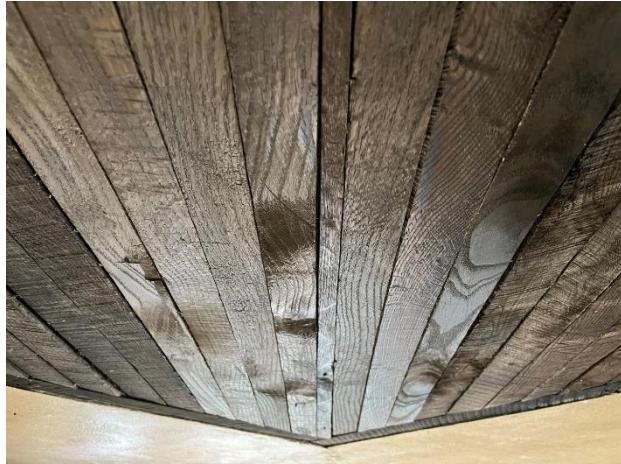
Figure 410. Underside of wood-framed flooring at lookout tower.

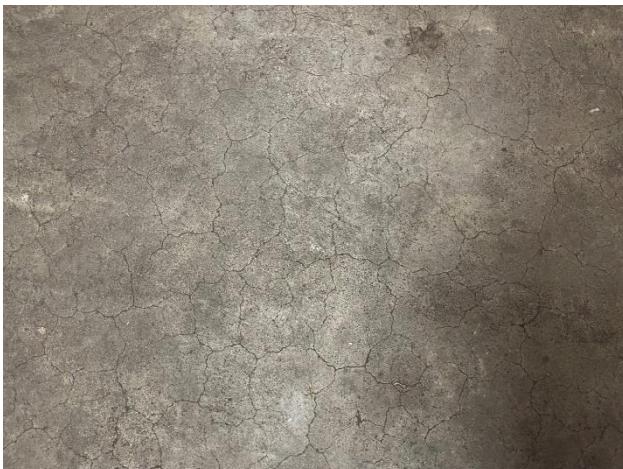
Non-original flooring systems include the cast-in-place concrete flooring at the north annex (Figure 410). The flooring of the north annex abuts the stone-paved flooring and threshold at the east room. The covered patio, an exterior space located north of the north annex, has a concrete-paved deck that is shared with the exterior north terrace.

Figure 411. Non-original flooring systems include the concrete flooring located at the north annex.

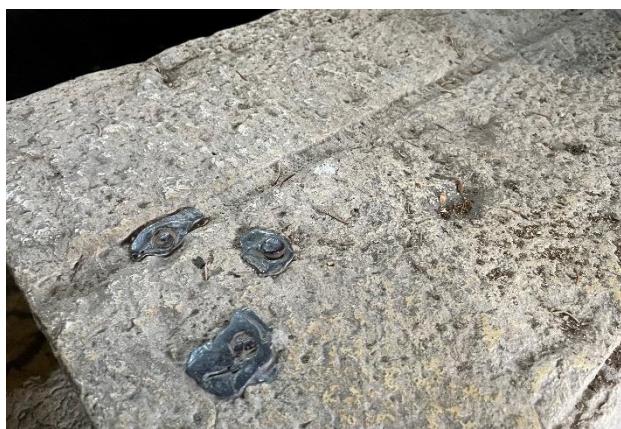
Figure 429. Embedded anchors and routed channel in stone indicate a previously installed screen feature on stone.

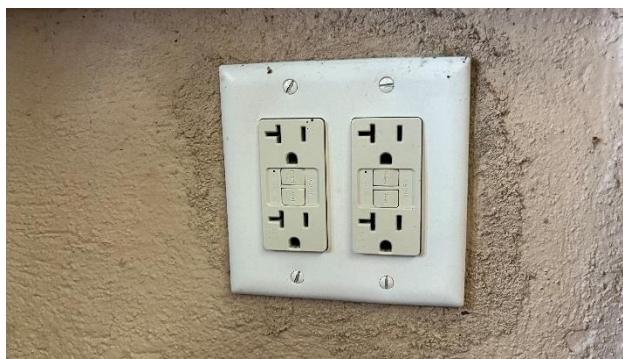
Based on conditions observed, the original electrical wiring has been removed and replaced with PVC-jacketed wiring routed through flexible coiled steel conduit. The conduit is mostly routed through the wood-framed roof eaves that are open and accessible from the interior (Figure 435). At rooms with exposed roof framing, the conduit is attached to wood joists and extends to surface-mounted ceiling light fixtures. The conduit at the walls is either surface-mounted or recessed within the plaster and stucco finishes. At the west room of the west pavilion and covered patio, north annex, and private dining room of the east pavilion, the conduit is set within the walls and supports wall-mounted light fixtures, switches, and GFCI receptacles recessed into the plaster walls (Figure 436 and Figure 437). At the east room, the

Figure 436. Non-original GFCI receptacle set into wall. Note evidence of previous plaster repair around the outlet.

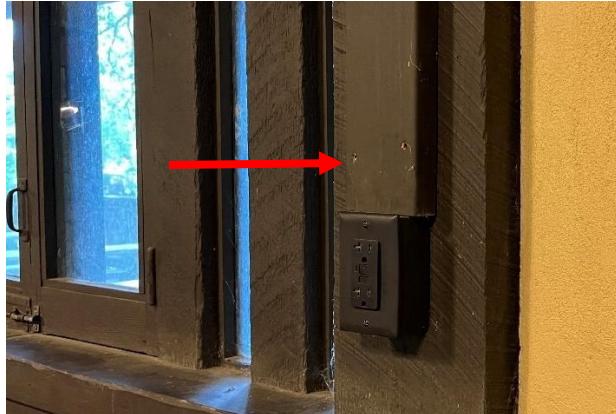
switches and receptacles are surface-mounted and some of the conduit has been covered by a notched 2x4, painted brown (Figure 438).

Figure 438. Non-original outlet with wood 2x4 concealing the surface-mounted conduit.

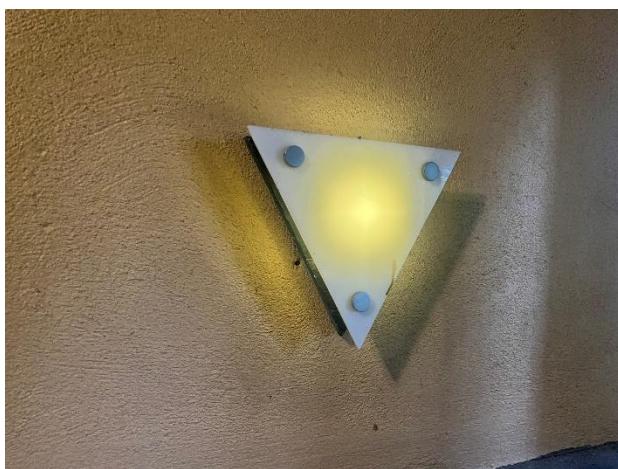
Figure 447. Triangular wall sconce at private dining room.

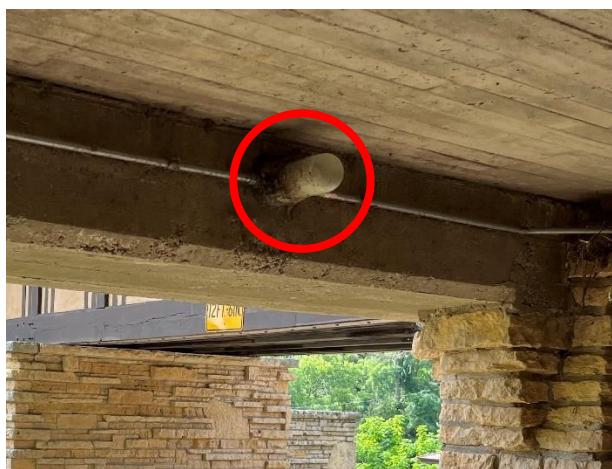
Figure 448. Non-original surface-mounted light at stone terrace.

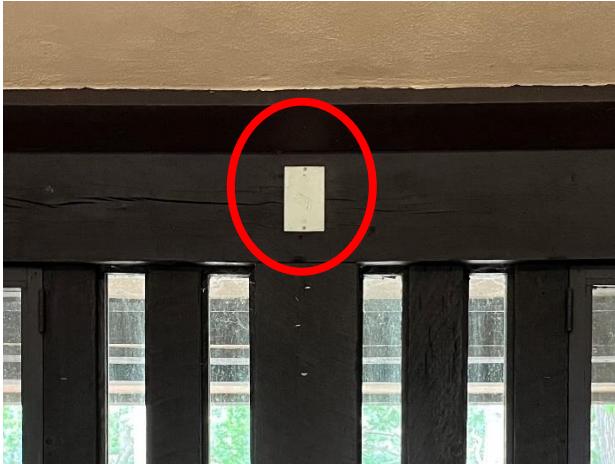
Figure 449. Cover plate over abandoned junction box.

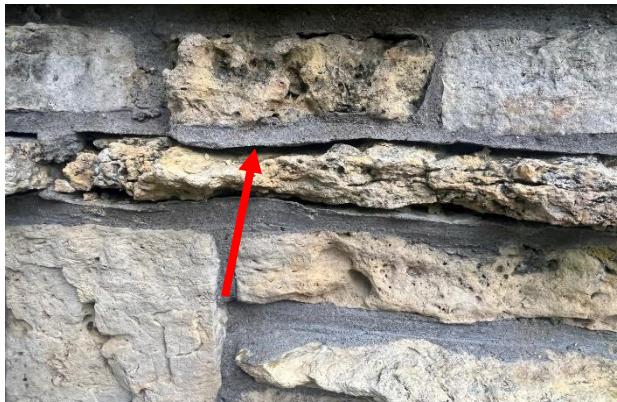
- *Spalling and Deterioration of Stone Along Mortar Joints.* At a few locations, spalling and erosion of the stone was observed along mortar joints (Figure 450, Figure 451, and Figure 452). The mortar joints remain intact; however, the stone is deteriorated and there are gaps or spalls along the joints.

Figure 450. Spalling and erosion of stone along a mortar joint.

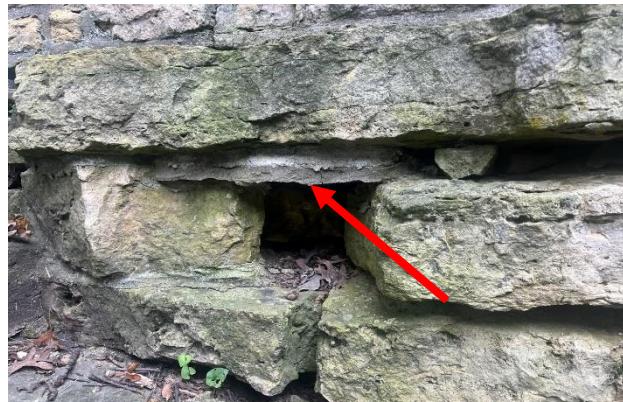
Figure 451. Spalling and erosion of stone along a mortar joint. Arrow shows continuous mortar above a stone spall.

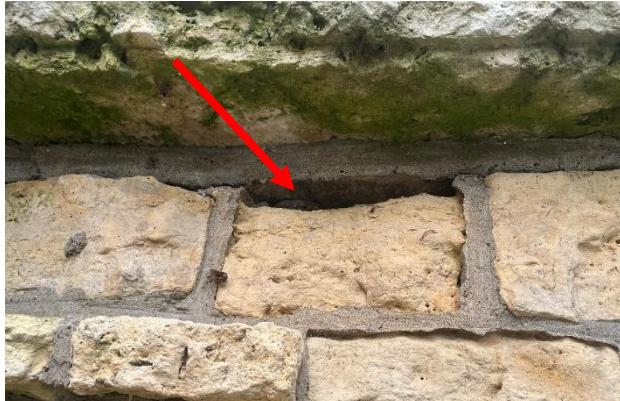
Figure 452. Spalling and erosion of stone along a mortar joint.

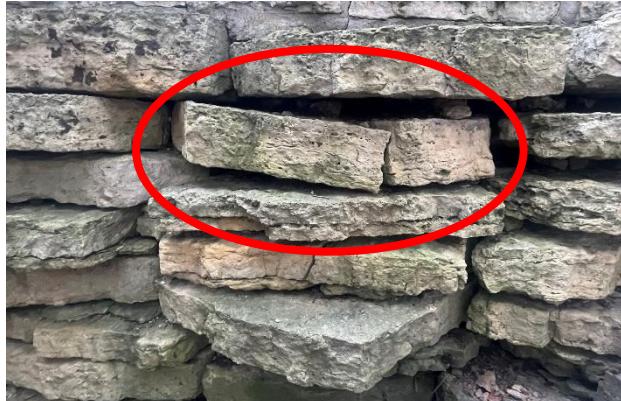
- *Individual Cracks Stone Units at Retaining Wall.* The retaining wall that supports the stone balustrade at the top of the archway stair has individual units that are cracked. At a few locations, the cracking extends the full depth of the stone and the stone has displaced (Figure 453).

Figure 453. Cracking extending the full depth of the stone, with stone displaced.

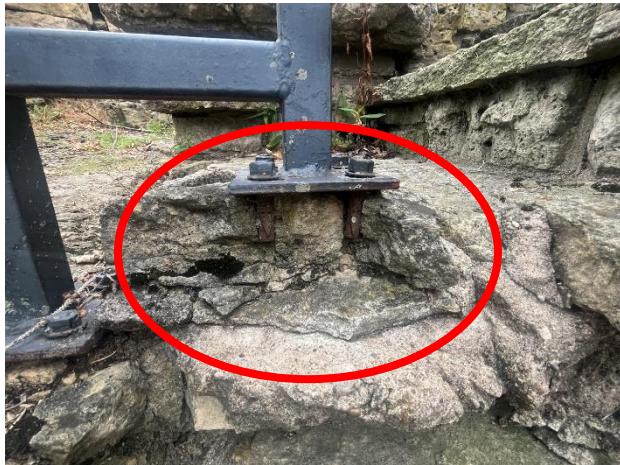
- *Spalled Stone at Anchor Penetration.* One of the stone stair treads at the east stair has spalled (Figure 454). The spall is associated with embedded anchors for a stair railing. The embedded steel guardrail post is in good condition but the metal anchors used to secure the guardrail were observed to be corroded.

Figure 454. Spall at the end of a stone stair tread at the east stair.
