Caldwell-Designed Structures at Eagle Point Park

Historic Structures Report

2601 Shiras Avenue
Dubuque, Iowa 52001

April 16, 2025
WJE No. 2024.0714.0

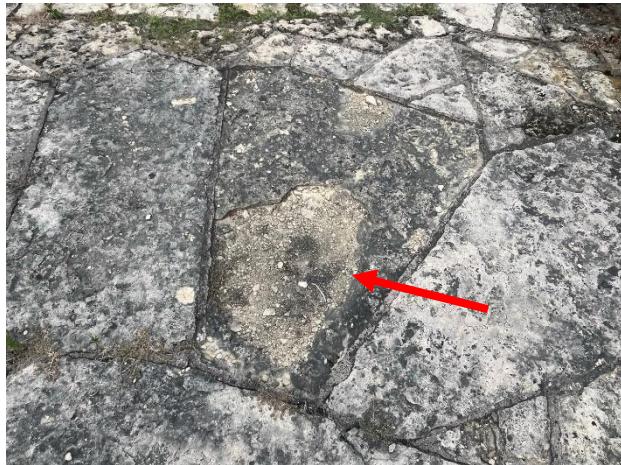
- *Cracked and Spalled Stone Pavers.* Several of the stone pavers at the stairs have distress that include cracking at stone tread units, surface spalling and pitting, and full-depth spalling of the pavers. Cracking typically extends across stone units and measures less than 1/16 inch wide. Surface spalling was observed at the face of stone units and consists of a loss of surface material to a depth of as much as 1/2 inch (Figure 455). Localized areas of full depth stone paver spalls were observed at stair treads and landings, where the edge of the stone paver is exposed to view (Figure 456).

Figure 455. Surface spalling at the face of a stone unit.

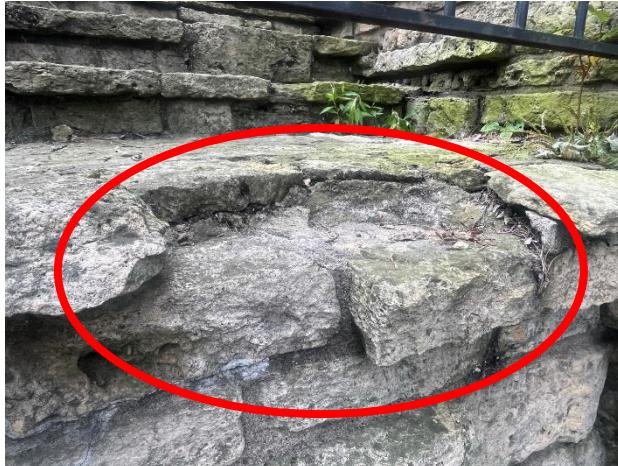
Figure 456. Localized spall the full depth of a stone paver.

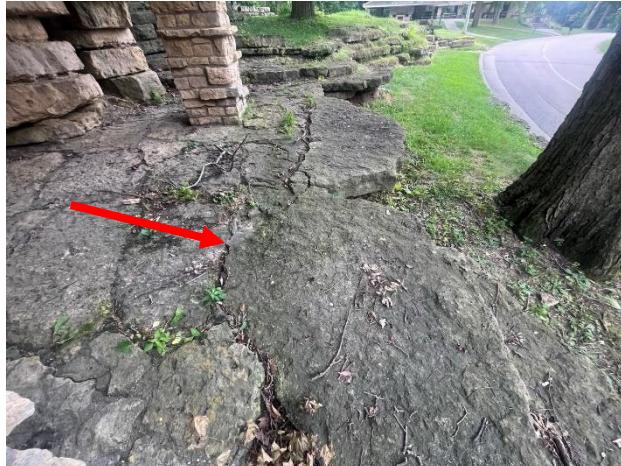
- *Erosion of Foundation at Stone Paving.* The stone paving at the north end of the covered stone terrace is cracked and displaced. The cracking runs along joint lines, parallel to the length of the terrace. The stone units to the west of the crack are displaced and sloped away from the terrace (Figure 457). Stone units around the base of the stone terrace piers were likely installed onto the concrete foundation of the pier and remain intact and level (Figure 458).

Figure 457. Displaced stone unit, sloped away from the terrace.

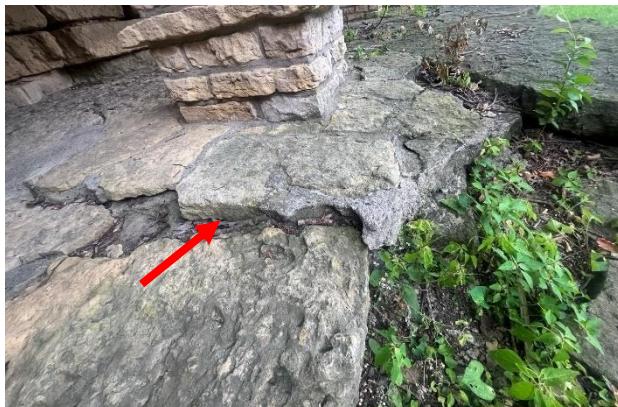
Figure 458. Displacement of stone pavers adjacent to concrete footing for pier.

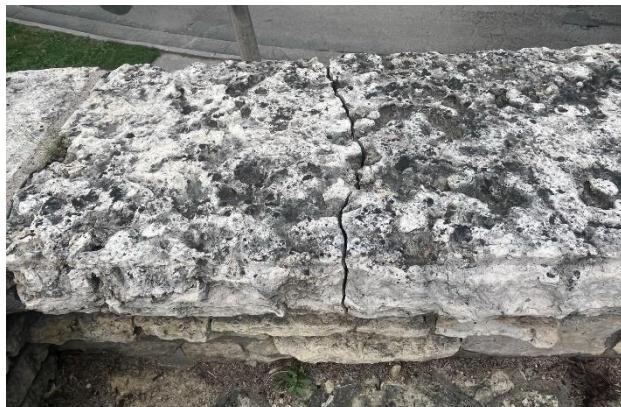
- *Cracking at Stone Below Coping.* Cracking was observed at the west stair that extends from an open crack, measuring 1/8 inch wide, and vertically through stone units and mortar joints (Figure 459 and Figure 460). The cracking extends the full height of the wall and the lower 5 feet exhibited soiling and staining indicative of water infiltration (Figure 461).

Figure 459. Cracking at coping unit.

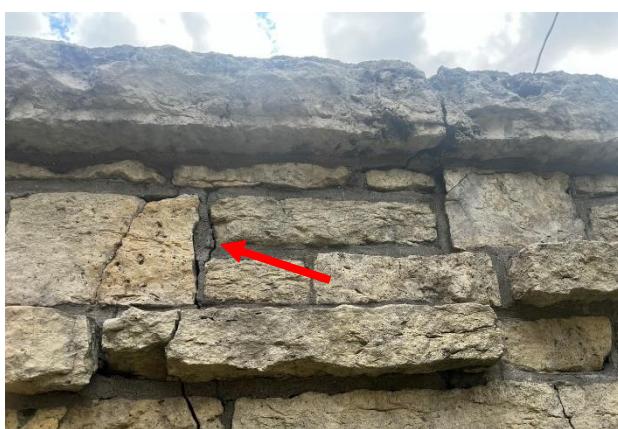
Figure 460. Cracking at stone wall that extended from coping.

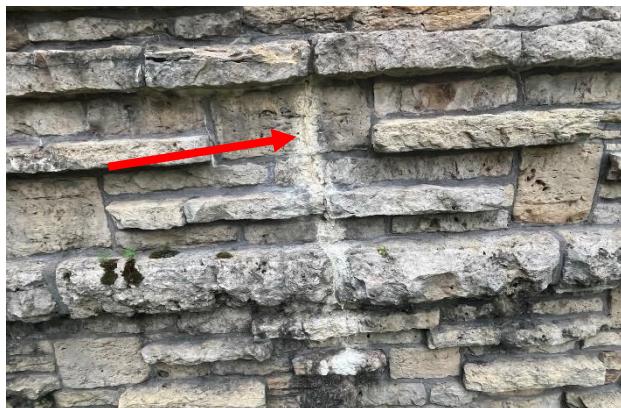
Figure 461. Efflorescence at lower portion of a vertical crack.

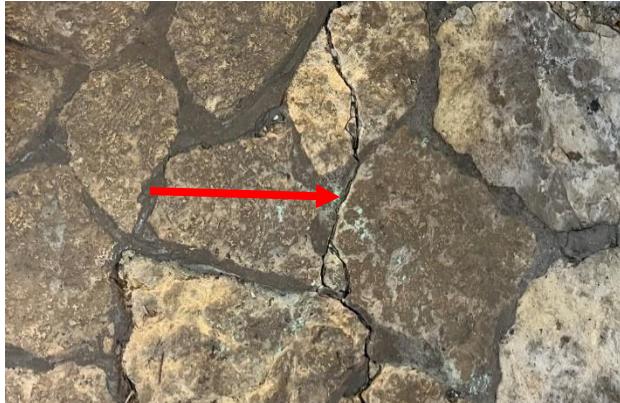
- *Cracking at Stone Pavers.* Cracking was observed at the stone paving at the east end of the bridge. The crack is located along the south side of the bridge and extends for approximately 15 feet, parallel to the south wall of the bridge and to the south terrace door (Figure 462). The crack extends through stone units, mortar joints, and cementitious patch repairs that were likely installed to address damage to the stone.

Figure 462. Cracking at stone floor pavers.

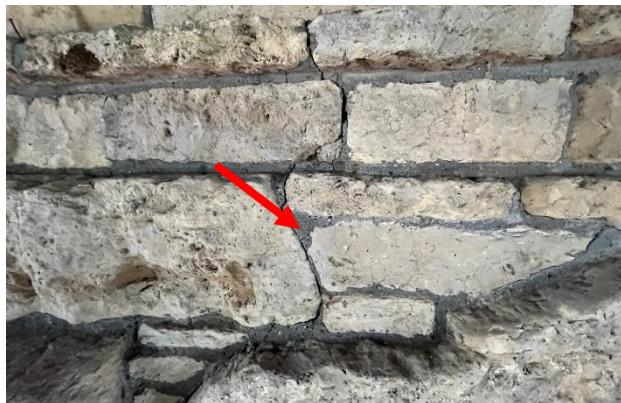
Figure 463. Vertical cracking at west room fireplace.

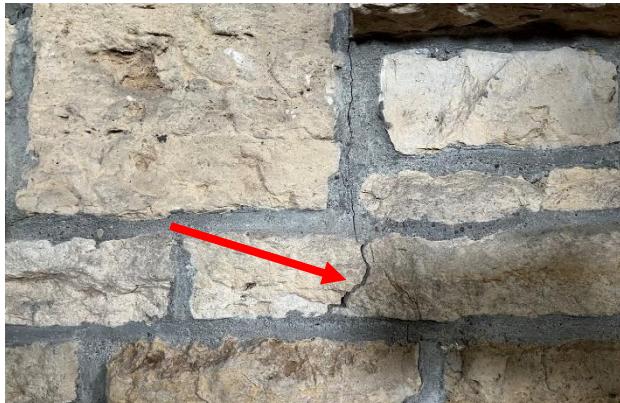
Figure 464. Vertical cracking at west room fireplace.

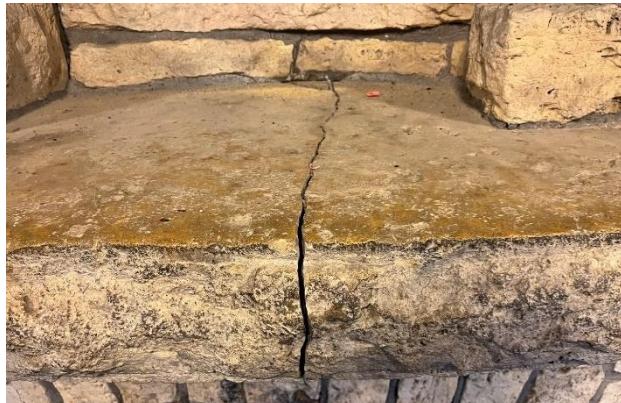
Figure 465. Cracking at mantel of east room fireplace.

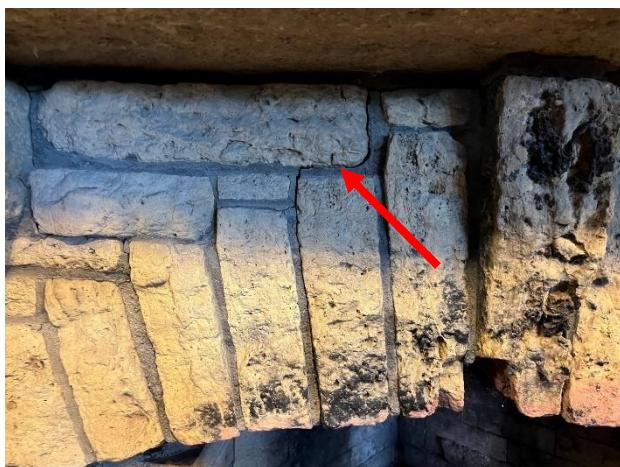
Figure 466. Cracking at stone below mantel at east room fireplace.

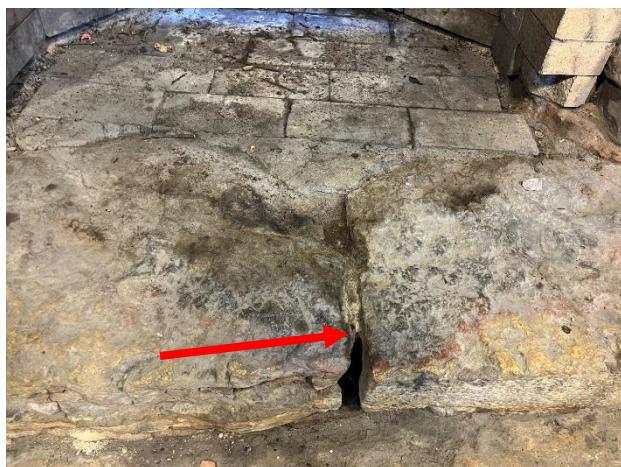
- *Open Joints at Stone.* The stone hearth at the east fireplace has open mortar joints between stone units as well as at the brick firebox (Figure 467).

Figure 467. Open joint at hearth stone.

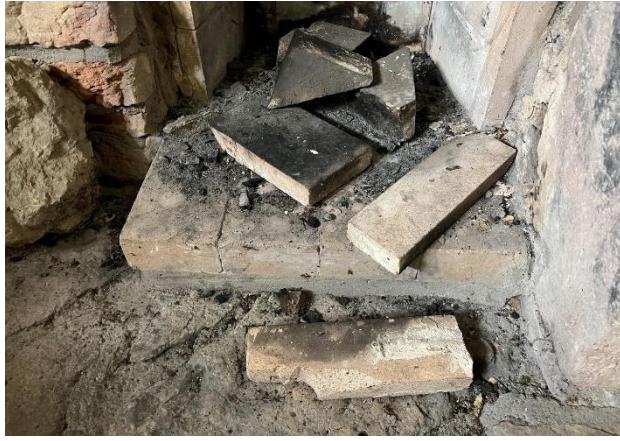
- *Displaced Firebox Brick.* The thin brick cladding at the firebox of the west fireplace has broken and come loose from the wall. Approximately four of the upper brick units have become loose (Figure 468). One stone unit at the fireplace surround has a large spall (Figure 469).

Figure 468. Four of the upper brick units that are loose.

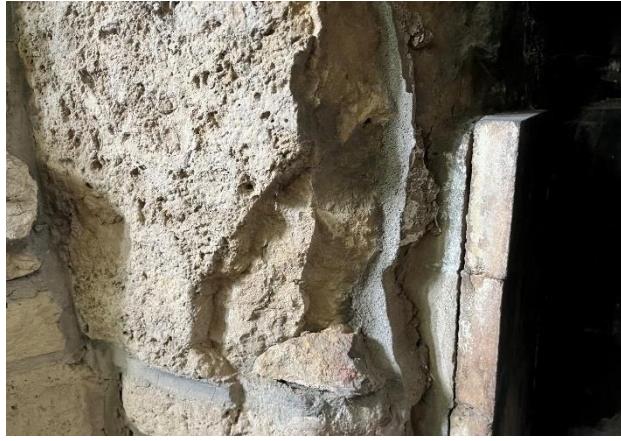
Figure 469. Spalled stone unit adjacent to firebox.

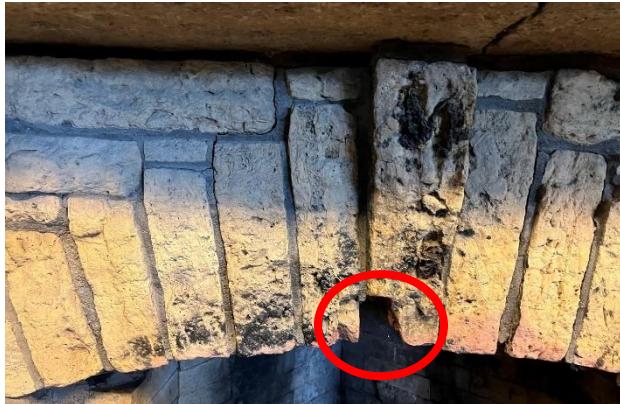
Figure 470. Spall at the bottom of the stone keystone at the fireplace mantel.

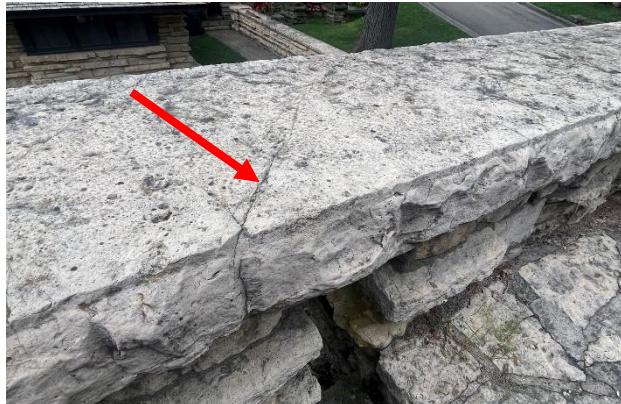
Figure 471. Cracking at the upward-facing surface of a ledge unit.

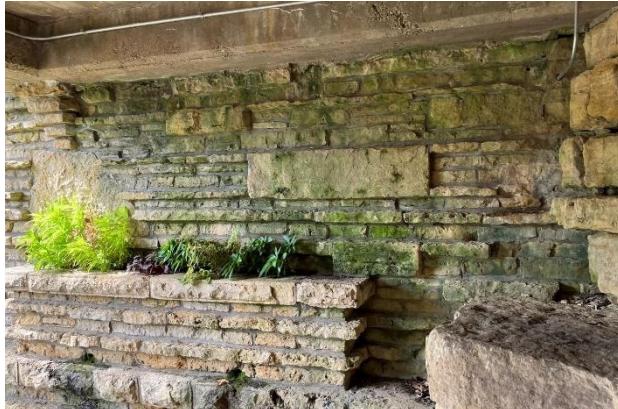
Figure 474. Biological growth above the planter box at the covered stone terrace.

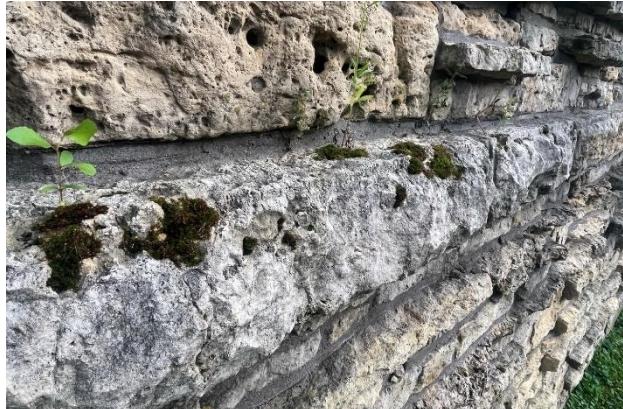
Figure 475. Plants and biological growth at the stone cladding.

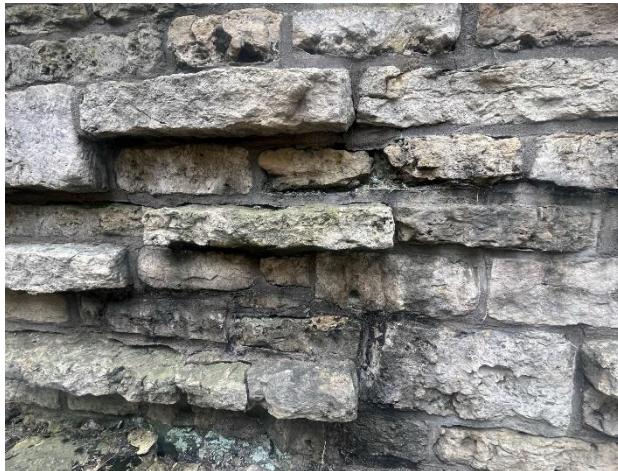
Figure 476. Black-colored soiling at the stone units at the cheek wall for the east stair.

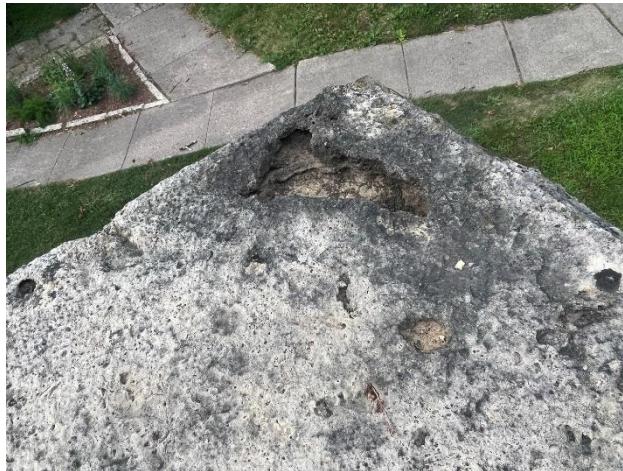
- *Divots and Voids in Stone.* At several locations, large divots and voids were observed in the stone (Figure 477). The voids appear to be associated with natural erosion of the stone that may have been accelerated at isolated locations on the stone. Voids and divots in the stone have the potential to collect more debris, water, and biological growth.

Figure 477. Large divot in stone at coping unit.

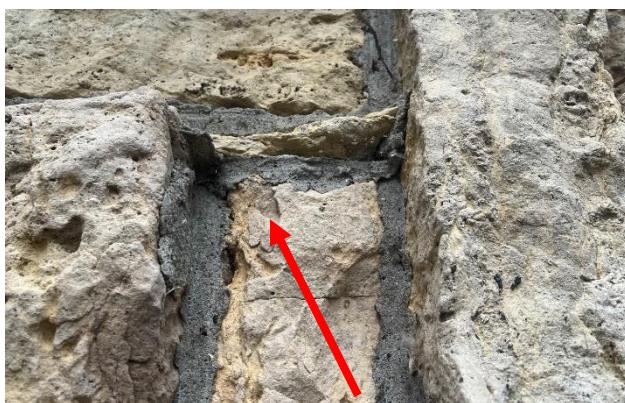
- *Chipped Stone Drip Ledge.* At the east elevation of the archway, there are thin stone ledges intended to direct water to the sides of the arch. The stone ledges have chipped (Figure 478).

Figure 478. Chipped stone ledge unit.

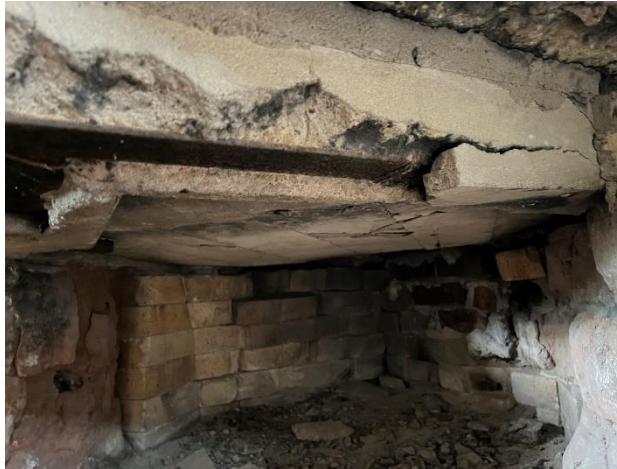
- *Spalled Concrete Encased Lintel.* The concrete encasing the metal lintel over the west fireplace has spalled and the steel is exposed to view (Figure 481). The lintel supports two mantel stones and the mortar joint between the stones is cracked. In addition to the distress at the mantel, the brick cladding at the firebox below the lintel is loose and displaced (Figure 482).

Figure 481. Spalled concrete exposing the metal lintel over the west fireplace.

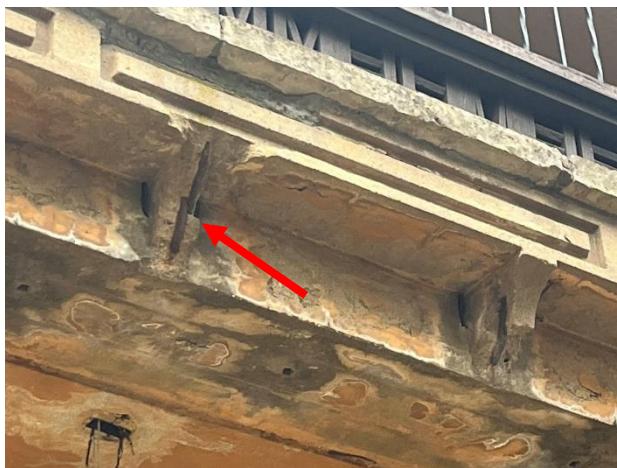
- *Spalled Concrete.* The decorative concrete brackets at the underside of the planter box that surrounds the balcony have spalled and the steel reinforcing is exposed to view (Figure 483). The reinforcing exhibits minor surface corrosion. Spalling and cracking was also observed at the vertical surface of the planter boxes and balcony soffit (Figure 484).

Figure 483. Spall at concrete bracket at balcony.

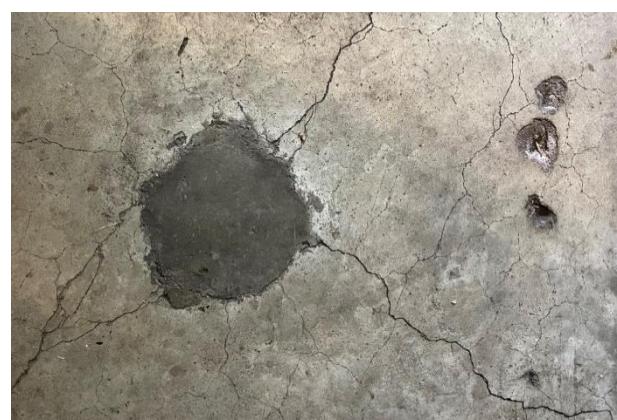
- *Cracking and Spalling at Concrete Flooring.* Cracking and spalling was observed at the concrete flooring of the north annex (Figure 485 and Figure 486). Hairline cracks radiated from a location with a previous patch repair. Spalling was observed near the base of a door frame.

Figure 485. Cracking and spalling at the concrete flooring of the north annex.

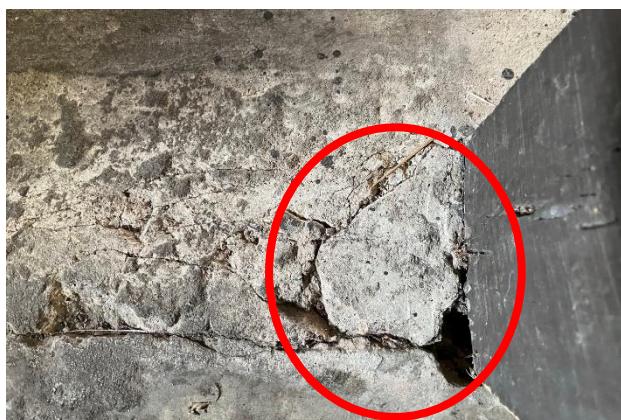
Figure 486. Crack and spall at concrete flooring of north annex.

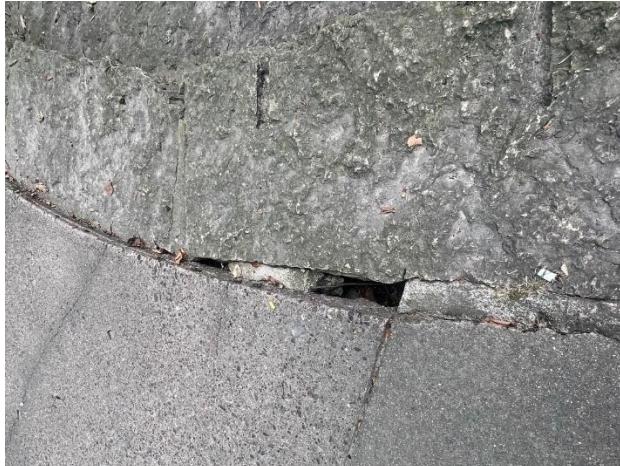
- *Open Joint Between Paving Units.* The joint between the non-original concrete paving and stone paving at the top of the archway stair is open (Figure 487). The mortar is cracked and has fallen loose at many locations along the joint.

Figure 487. Open joint between concrete sidewalk and stone stair.

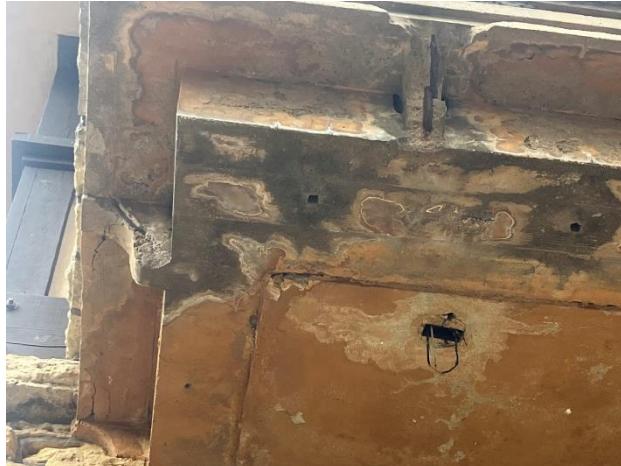
- *Moisture Staining.* Moisture staining was observed at the concrete at the underside of the balcony (Figure 488). The staining is most prevalent along the edges of the balcony and at an embedded abandoned electrical junction box. The tinted finish on the concrete has eroded.

Figure 488. Moisture staining at the concrete at the underside of the balcony.

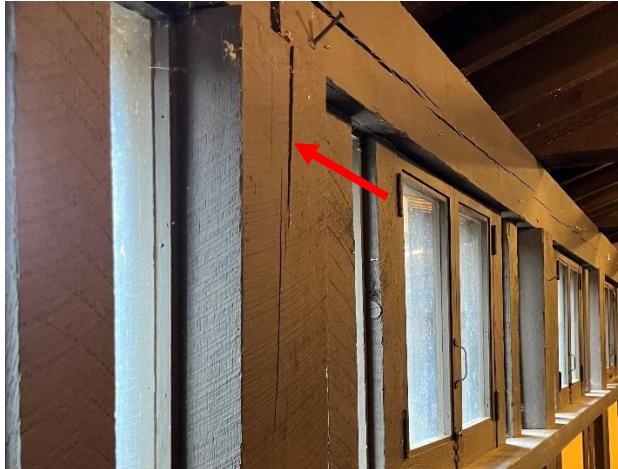
- *Splits and Cracks in Wood Post Framing.* A number of the 8 inch by 8 inch wood wall framing posts exhibit splits that extend most of the height of the post (Figure 489). At approximately three locations along the west elevation of the east room, the splits are full depth, measure approximately 1/2 inch wide, and could be viewed from the interior and exterior (Figure 490). Where multiple split wood posts were observed, such as at the west elevation of the east room, other distress conditions were also observed, such as door frames that are not plumb and sagging, displacement and bowing of wood roof framing beams, and separations at joints between wood framing members (Figure 491, Figure 492, and Figure 493).

Figure 489. Vertical split in wood post framing viewed from interior.

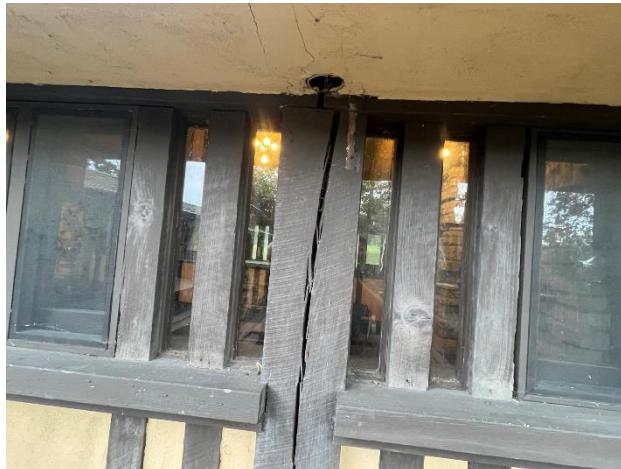
Figure 490. Vertical split in wood post framing, viewed from exterior.

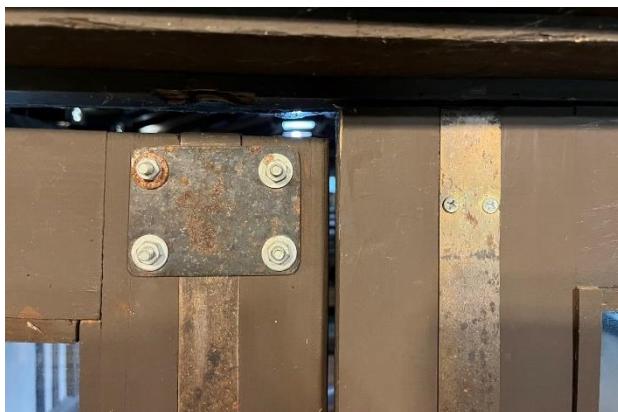
Figure 491. Door leaf out of plumb near area of displaced roof framing.

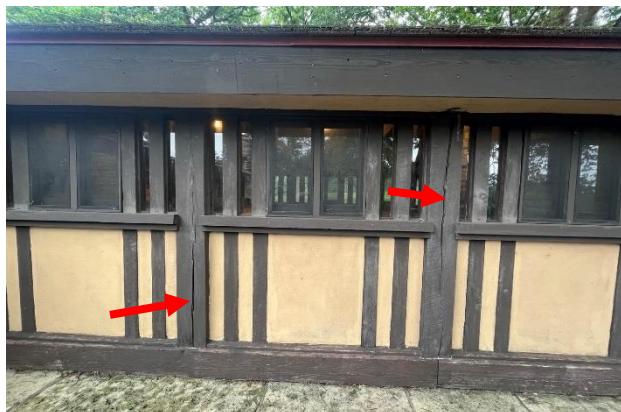
Figure 492. Vertical splits in wood post framing, viewed from exterior.

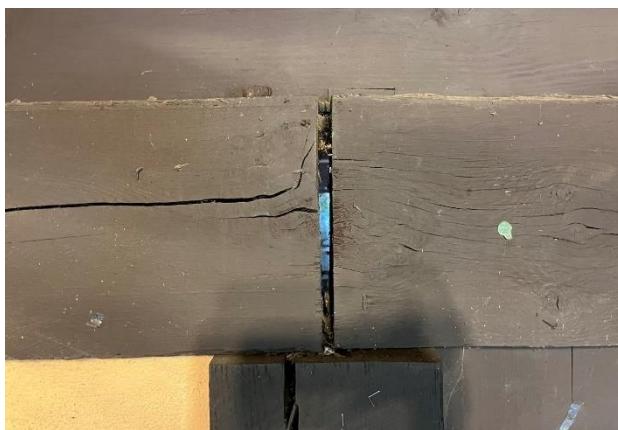
Figure 493. Separations at joint between wood framing members.

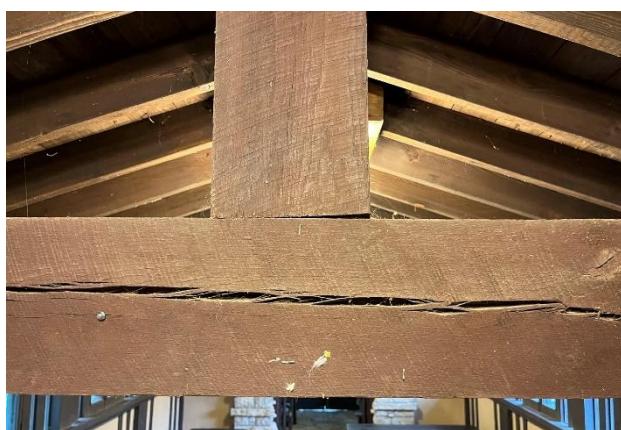
- *Splits and Displacement of Wood Beams.* Splits were observed along the center of some wood roof beams that span across the east room (Figure 494 and Figure 495). The splits extend most of the length of the beams. In addition to splits, the beams appear to be bowed and displaced at the center. When evaluated with a level, the displacement was measured to be 1/8 inch per foot at some locations. The areas with the most significant distress align with the three wood framing posts that exhibit distress, as described above.

Figure 494. Split along the center of a roof beam that spans across the east room.

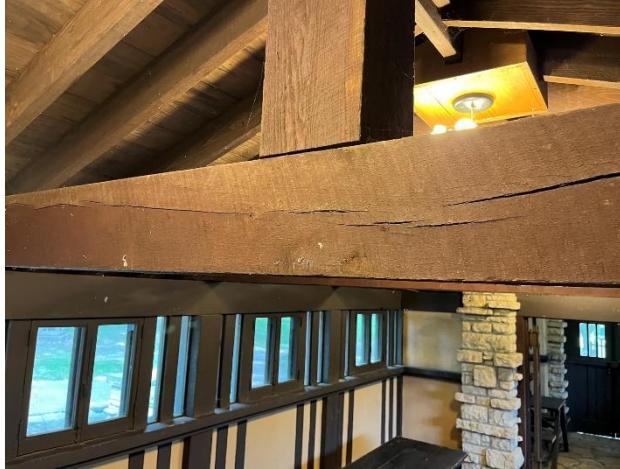
Figure 495. Splits along the center of a roof beam that spans across the east room.

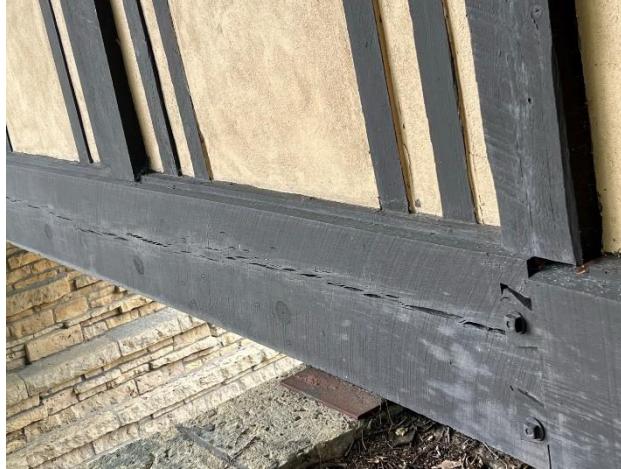
- *Splits at Bridge Framing.* The east portion of the south bridge framing member exhibits a split that extends approximately 20 feet along the middle of the wood beam (Figure 496). The split originates from a dovetail joint and anchor connection between framing members.

Figure 496. An approximately 20-foot-long split extending through the middle of the wood beam at the east portion of the south bridge framing member.

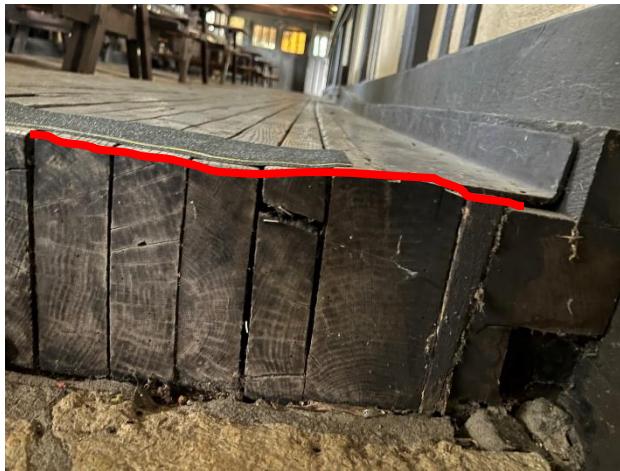
- *Irregularities in Wood Bridge Decking.* The bridge deck surface is irregular and appears to have localized areas where the flooring is crowned (Figure 497). Many of the wood members also exhibit some warping which has caused open joints between the wood floor beams (Figure 498). It does not appear that the bridge deck was originally intended to have a finished and level floor surface as evidenced by all of the wood beams having slightly different heights. The irregularities appear to have been accentuated by warping and twisting of the deck beams.

Figure 497. Irregular bridge deck surface and localized crowned area.

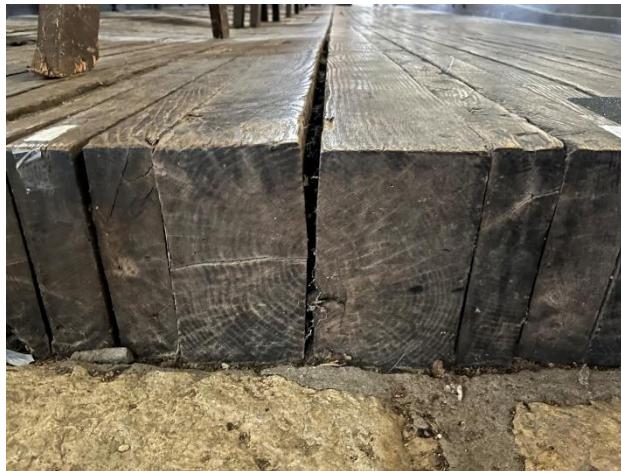
Figure 498. Open joint between wood floor beams resulting from warping.

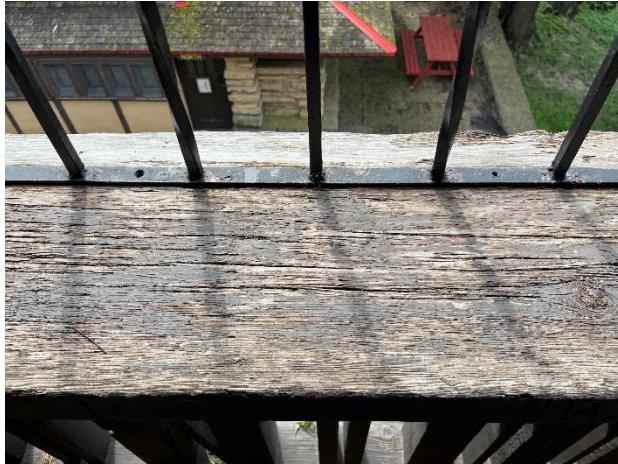
- *Deteriorated Wood at Terrace Guardrails.* Distress and deterioration at the wood railings included open joints at mitered corners, biological growth, bowed and twisted boards, peeling paint, splits, insect damage, and areas where wood was found to be damp and soft when probed with an awl (Figure 499, Figure 500, Figure 501, and Figure 502).
- *Pest Infestation.* Insect nests were observed at window openings, and at projecting stone units on the building facade (Figure 503 and Figure 504).

Figure 499. Deterioration at wood top rail of balcony guardrail.

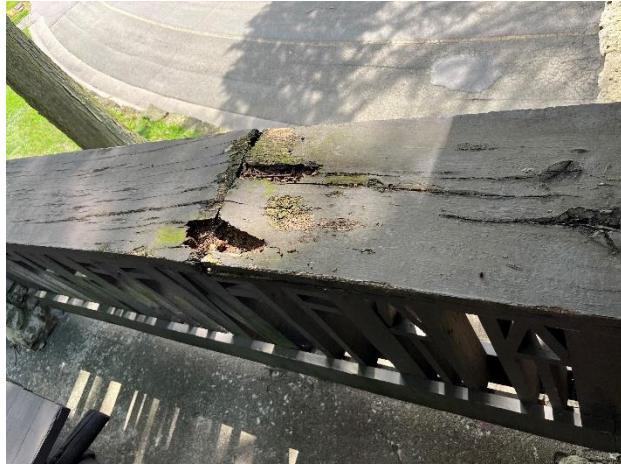
Figure 500. Severe deterioration and biological growth at wood of top rail of railing.

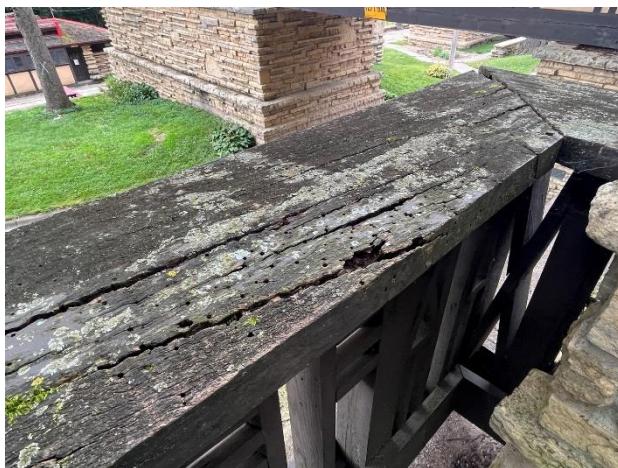
Figure 501. Severe deterioration and biological growth at wood of top rail of railing.

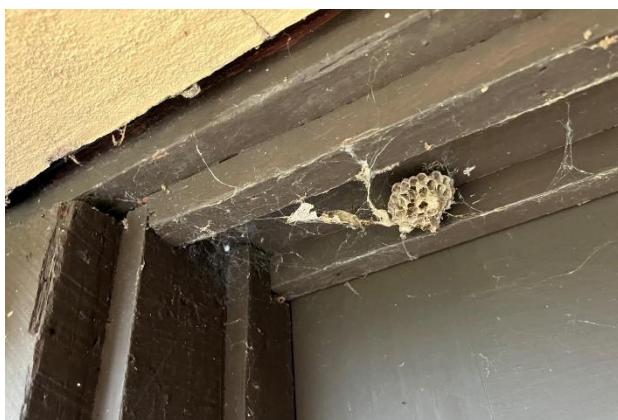
Figure 503. Insect nest at wood window framing.

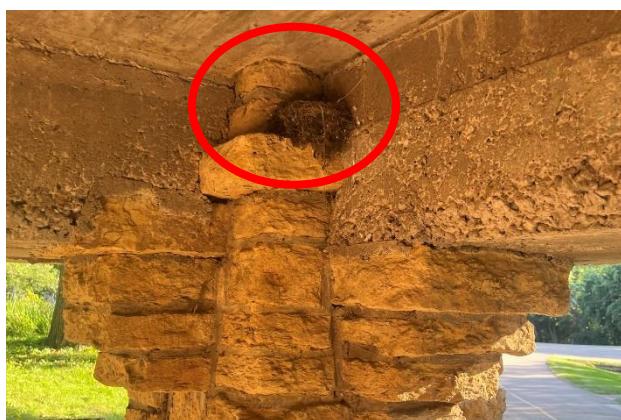
Figure 504. Birds nest at recess between stone units.

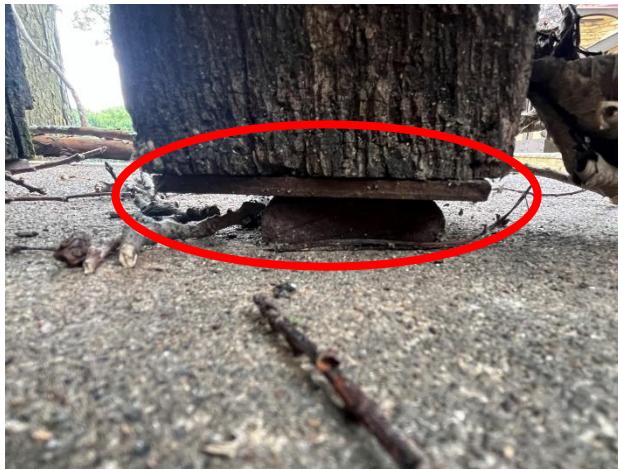
- *Corrosion of Steel Post Supports at Guardrails.* The steel plates that support the wood posts for the terrace guard rails exhibit surface corrosion (Figure 505).
- *Abandoned Anchors.* At a few locations, metal anchors, junction boxes, and eye hooks were observed at the stone cladding and stucco soffits that are no longer being actively used (Figure 506 and Figure 507). The anchors and embedment's exhibit surface corrosion with some staining or cracking of the adjacent stone or stucco.

Figure 505. Surface corrosion at a steel plate that supports a wood post for the terrace guard rail.

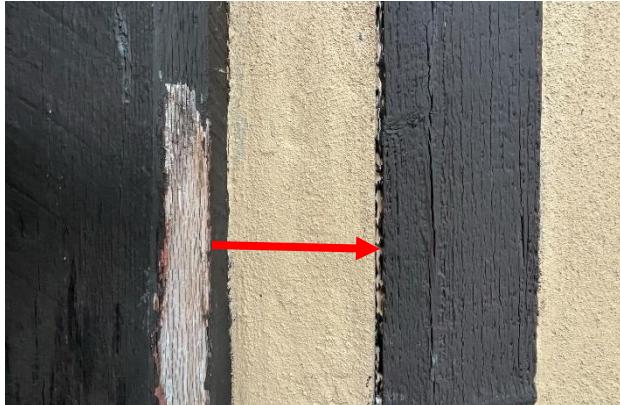
- *Gaps in Wall Framing.* Gaps and open joints were observed between the stucco wall and the wood post framing (Figure 509 and Figure 510). The gaps measure as much as 1/4 inch in width and daylight was visible through the joint.

Figure 509. Gap between stucco wall framing and wood post framing.

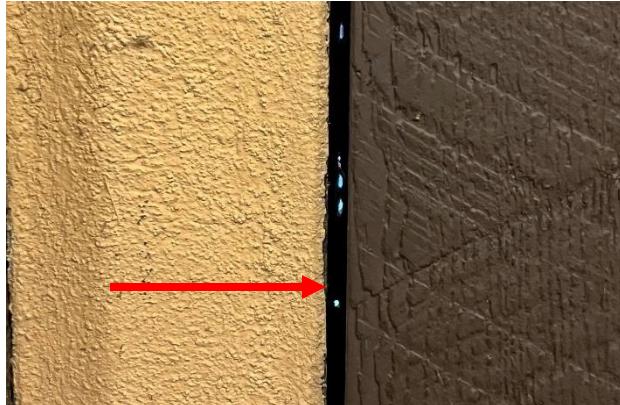
Figure 510. Open joint between stucco wall framing and wood post framing.

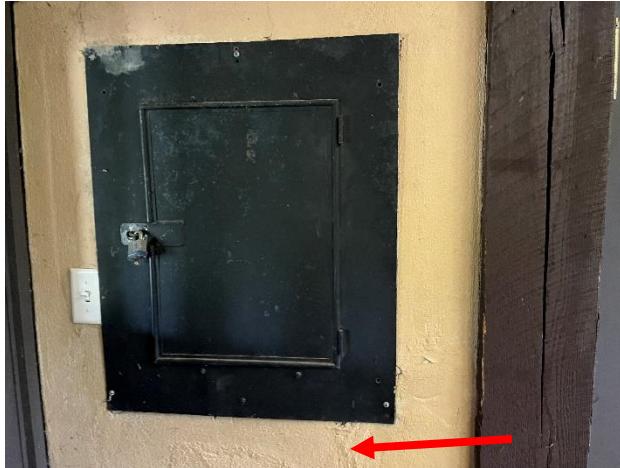
- *Cracking of Stucco Finish.* A vertical hairline crack and evidence of a previous patch repair were observed at the stucco finish (Figure 511). The crack appears to extend from the corner of the non-original electrical box embedded in the wall. The cracking may be associated with installation of the non-original box.

Figure 511. Vertical hairline crack extending from the corner of a non-original electrical box.

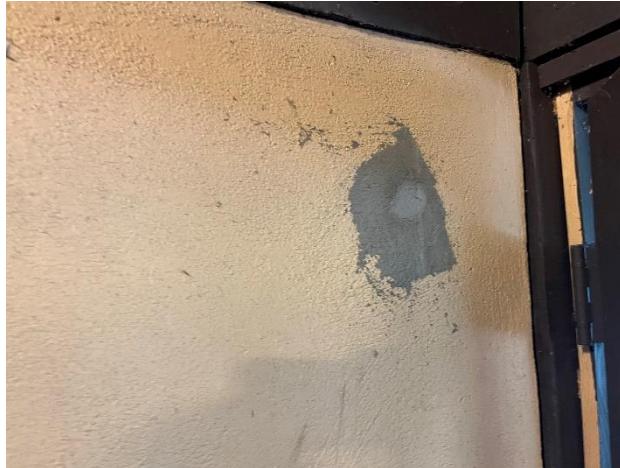
- *Previous Stucco Repairs.* Previous localized patch repairs have been performed at the stucco. The patches were typically not painted (Figure 512).
- *Unsealed Wall Penetrations.* Non-original penetrations in the stucco walls are typically associated with installation of non-original electrical conduit. Some of the penetrations were not treated, leaving a gap between the conduit and stucco (Figure 513).

Figure 512. Unpainted patch at previous patch repair.

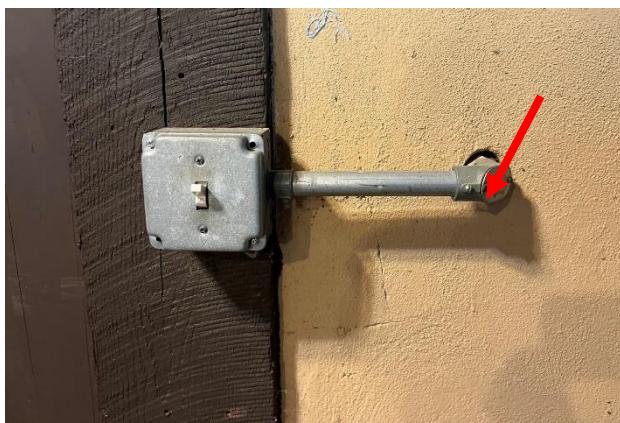
Figure 513. Untreated penetration with gap between conduit and stucco.

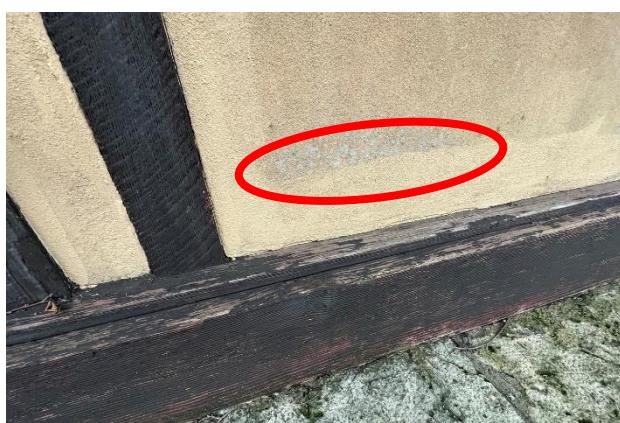
- *Peeling Paint at Stucco.* At a few locations, the paint at the stucco walls has failed and the underlying stucco is exposed to view (Figure 514).

Figure 514. Failed paint at stucco wall exposing the white underlying stucco.

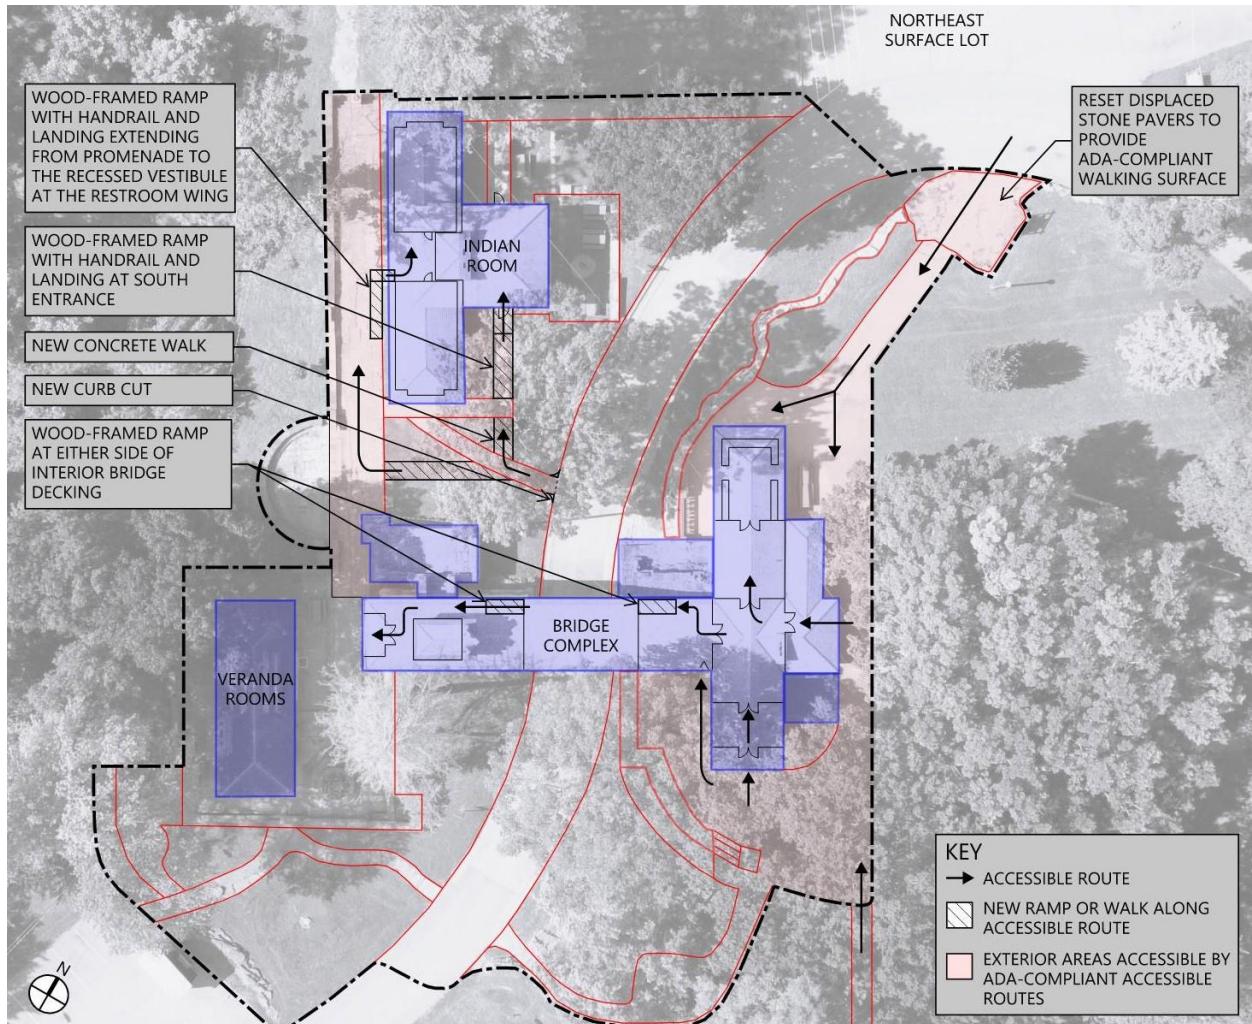
Figure 521. Schematic plan depicting a means for improving site accessibility without impacting the historic integrity.

Considering the overarching treatment approach of preservation, Figure 521 shows a schematic plan for improving access across the site and within buildings while maintaining historic integrity. The plan relies on the existing non-original concrete and original stone-paved walks and identifies approaches for developing accessible routes while preserving the historic material. Conceptually, the schematic design is intended to be minimally intrusive to the existing original material, such as the stone-paved walks, by using surface-mounted ramps to navigate stepped terraces, raised construction, and door thresholds. Ramps would likely include wood-framed systems installed on the existing stone or concrete paving in a

Other approaches could be considered for improving accessibility across the site, beyond the preservation approach outlined below and depicted in Figure 521. However, these other approaches would likely require more intervention and have a more significant impact on the buildings and site. The schematic design is intended to depict how site access could be improved with minimal interventions and to identify those locations where universal access, if desired, may require more significant alterations that may impact the historic character and integrity of the site. The schematic design can assist in framing the objectives for future studies and repair projects associated with site access. A separate and detailed study should be performed of the site to identify the potential accessibility options. The study would likely include a topographic review of the site; define objectives as to what features the City would like to provide access; review codes relevant and applicable to the specific project; and evaluate different design options and their impact on the historic site.
